Illustrated Catastrophes

By Joe Tedesco, NEC Columnist

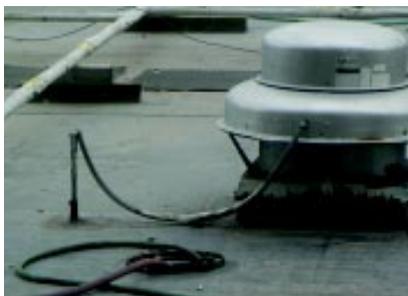
BROKEN LIQUIDTIGHT FLEXIBLE METAL CONDUIT

In addition to supplying ventilation equipment, this piece of LTFMC was also used as a perch by a few pigeons that frequent this hotel rooftop everyday.

Lack of proper support and the weight of the pigeons and their droppings probably caused these connections to break and show signs of lost electrical continuity.

This installation violates 300.10 Electrical Continuity of Metal Raceways and Enclosures. Metal raceways, cable armor, and other metal enclosures for conductors must be metallically joined into a continuous electric conductor and must be connected to all boxes, fittings, and cabinets so as to provide effective electrical continuity.

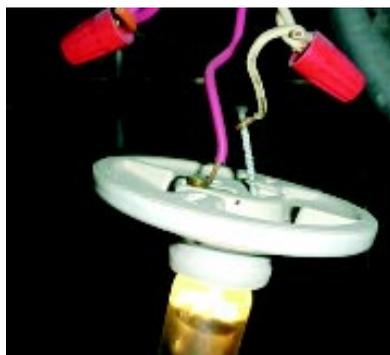
SCREWED-UP CONNECTION

David Lewis, a service technician and assistant manager for Haymaker Electric, found this keyless lampholder in the electrical equipment room of an 18-story office building in Birmingham, Ala.

The lampholder isn't secured to the outlet box because the installer didn't use the supporting screws. As a result, it's hanging from the switch leg and the grounded circuit conductor.

The wire connectors show where there were other spliced conductors that have been cut away. However, the use of a long screw at the termination is the real issue here because it is being misused. The person responsible for this installation clearly isn't qualified as defined by Article 100.

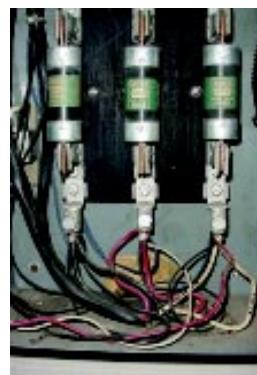
MULTIPLE CONNECTIONS

Blane Quilhot, a maintenance engineer, and his father-in-law Philip Sattler, a retired master electrician, both of Quincy, Mich., discovered this 150A disconnect while tracing the wiring for a blower control. It was connected to several lugs not recognized for use with more than one conductor. This is a common violation of Sec. 110.14(A), which requires conductors to be connected to terminal parts without damaging the conductors. The connections must be made by means of pressure connectors (including set-screw type), solder lugs, or splices to flexible leads. This installation is in violation of the requirement that any terminal used for more than one conductor and any terminal used to connect aluminum must be so identified.

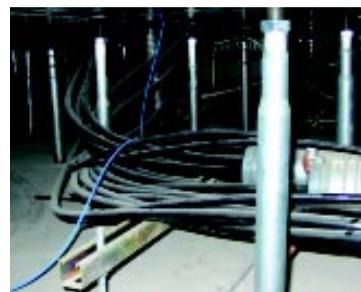
UNRECOGNIZED UNDERFLOOR WIRING

Steve Sullivan, a project engineer, discovered these feeders that run in the open from raceways bonded together in the underfloor space of an information technology equipment room. The open feeder conductors are neither enclosed in a proper raceway nor are they installed according to a recognized practice.

The installer should have complied with 654.2 and the rule in 645.5(D)(2) for areas under raised floors, which requires field-wired equipment to be installed in rigid metal conduit, rigid nonmetallic conduit, intermediate metal conduit, electrical metallic tubing, or electrical nonmetallic tubing. It must also be installed in metal wireway, nonmetallic wireway, surface metal raceway with metal cover, nonmetallic surface raceway, flexible metal conduit, liquidtight flexible metal conduit, liquidtight flexible nonmetallic conduit, Type MI cable, Type MC cable, or Type AC cable. These supply conductors must also be installed in accordance with the requirements of 300.11.
