A Accredited Inspection Service, Inc.
6742 Forest Hill Blvd # 271, West Palm Beach,, FL 33413
561-966-8868
Copyright 2004 2005
All Rights Reserved

Client: Anna Morph
Property Address: Ascospore # 8, Mycology FL 01010
Date: 6-16-06

INSPECTORS FINAL CONCLUSIONS

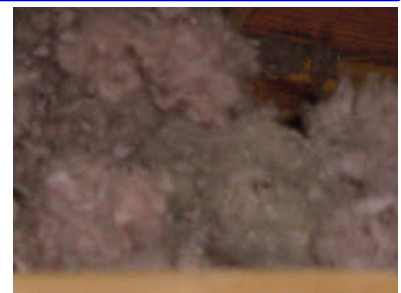
PHOTO 1

The following is a digital photo of mold on insulation in attic.

Replace all insulation at the front and rear of the houses attic.

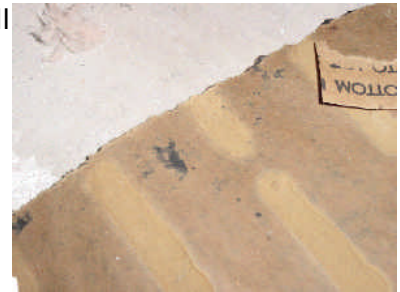
PHOTO 2

Stachybotrys mold growing on the back of drywall paper on wall that separated kitchen from hall bathroom.

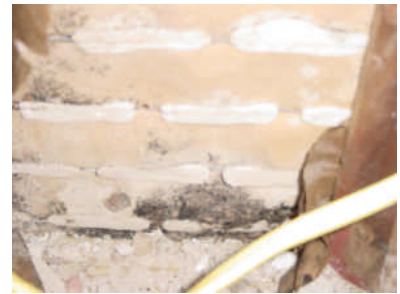
PHOTO 3

Stachybotrys mold growing on plaster hidden in wall that separated kitchen from hall bathroom.

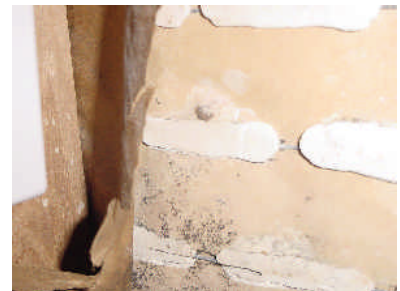
PHOTO 4

Stachybotrys mold growing on plaster hidden in wall that separated kitchen from hall bathroom.

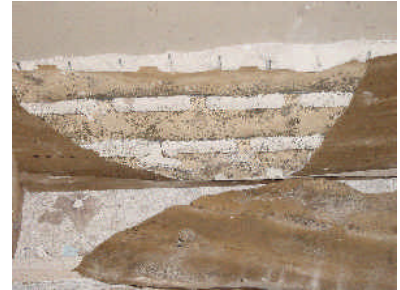
PHOTO 5 More mold on wall between kitchen and hall bathroom.

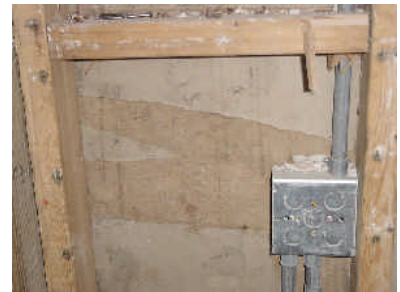
PHOTO 6 Mold and moisture stains on wall between kitchen and bathroom.

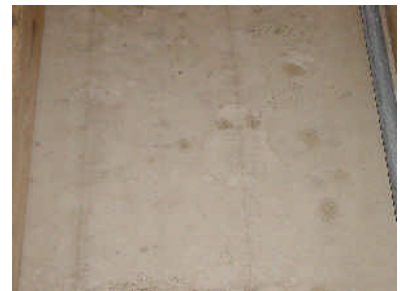
PHOTO 7 Mold and moisture stains on wall between kitchen and bathroom.

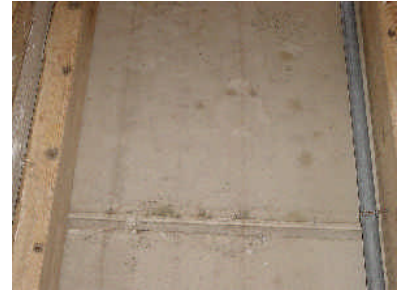
PHOTO 8

Mold and moisture stains on wall between kitchen and bathroom.

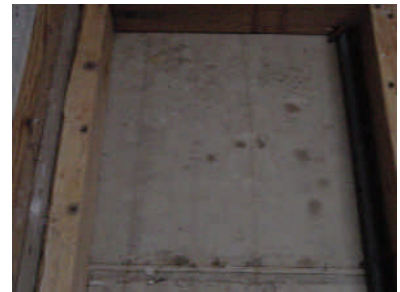
PHOTO 9

Mold and moisture stains on wall between kitchen and bathroom.

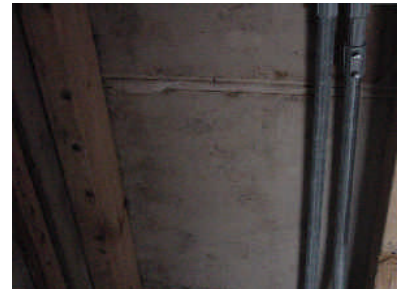
PHOTO 10

Mold and moisture stains on wall between kitchen and bathroom.

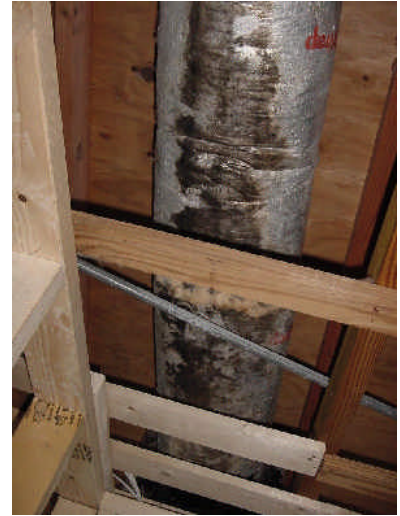
PHOTO 11

The following is a digital photo of heavy cladosporium mold growth on the insulation located on the outside of a attic AC duct.

Some branch HVAC ducts were not metal thus should be replaced, main trunk duct was the original metal duct but the insulation on its outer surface was extremely moldy thus this duct should be replaced as well, replace all ducts and plenums.

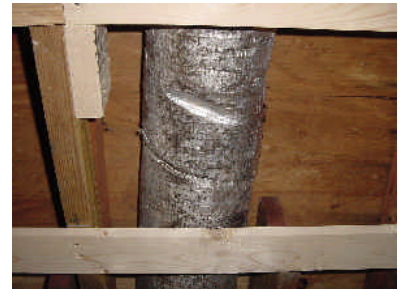
PHOTO 12

The following is a digital photo of heavy cladosporium mold growth on the insulation located on the outside of a attic AC duct.

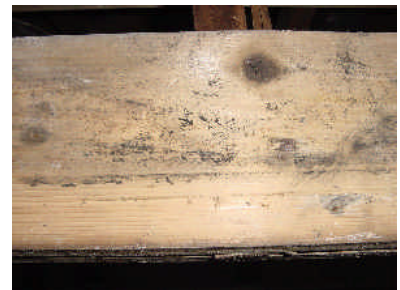
PHOTO 13

Mold on wooden header beam near kitchen and rear family room area.

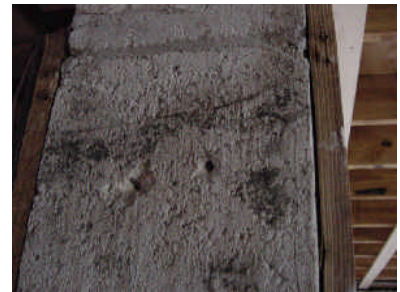
PHOTO 15 Mold on concrete near rear family room area.

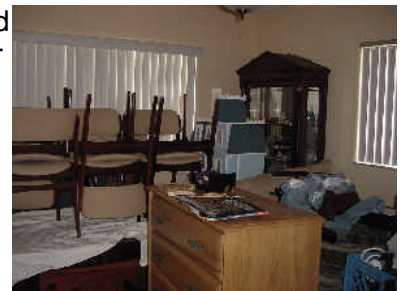
PHOTO 16 Note that during mold remediation the household items were never removed to a safe dry place for storage, nor were they left at the property and covered in protective plastic to prevent cross contamination.

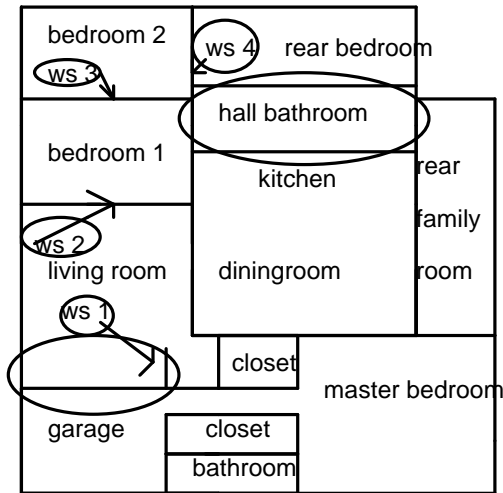
INTERIOR SCHEMATIC

The above is a diagram of the entire house, the bathroom circled received water leakage during the hurricane, and mold grew in it's walls, but it was not remediated, all areas around this bathroom were remediated. Remediate the circled bathroom, also the West wall of the living room is circled because spore levels were high in this wall.
