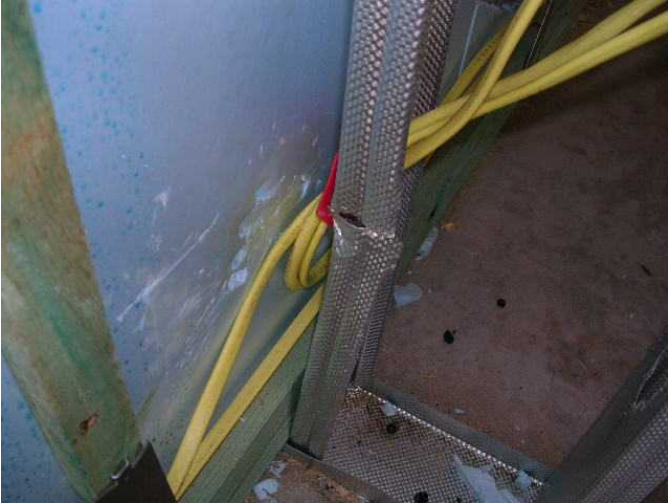
Photo 1 shows a cut stud that needs repaired. The construction supervisor was made aware of this and it will be fixed.

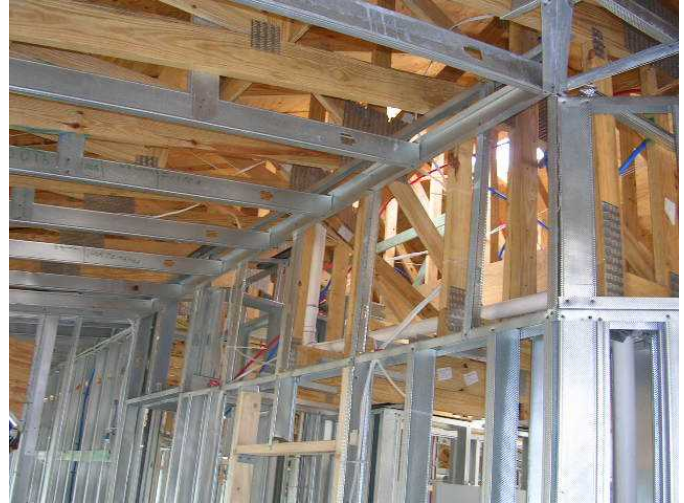
Photo 2 shows the area at the high end of the ceiling in the front living room. This framing is light-weight and may have problems supporting the weight of the ceiling drywall. Note that the ceiling joists are cantilevered and not supported by much on the end.

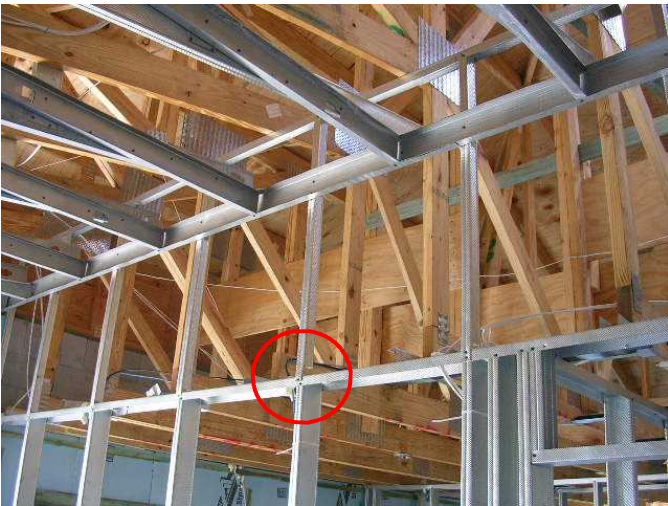
This is the same condition at the back of the home. Circled area shows the stud doesn't even rest on the plate. (Use zoom feature on adobe toolbar if needed.) It may have problems carrying the weight of the ceiling drywall. The wall drywall will tie all of this together to a certain degree, but may not prevent future settlement and cracking issues.
