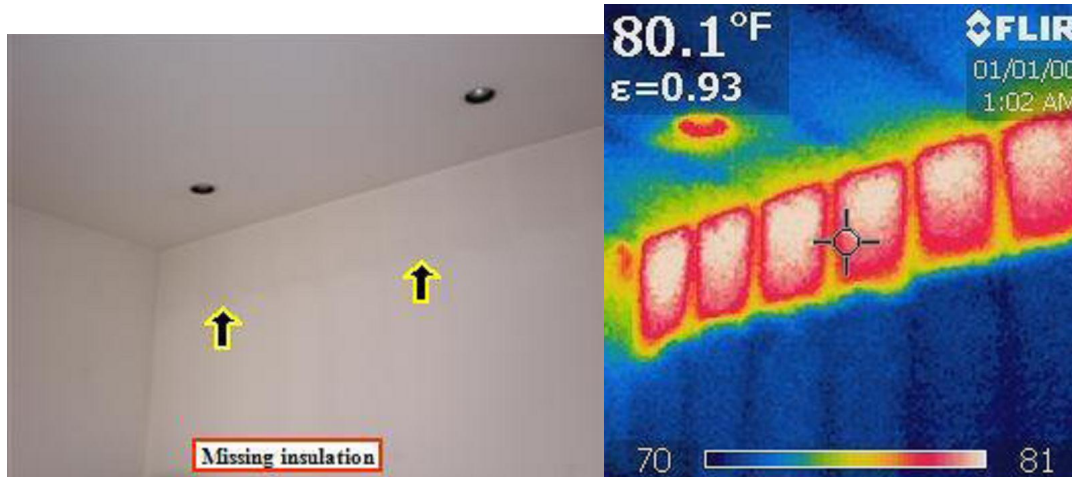
RR: A section of the upper wall in the Living room is missing insulation. An infrared thermal imaging camera was used to scan the wall. The thermal image below shows heat gain (loss) at the upper section of the wall. I recommend installing insulation behind the wall for improved energy efficiency.
