A Accredited Inspection Service, Inc.
6742 Forest Hill Blvd # 271, West Palm Beach,, FL 33413
561-966-8868
Copyright 2004 2005
All Rights Reserved

Client: Anna Morph
Property Address: Ascospore # 8, Mycology FL 01010
Date: 6-16-06

INSPECTORS FINAL CONCLUSIONS

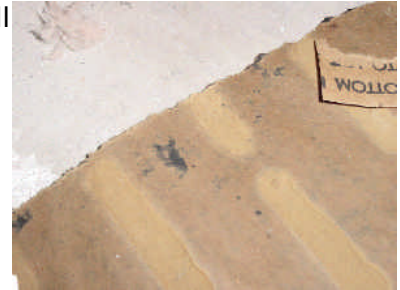
PHOTO 2

Stachybotrys mold growing on the back of drywall paper on wall that separated kitchen from hall bathroom.

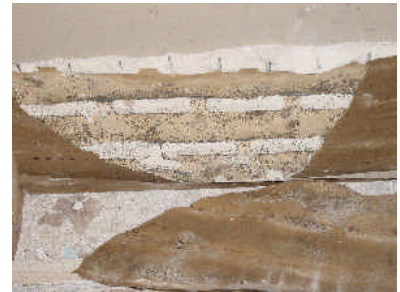
PHOTO 5 More mold on wall between kitchen and hall bathroom.

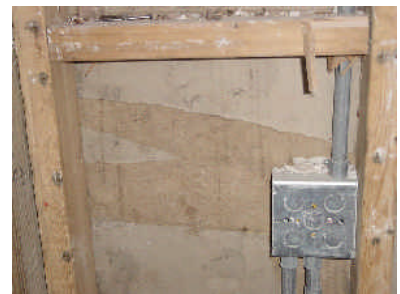
PHOTO 6 Mold and moisture stains on wall between kitchen and bathroom.

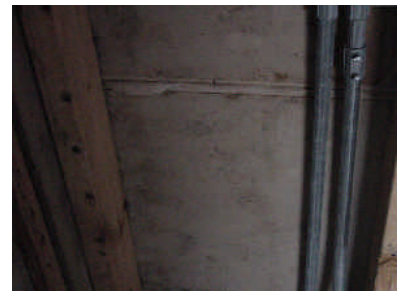
PHOTO 10 Mold and moisture stains on wall between kitchen and bathroom.
