Property Inspection Report

10812 Collington Dr, Midlothian, Va, 23112

April 9, 2019

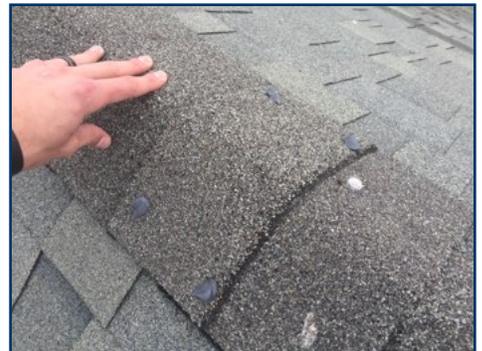
- 2.1. The sealant at the nail heads at the ridge caps was worn. It would be prudent to have the nails re-sealed.
- 2.2. There was an exposed nail observed near the upper most ridge, at the left side. I recommend having the nail sealed.
- 2.3. There were previously sealed nails observed in various locations at the roof covering materials. The sealant was worn and in need of replacement. I recommend having any worn sealant at nails in the roofing fields re-applied.

Worn Sealant Observed

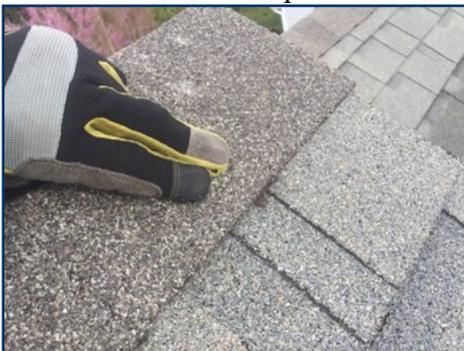
Exposed Nail Observed

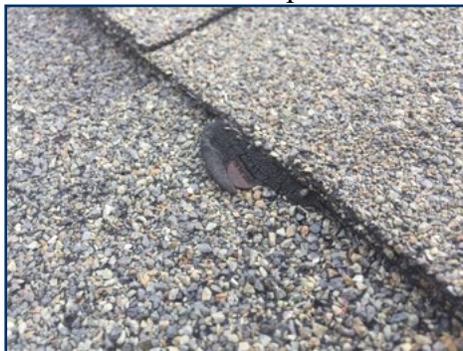
Worn Sealant Observed

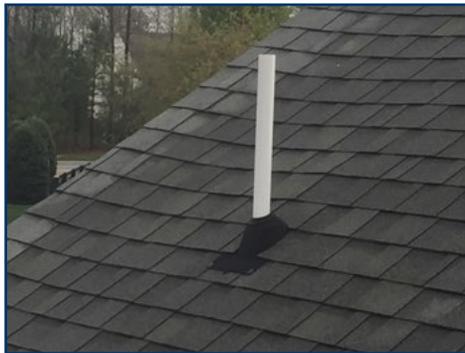
5.1. The sealant on the nails of the roof penetrations was worn. Regular maintenance of the roof includes having these nails resealed to prevent rusting and leaks.

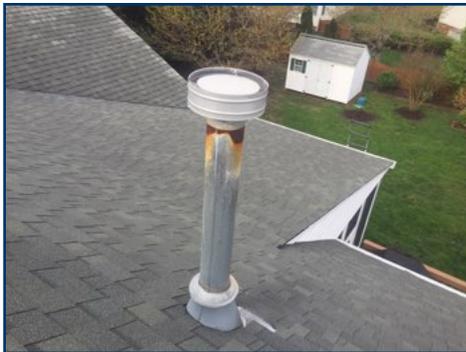
6.1. There was some rust observed on the metal vent towards the left side of the home. It may need to be replaced soon.

Some Rust Observed

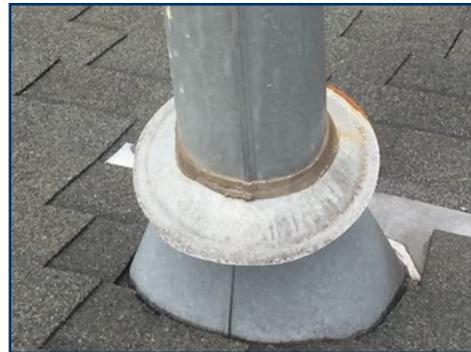
6.2. The sealant on the flue collars was worn/missing which can cause water to run down the vents into the attic. I recommend having them resealed. (\$50-\$75+)

Worn Collar Sealant Observed (Representative Photo)

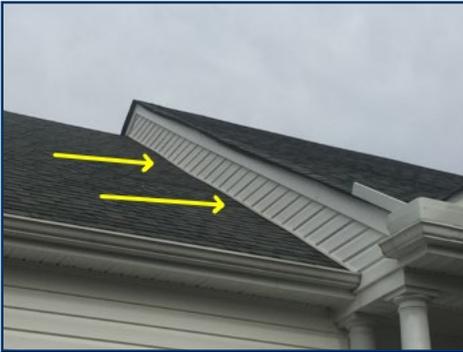
1.1. The bottom of the vinyl siding was in contact with the roof. This can cause heat damage to the siding such as warping and holes. Most vinyl siding manufacturers recommend at least a 1" clearance to prevent this damage. Although there was no damage at the time of inspection, it is possible that it can be damaged in the future necessitating repairs.

Example of Vinyl in Contact with Roof

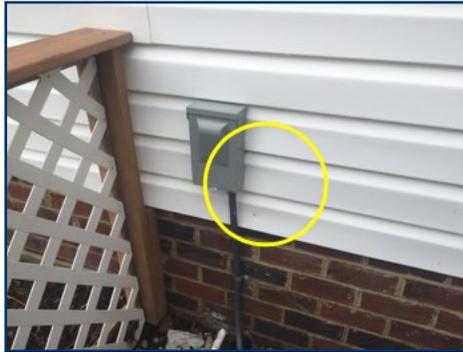
1.2. There was some minor damage to the siding. (See photos) Any damage to the siding can leave the building materials prone to moisture problems. I Recommend having the siding repaired.

Minor Damage to Vinyl Observed Here

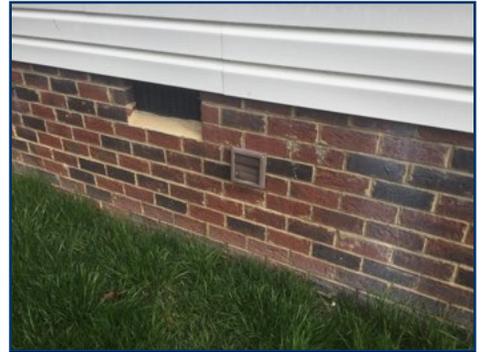
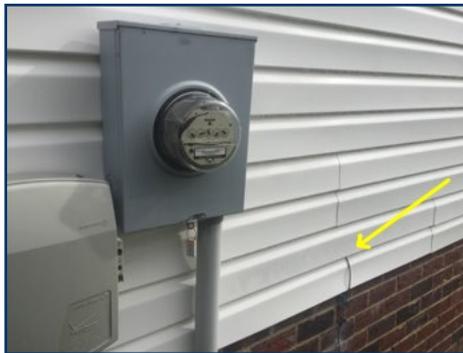
Seal this penetration through the siding to prevent moisture and pest intrusion

1.3. I recommend having all noted penetrations through the siding sealed to prevent pest intrusion.

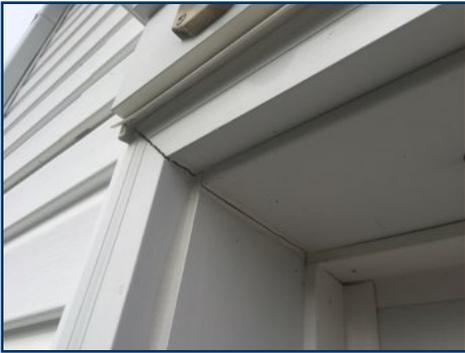
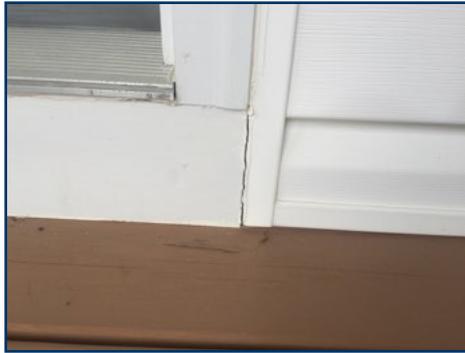
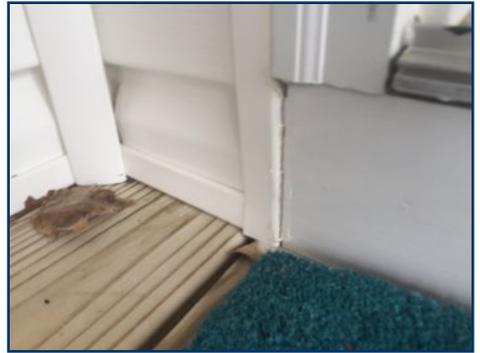
2.1. Some of the caulking around the the house was dried, cracking, or missing. These areas will be prone to air and moisture leaks. Replacing caulk is general home maintenance and should be done regularly. I recommend having any deficient caulk replaced.

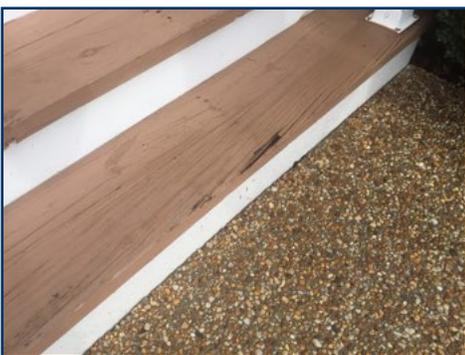
4.3. There was some deterioration observed at the lowest tread at the steps at the front porch. You may wish to have this repaired.

Deterioration at Front Porch Steps

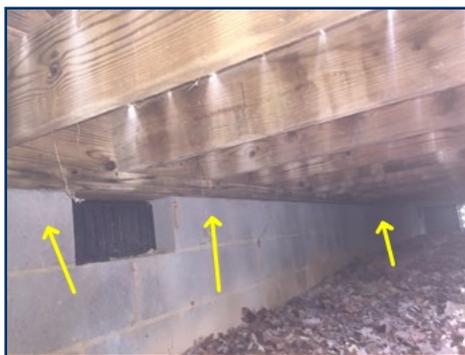
4.2. The front porch and rear screened porch ledger board flashing was installed improperly (older method used) with the flashing behind the ledger board. Water resistant flashing must be installed over the ledger board to prevent moisture damage to the band joist. I recommend having the flashing improved/corrected by a qualified contractor.

Older Flashing Method Utilized at Front Porch Ledger Board

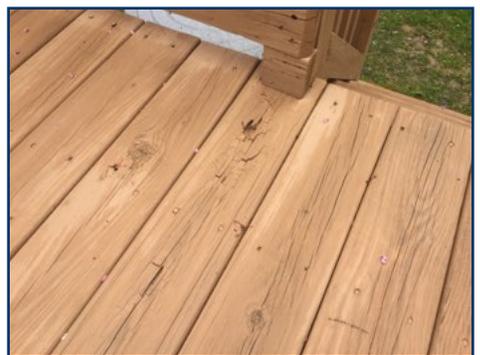
4.4. A few boards at the rear deck were weathered and may need to be replaced soon.

Some Weathering Observed

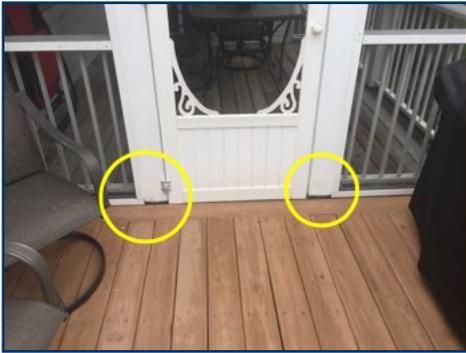
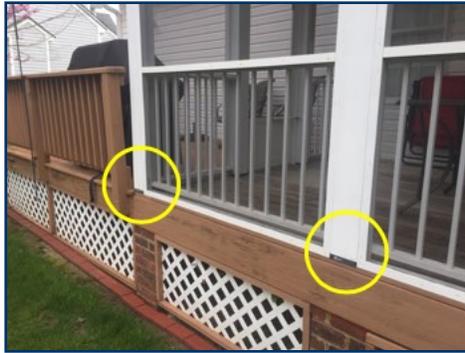
4.5. Rot was observed at the bottom of four of the posts at the screened portion of the rear deck. I recommend repair by a qualified contractor. (\$200-\$400+)

Rot Observed Here

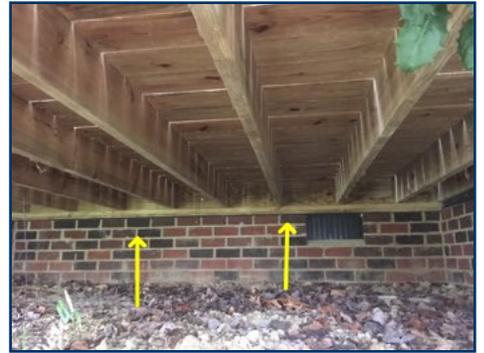
Older Flashing Method Utilized at Rear Screened Deck Ledger Board

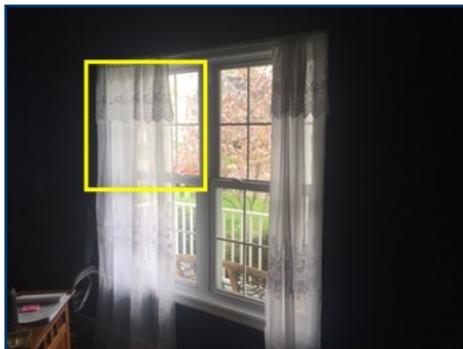
6.1. One of the windows the downstairs office room had condensation or staining between the panes. This is a defective condition that reduces the r-value (and appearance) of the the window, and occurs when the interior seals fail, the inert gas escapes (typically argon), and the manufacturer installed desiccant becomes saturated. Typically, only the glazing assembly needs to be replaced, but the sash or even full window replacement is sometimes necessary. I recommend having the windows repaired/replaced as needed. (\$175-\$500+)

The upper sash of this window in the downstairs office room had condensation between the panes

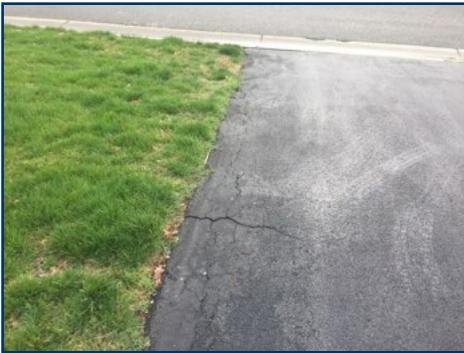
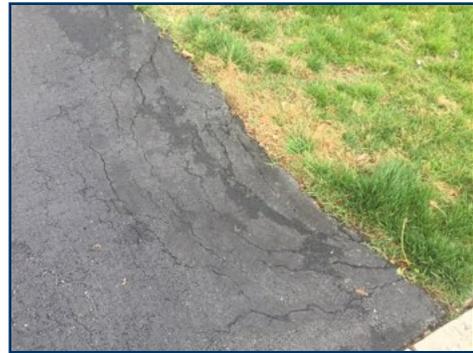
9.1. The driveway had typical cracking and wear and tear. You may want to fill the cracks and reseal the driveway.

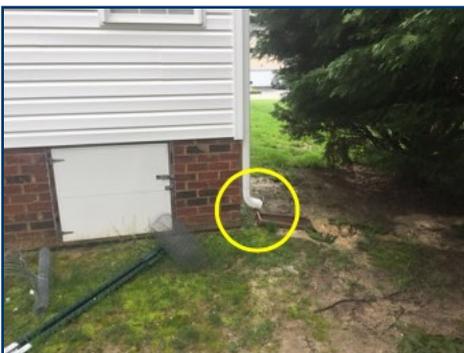
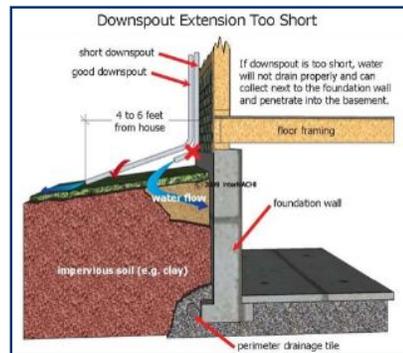
11.1. Some of the downspouts terminated too closely to the foundation. This concentrates water at the foundation and cause moisture intrusion into the foundation. I recommend having the downspouts extended 4-8 ft from the house.

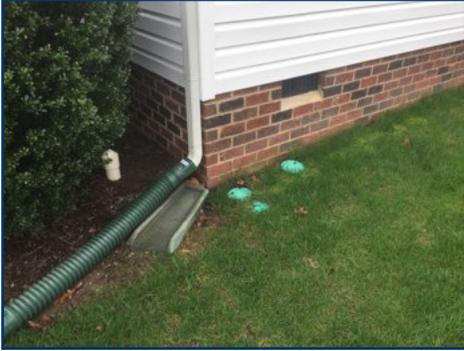
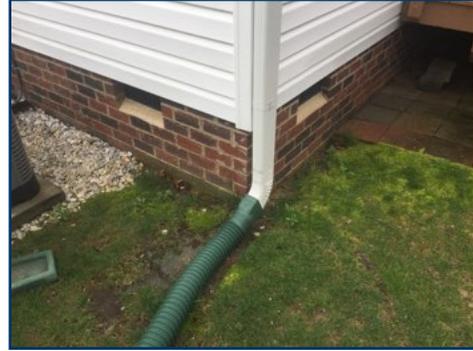
12.1. There are some low spots along the foundation. I recommend adding additional backfill to create the proper slope away from the house to allow for effective drainage.

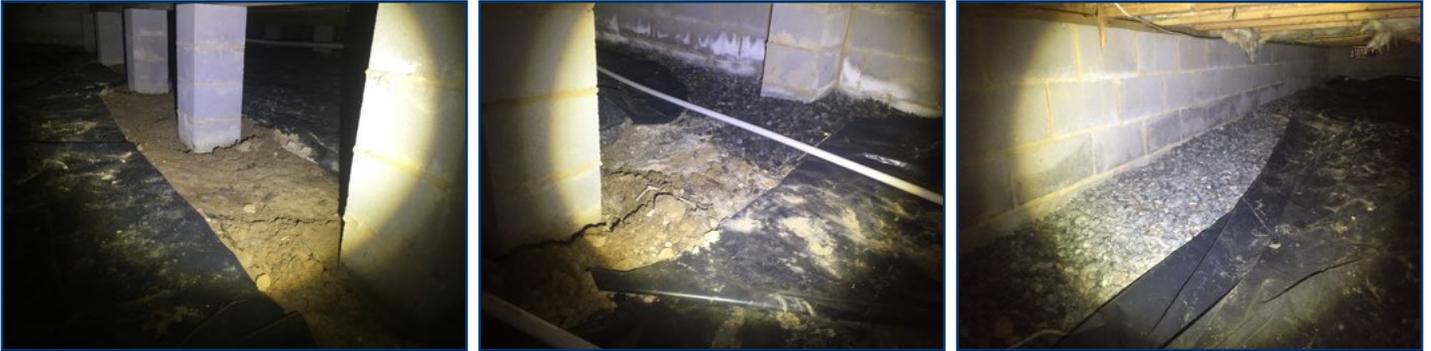
3.1. The soil cover was missing in some areas. The cover helps prevent vapors from the ground creating a humid environment in the crawlspace. I recommend straightening out the cover, installing a cover on any missing areas, and securing them to prevent future movement. (\$100-\$200+)

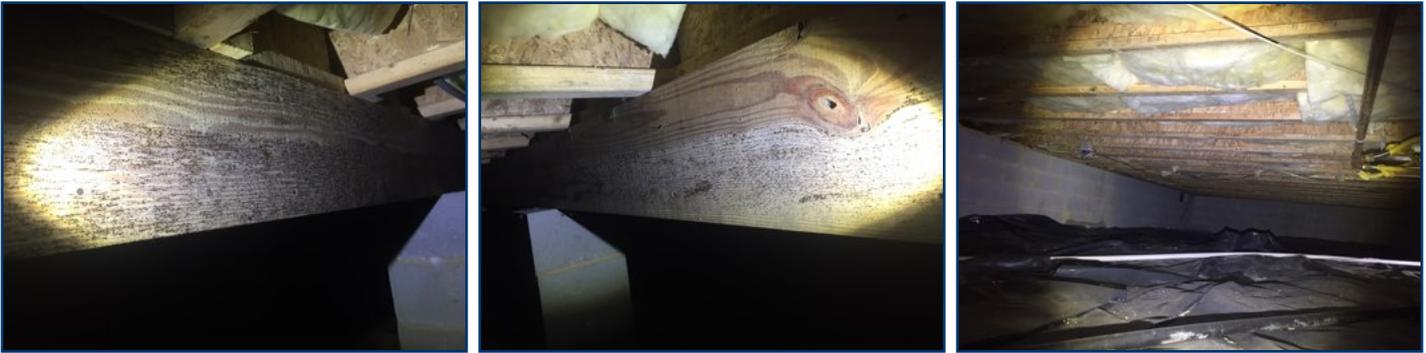
5.2. There was growth on the surfaces in the crawlspace consistent with mold/mildew/fungus. This type of growth occurs when there is elevated moisture in the crawlspace. Overtime, this condition can worsen and encourage wood rot, and pest activity. I recommend discussing options and costs for keeping the crawlspace dry, and remediation of the mold with a crawlspace contractor. (Cost TBD by Contractor)

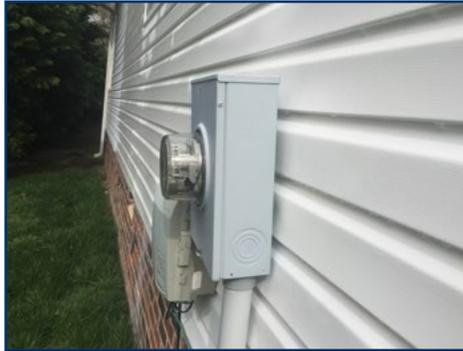
2.1. The meter was loose and should be secured by a qualified electrician. (\$50-\$100+)

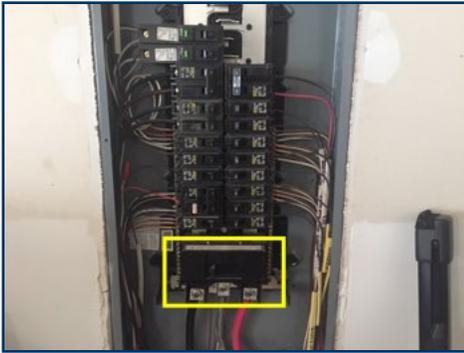
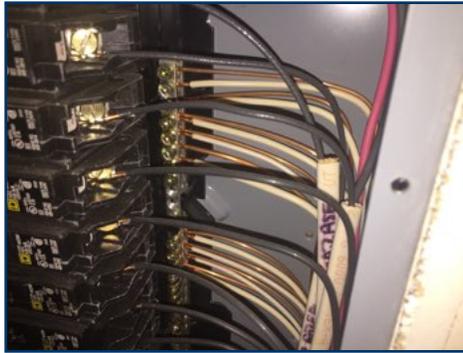
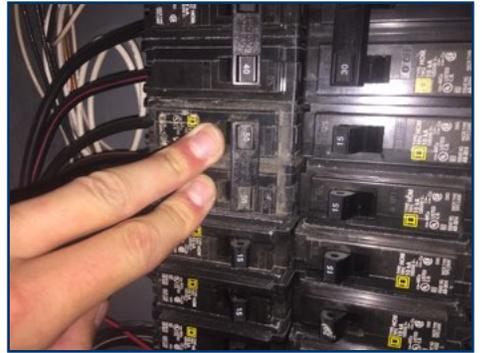
5.1. There were several lugs on the neutral/ground bus bar that have more than one neutral wire feeding to them. Each neutral wire should be attached to a separate lug to ensure a proper physical connection and to make sure that each circuit can be worked on independently. I recommend correction by a qualified electrician.

5.2. The **A/C** circuit breaker doesn't match what is listed on the data plate. I recommend having a qualified electrician repair as needed. (\$100-\$200+)

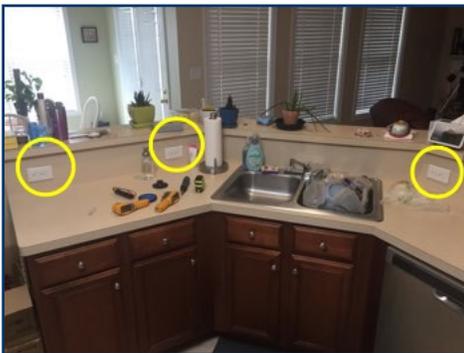
8.1. The outlets surrounding the kitchen sink, one outlet in the downstairs rear left bedroom, and an outlet in the upstairs bonus room were loose. This is a safety concern. I recommend repair by a qualified electrician. (\$100-\$200+)

These Outlets were Loose

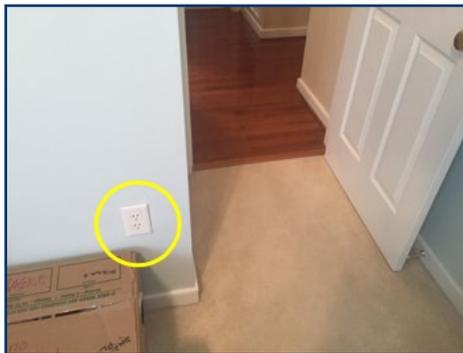
This Outlet in the Downstairs Rear Left Bedroom was Loose

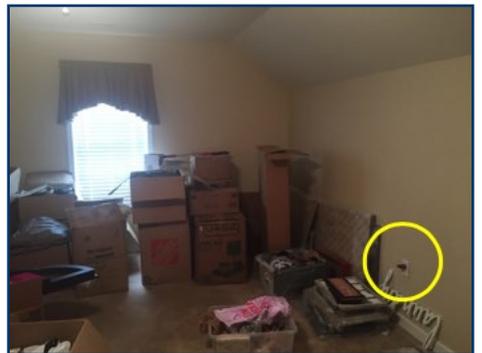
This Outlet in the Upstairs Bonus Room was Loose

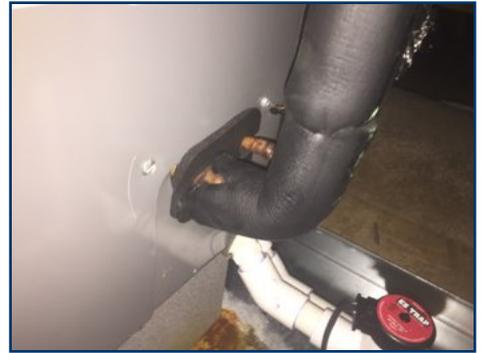
2.2. The refrigerant insulation needs to be extended all the way to the cabinet housing with a gasket in the opening. Any refrigerant line left exposed has the potential to form condensation and leak on building materials below.

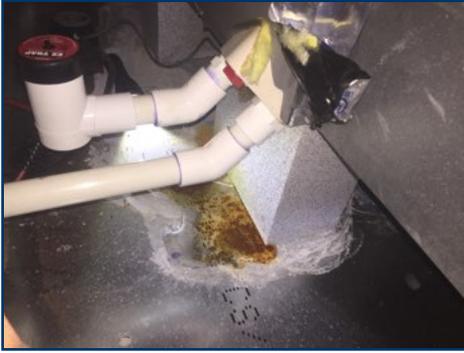
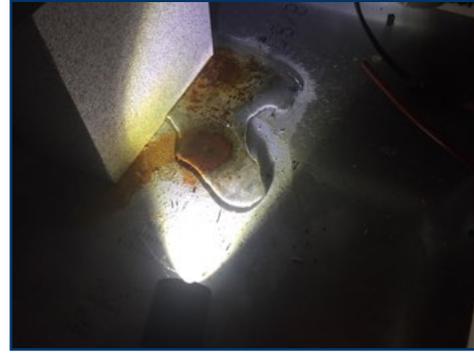
8.2. The air handler was leaking condensation into the overflow pan at the time of inspection. I recommend repair by a qualified HVAC contractor. (\$100-\$200+)

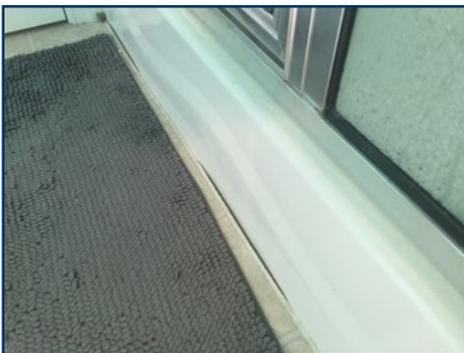
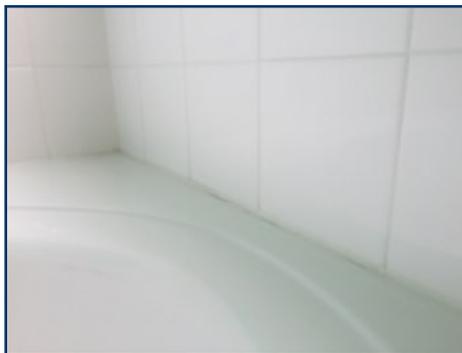
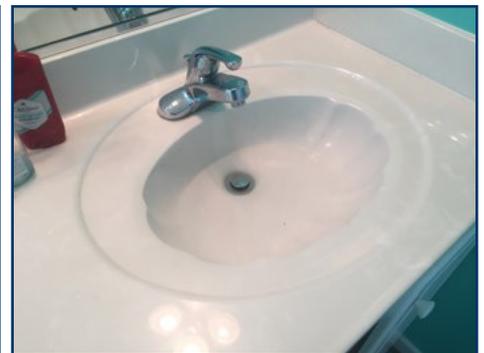
5.1. The caulk at the floor near the master bathroom shower, and at the tub in the master bathroom was worn. I recommend applying new caulk.

5.2. The right sink in the master Bathroom was draining slowly. You should have a plumber determine the problem and repair as needed. (\$50+)

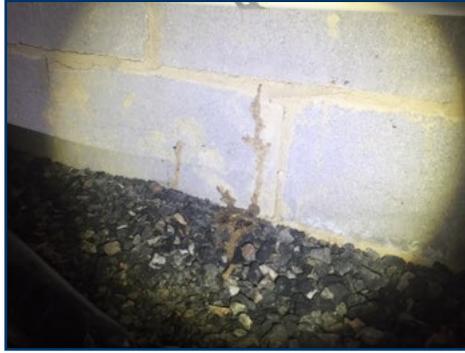
5.1. There were what appeared to be a termite mud tubes in the crawlspace, near the garage. I recommend getting a termite inspection.
