PEACH Inspections

THE HOME INSPECTION REPORT

07040304B - Mr. & Mrs. Client

Lafayette Hill, PA 19444 .

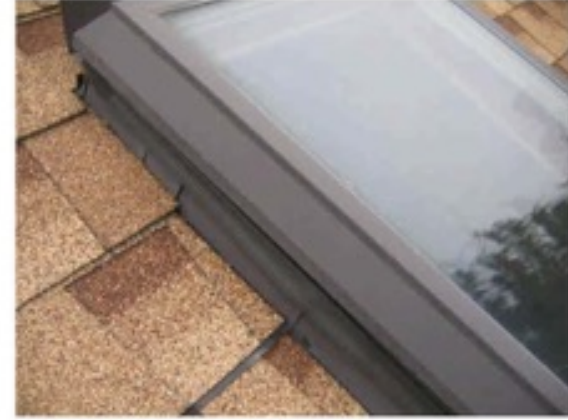
The roof has six skylights. Skylights are notoriously problematic and a common point of leaks. The skylights appear to be in good shape. However, it will be important to keep the area around them clean and to monitor them for evidence of leaks during heavy rains and winter snow melts.

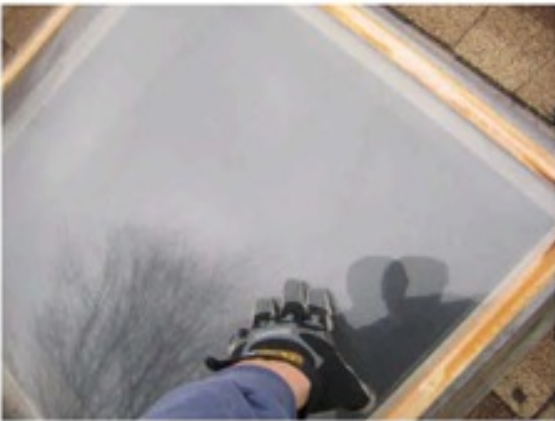
Each of the two skylight windowpanes appears to have numerous cracks in the inner window pane. The outer plastic bubble pane seems intact.

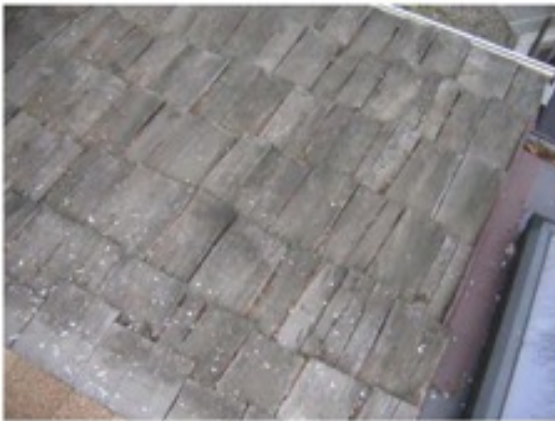
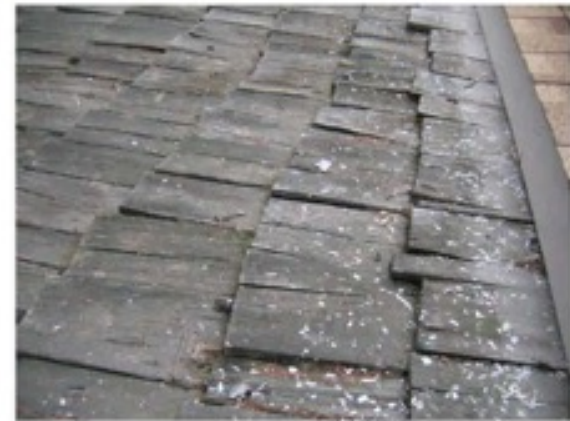
Wood cedar Roofing Material

The wooden cedar shingle material on the rear small roof appears to be in old, poor condition. The shingles appear weathered. This is not a guarantee against future leaks.

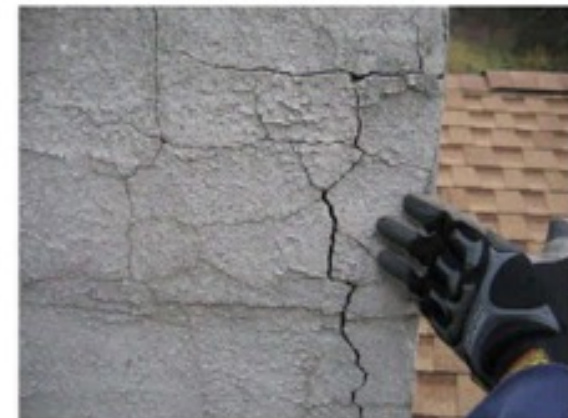
Observations

The chimney cement exterior is cracked. Loose sections. Open cracks.

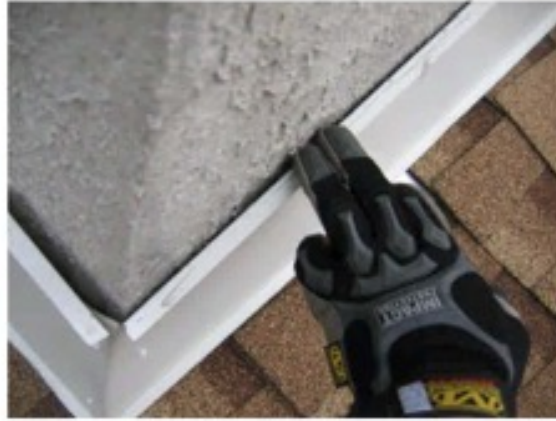
Chimney Flashings

An open gap at the flashing - prone to water penetration. Missing sealant.

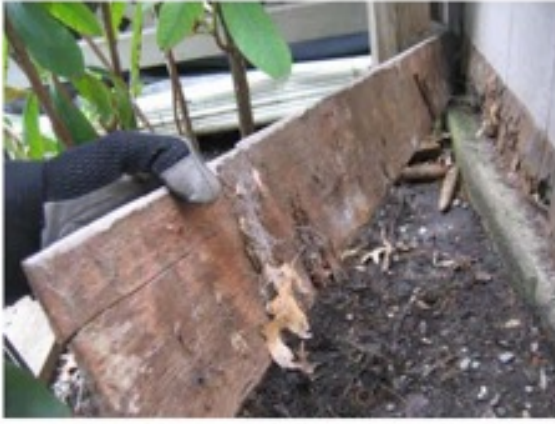
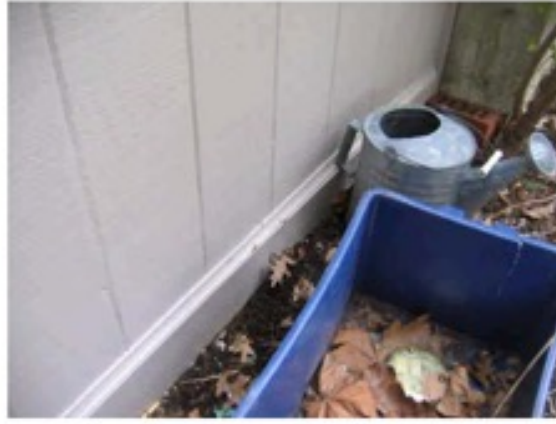
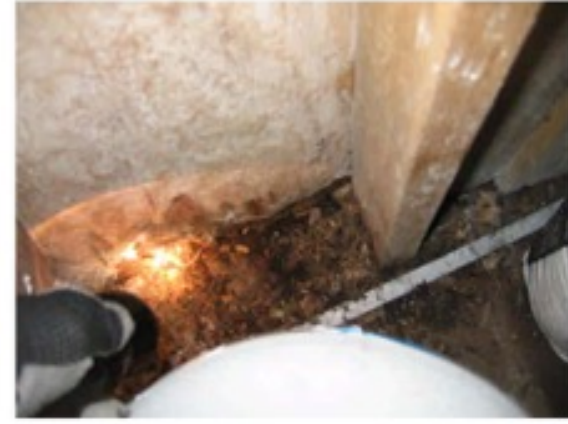
There is inadequate clearance between the bottom of the attached shed siding material and the ground surface. There is possibly some soil and wood contact. This condition can cause wood rot from water damage (or wicking), and could lead to the infestation of wood destroying pests. Recommend re-grading some of the ground surface near the siding to make minimum clearance (if at all possible).

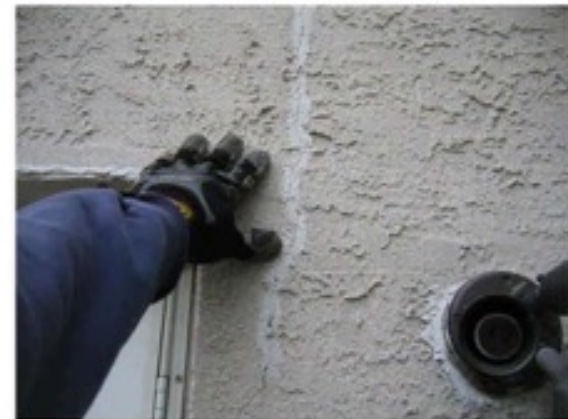
There are cracks in the stucco that need correction and further evaluation by a stucco professional. The cracks could indicate settlement or movement of the house structure. Most of the cracks are open, and not sealed or patched well. Located on the right-side wall, rear right corner, and rear wall.

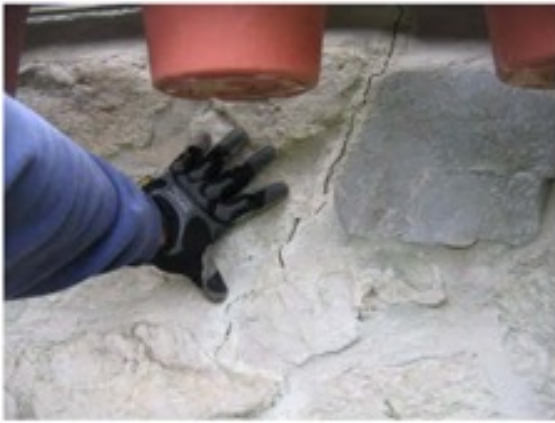
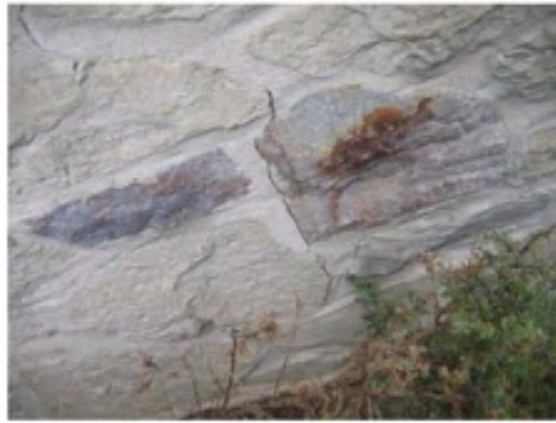
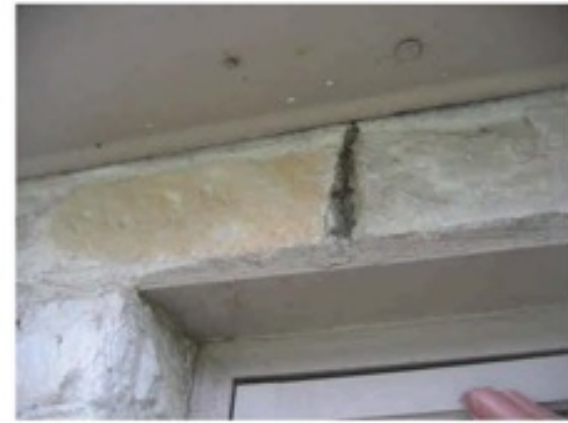
Stone

There are stress fractures or cracks in the stone that can result from movement. These cracks appear normal. Most people do not realize that structures move and settle, but they do and sometimes more or less continuously. Therefore, stress fractures can reappear after they have been repaired, and particularly if they have not been repaired correctly. Located on the front side of the house.

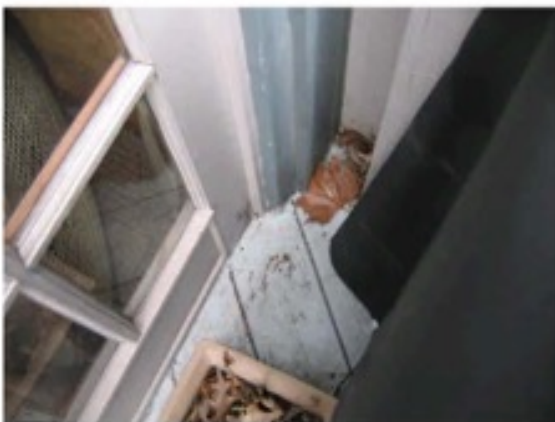
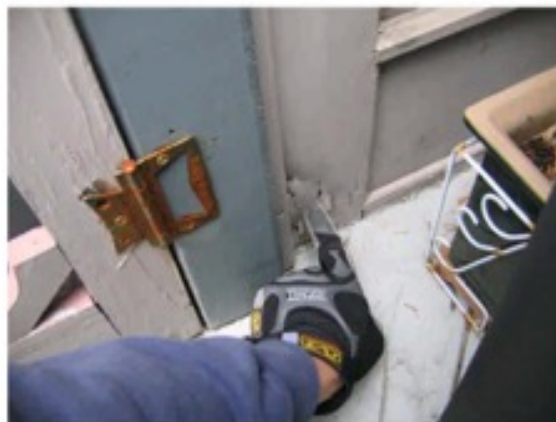
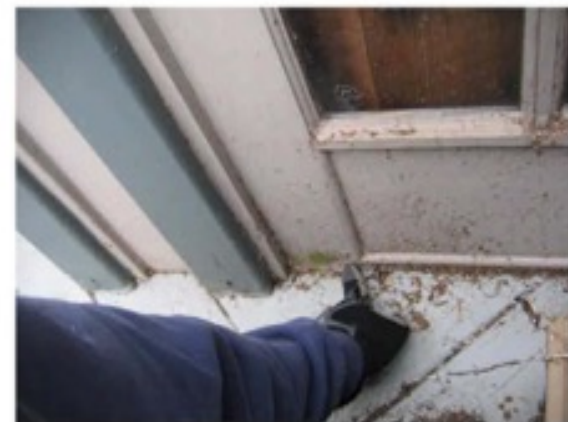
Wood Rot

Wood rot at the rear door and window area. Bottom corners are rotten and water damaged.

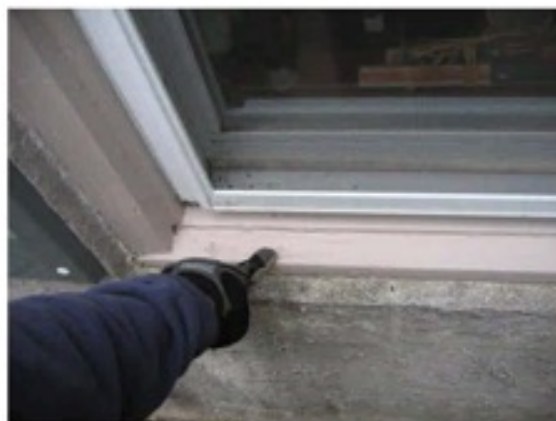
Wood rot at the left-side window. Trim boards.

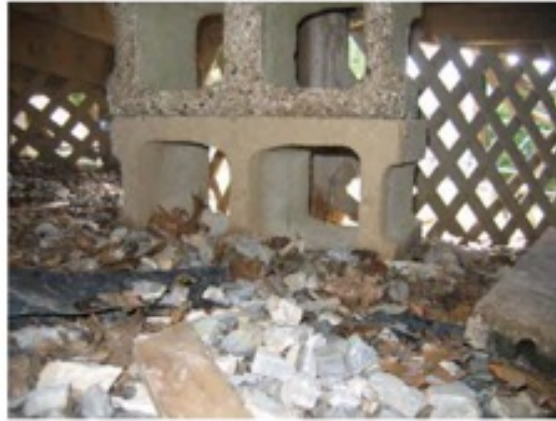
Concrete blocks being used for load-bearing support are turned on their side. Not installed properly. A block on its side is weak, and could collapse under weight.

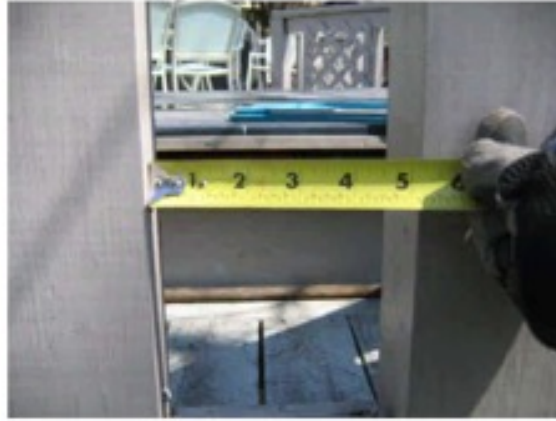
The deck spindles or boards have open spaces that are too far apart. No more than 4 inches of space is allowed by common standards. Safety hazard for small children. A protective barrier should be installed or correction to the spindle spacing. Lattice is not strong enough. Railing height is too low at 29 inches. Missing railing section at tub area.

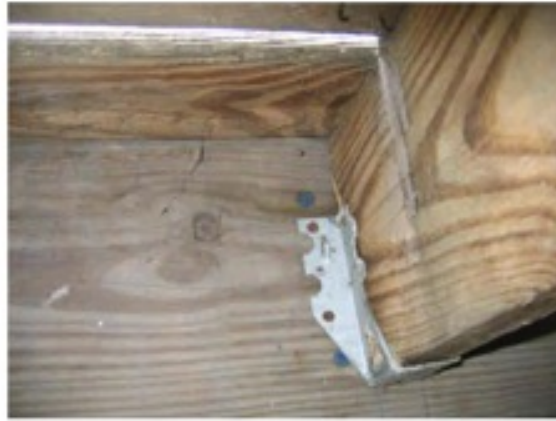
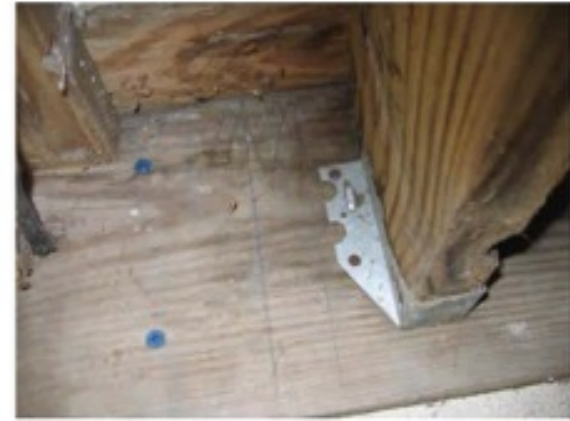
The deck ledger board is attached to the structure with some masonry screws. May be subject to withdrawal. Appears inadequate. The ledger board of the deck should be secured with large-diameter through-bolts or lag screws, every 16 inches or so. Further evaluation by a deck contractor is recommended.

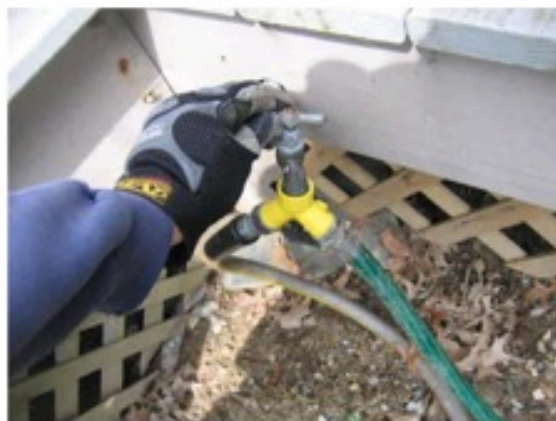
The faucet is not frost-free. Consider replacing the faucet with frost-free hose bibs. To prevent freeze-burst problems in the winter. Or be sure remove the hoses and drain the faucets before winter, to prevent freezing and bursting problems.

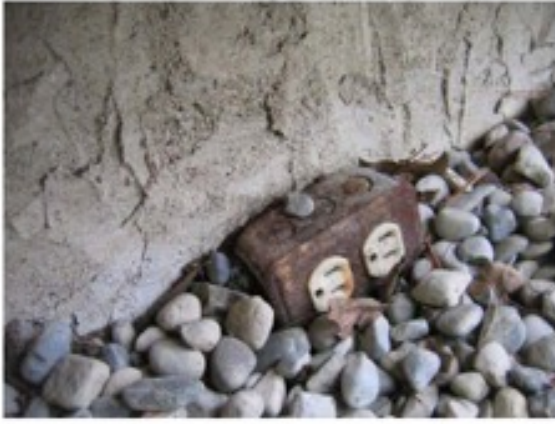
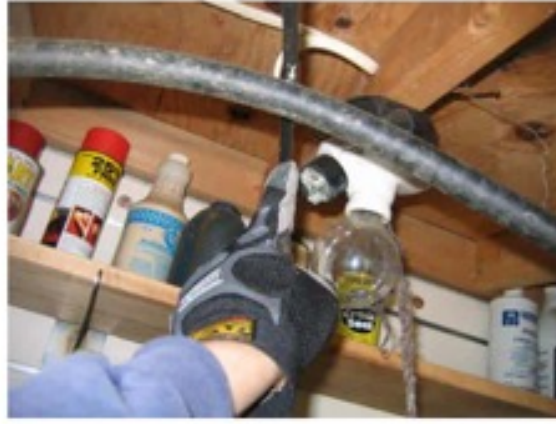
Receptacles & GFCIs

None of the exterior receptacles are testing as being GFCI-protected. Includes plug at light fixture inside the attached shed.

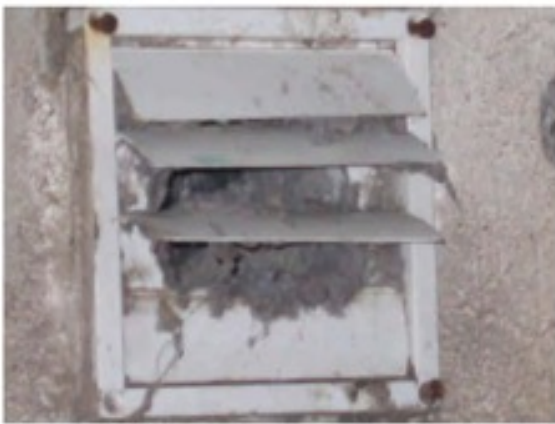
Recommend cleaning and inspecting the dryer's vent pipe and exhaust hood which appears to have a lot of lint inside of it.

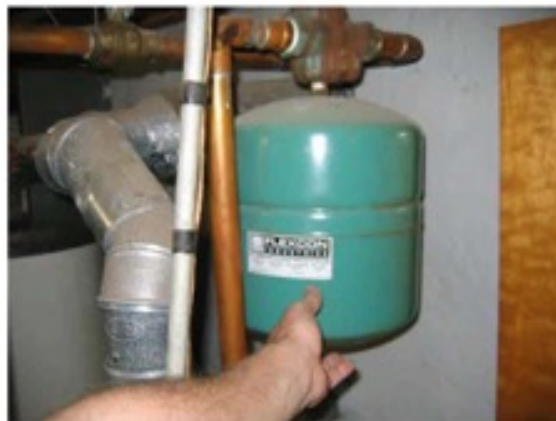
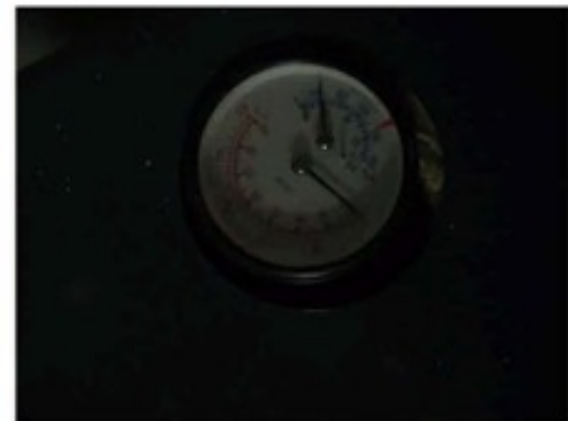
The relief valve on the boiler has no extension pipe installed for safety.

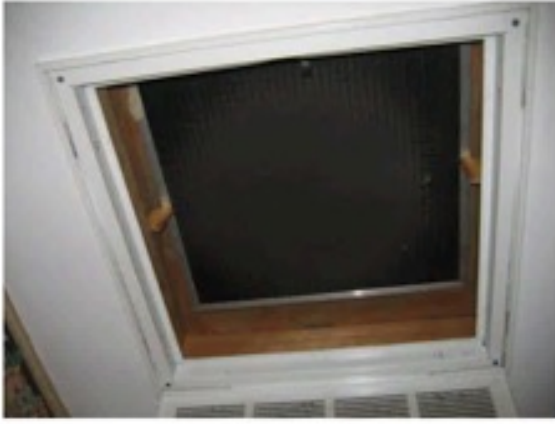
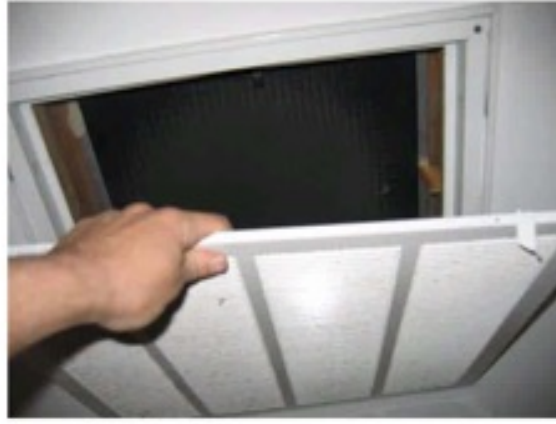
The air filter is washable and dirty. Wash filter and check every 30 days. Wash when necessary.

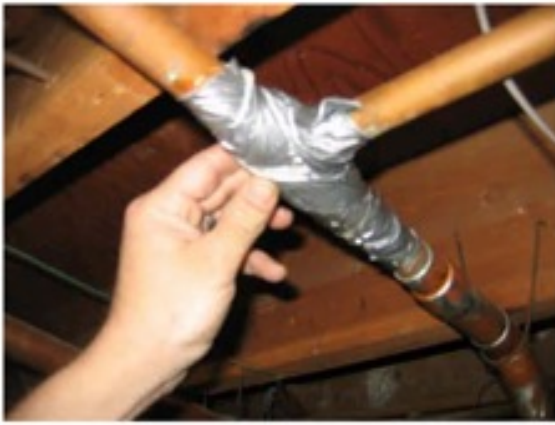
There is an active at a fitting which should be repaired by a plumber. Dripping water. Located at the above the boiler. Duct tape.
