## Majeske Home Inspection Services

## Certified Home Inspection Report

**601 E Sherwood Rd.**

Inspected on Mon, Jan 22 2018 at 9:00 AM

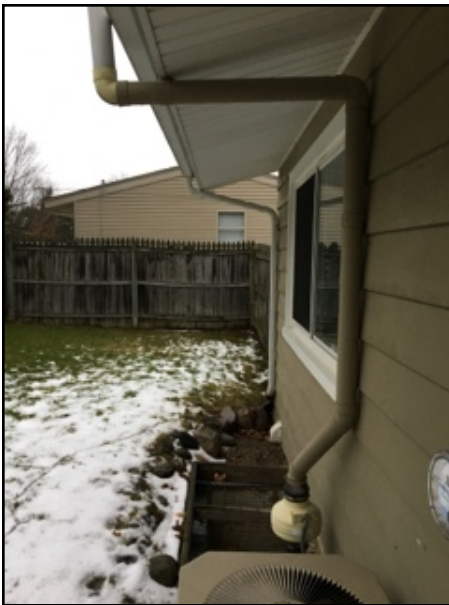
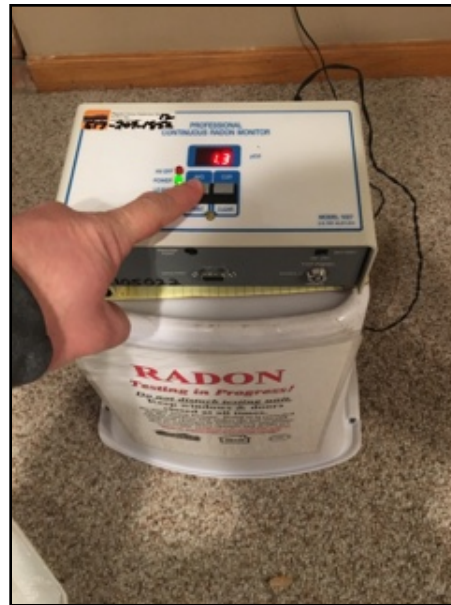
The house has a radon mitigation system installed. The unofficial radon results fall within acceptable limits. Official results will be attached in a separate email.

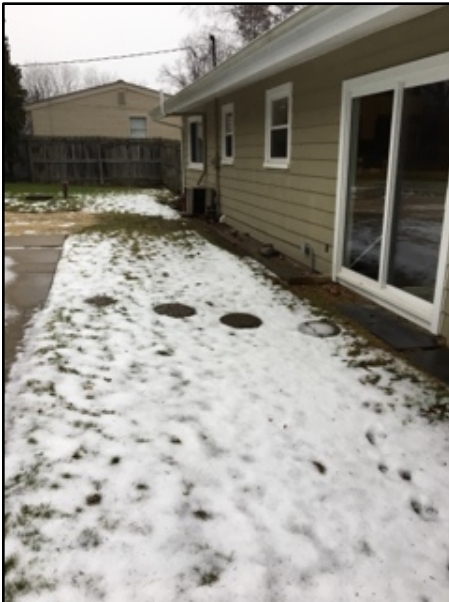
Figure 2-1

The external grading currently allows rain and surface water to flow towards the structure in several locations. This can contribute to potential water penetration into the structure. I recommend building up the grade with heavy fill dirt so that the ground slopes away from the structure for several feet with a grade of at least 1 inch/foot.

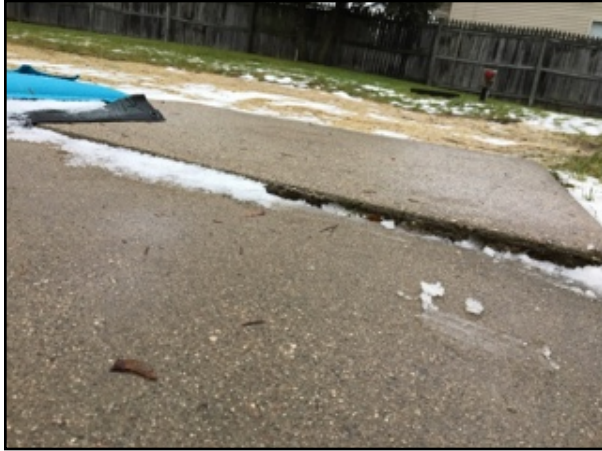
Figure 3-1

The concrete pool patio has settling and/or heaving that can pose a trip hazard. Recommend consulting with a concrete company to consider mud jacking the concrete to bring it back up to level or to consider replacement of the concrete.

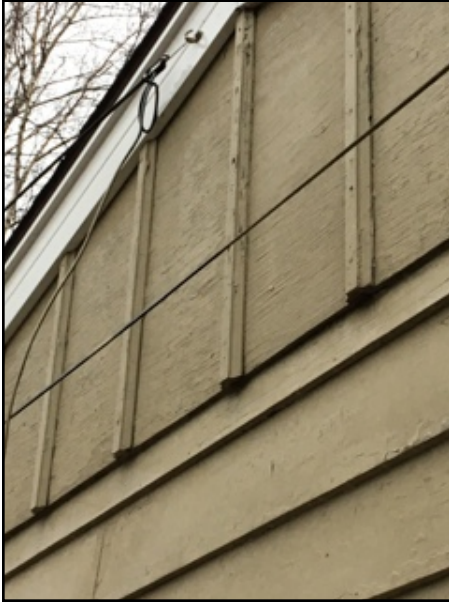
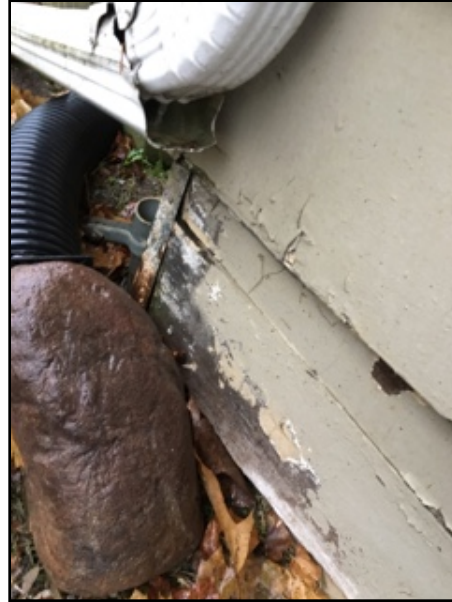
The wood siding has areas of exposed, unprotected wood surfaces. Recommend scraping and painting the wood to seal and prevent future water penetration.

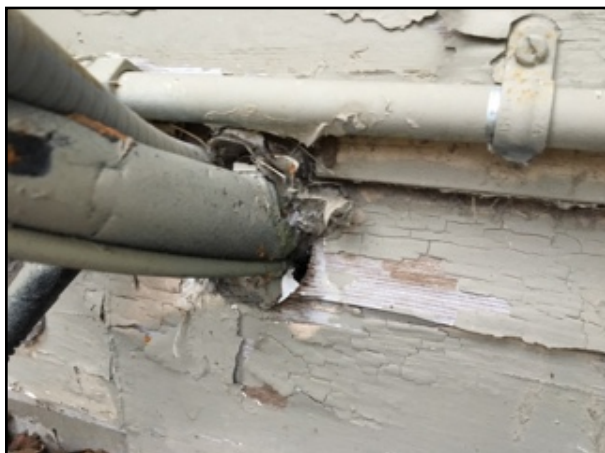
Figure 5-1

The hole(s) where the A/C line enters the house is not sealed properly. This can allow insects and rodents to enter wall. Recommend sealing the hole with steel wool and caulk or petroleum based plumbers putty.

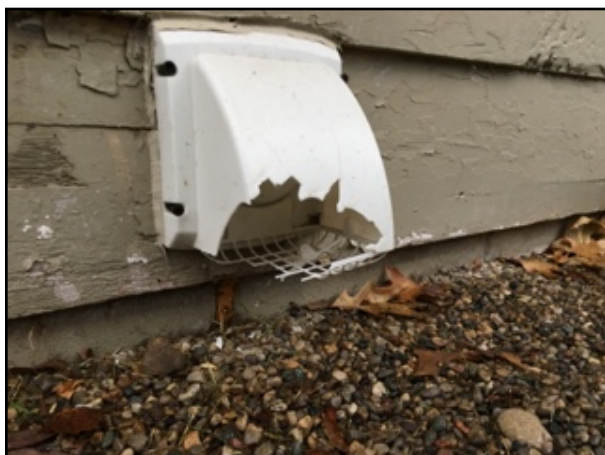
Figure 6-1

The dryer vent is damaged on the northeast corner of the house. This could allow animals and insects to enter the duct. Recommend repair or replacement.

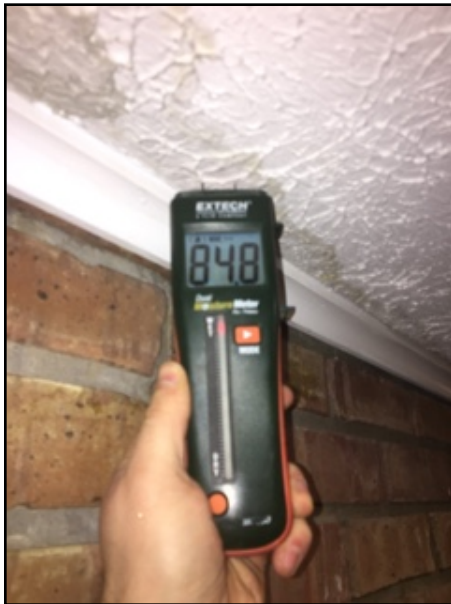
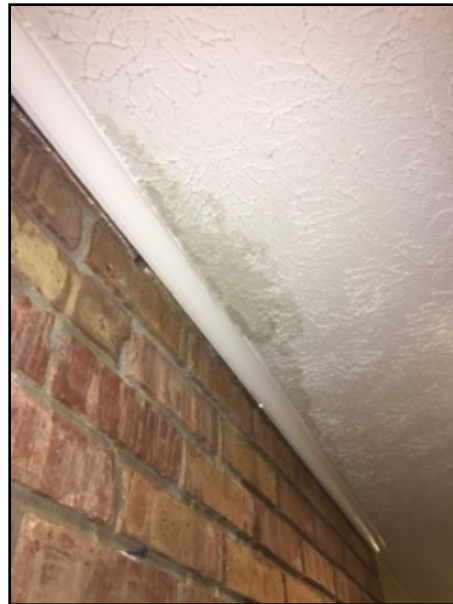
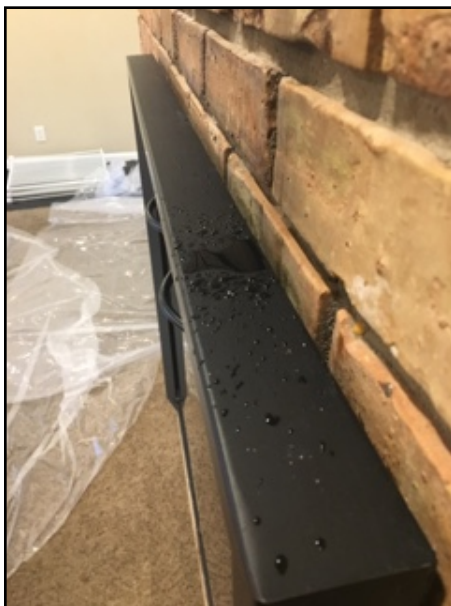
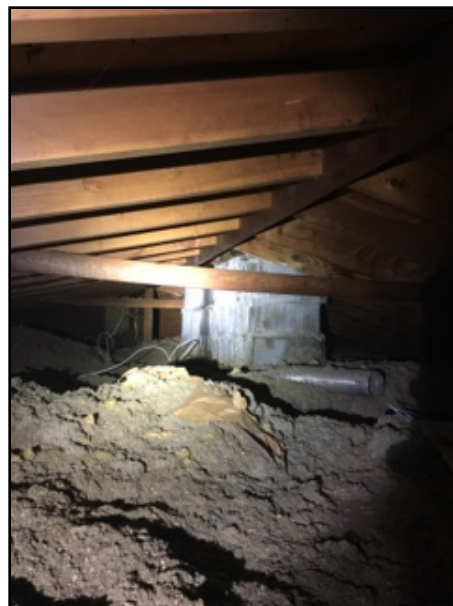
There is moisture and staining present on the drywall in the ceiling over the fireplace. This could indicate a roof leak or flashing issue. Recommend evaluation and repair by a roofer.

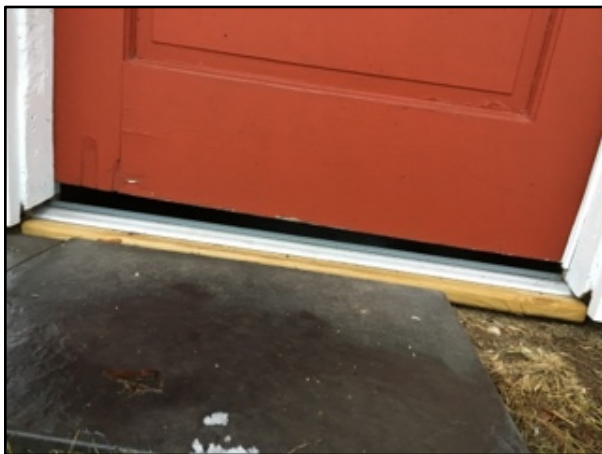
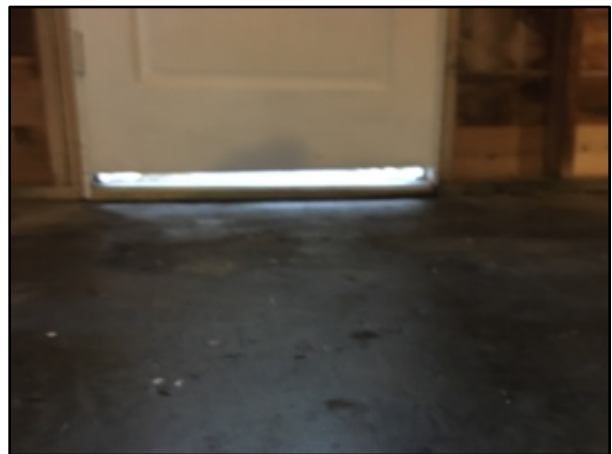
There is visible daylight below the service door to the garage. This could allow insects and animals into the garage. Recommend consulting with a door specialist to consider installing a weatherstrip or threshold around the perimeter of the door to more properly seal it.

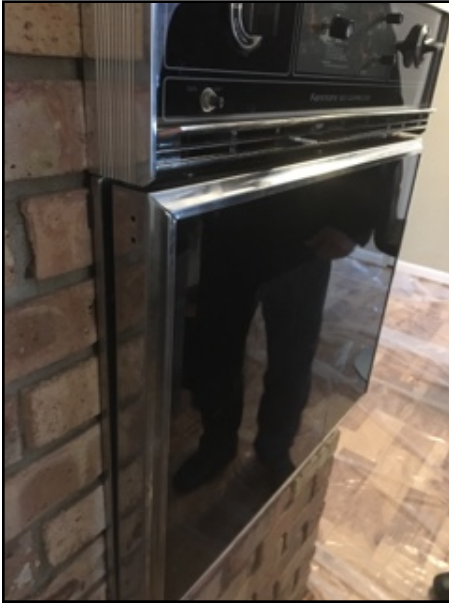
Figure 9-1

The handle is missing from the wall oven. Recommend repair.

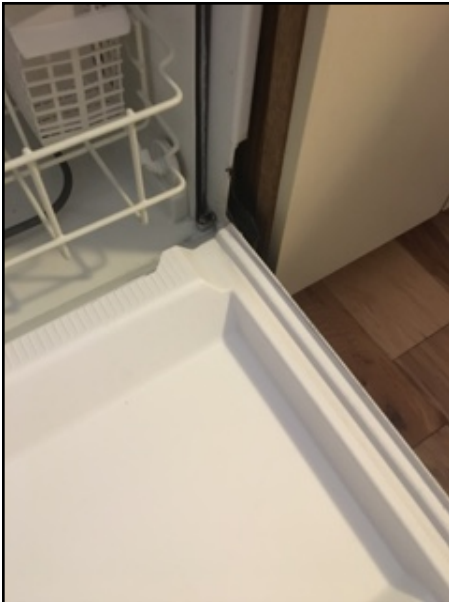
Figure 10-1

The dishwasher door hinges are damaged. Recommend evaluation and repair by an appliance specialist.

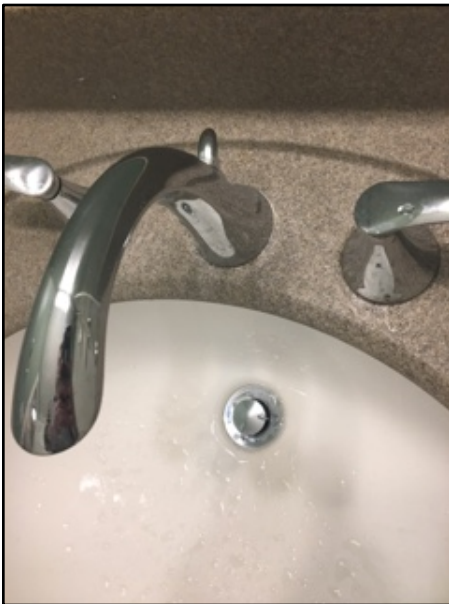
Figure 11-1

Main floor hallway sink drain stop does not operate. Requires repair for proper operation.

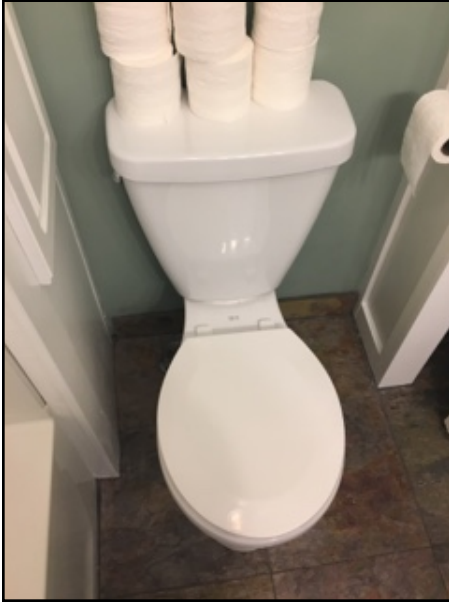
Figure 12-1

The main level hallway-bath toilet is loose on floor. Recommend properly securing the toilet to the toilet flange.

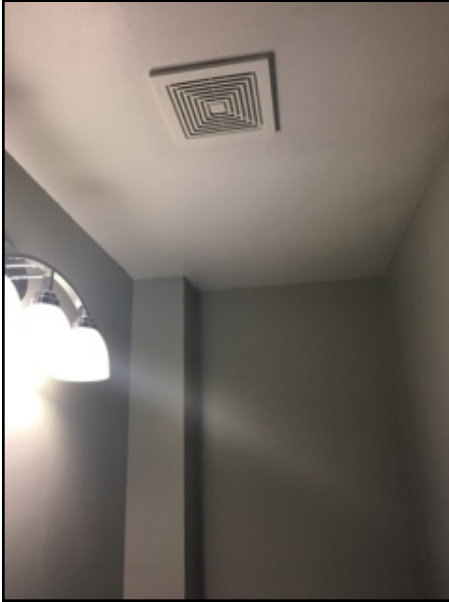
Figure 13-1

The ceiling fan does not operate in the master bathroom. Recommend evaluation and repair as necessary by an electrician.

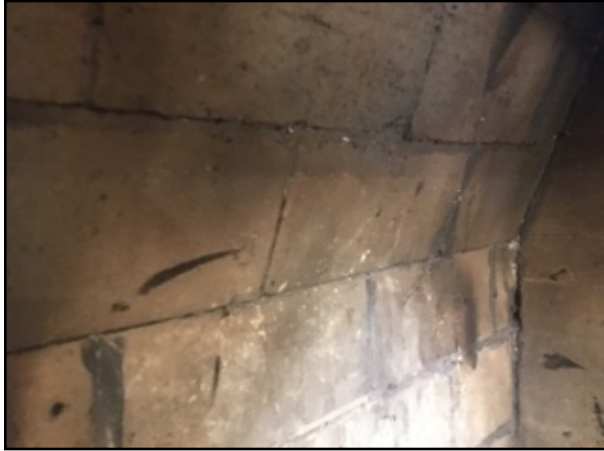
Figure 14-1

The brick firebox has loose mortar joints. This could allow for heat loss and damage to the rest of the chimney. Recommend evaluation and repair by a mason or chimney sweep.

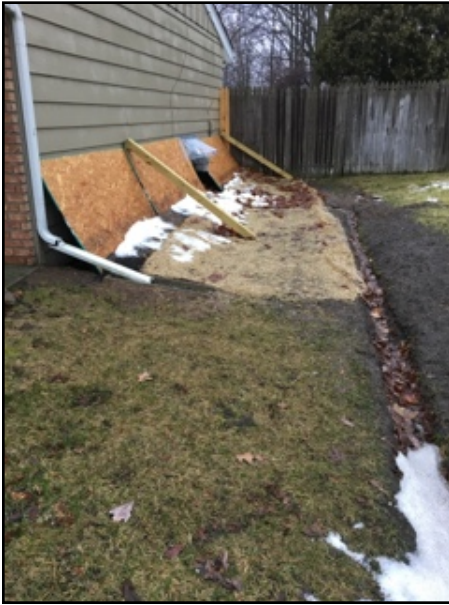
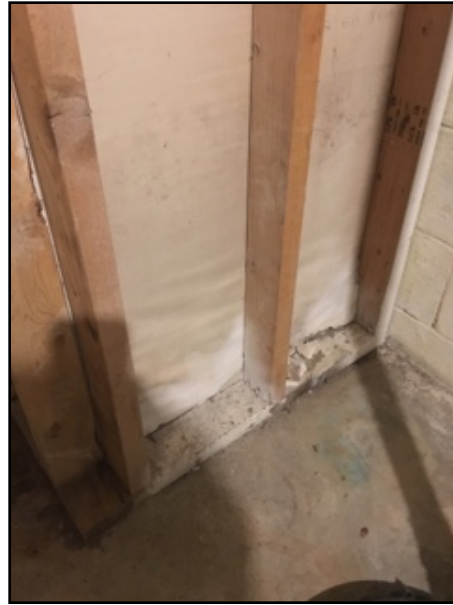
There are signs of prior water penetration into the basement. I recommend building up the grade around the house, keeping the gutters clean for proper operation and maintaining downspout extensions so as to direct the surface water away from the foundation. Further evaluation by a water containment company should be considered.

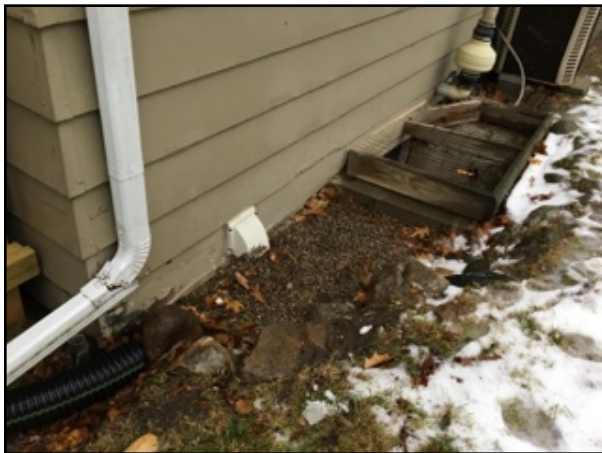
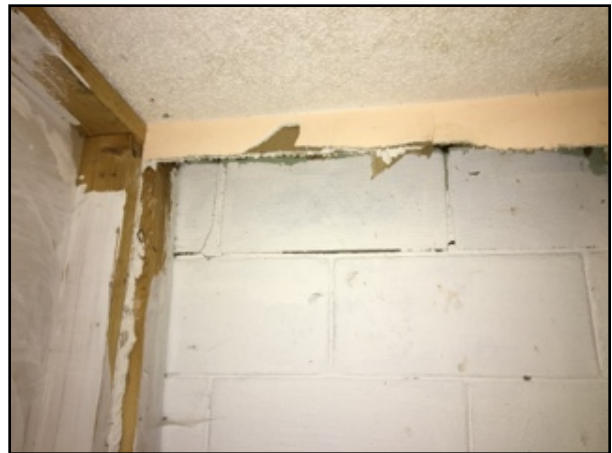
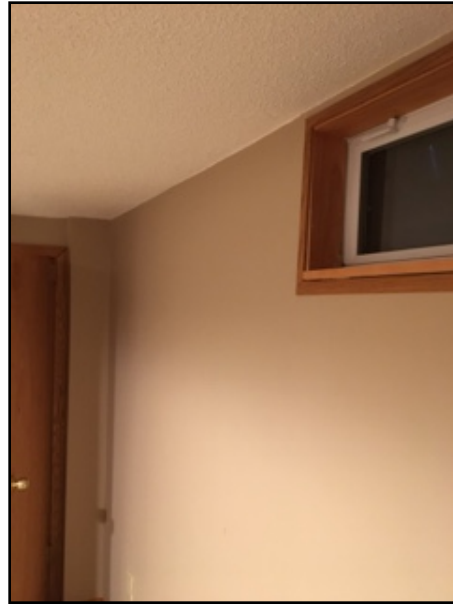
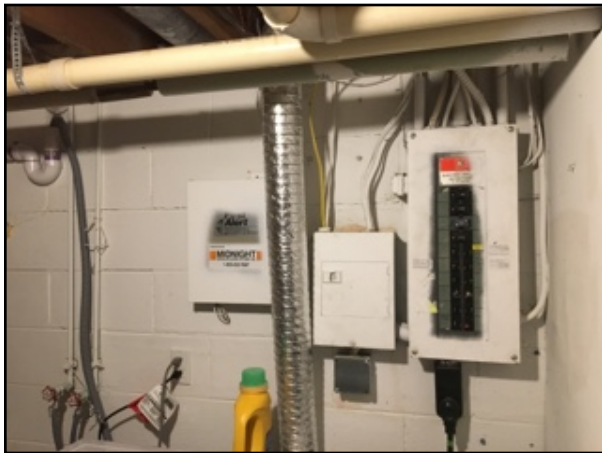
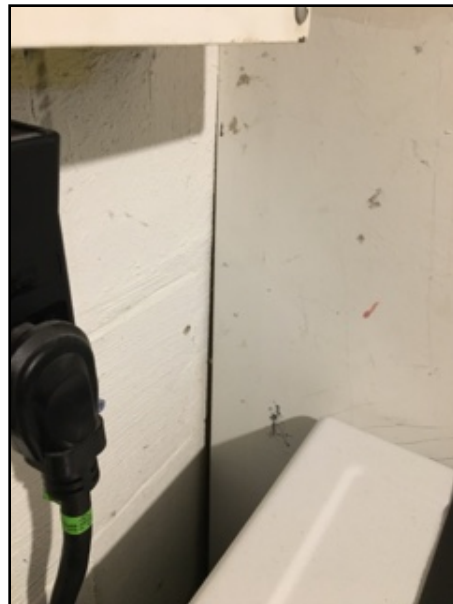
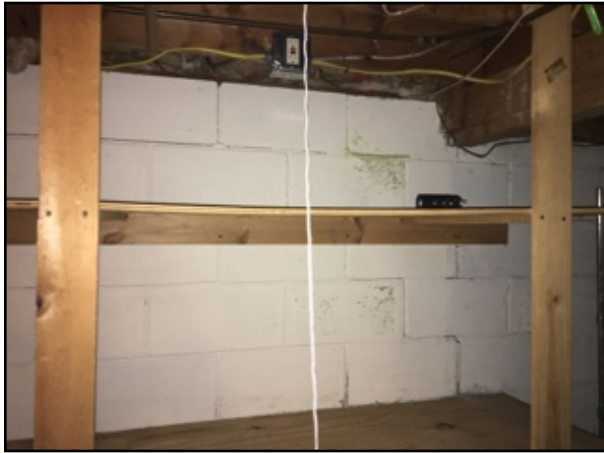
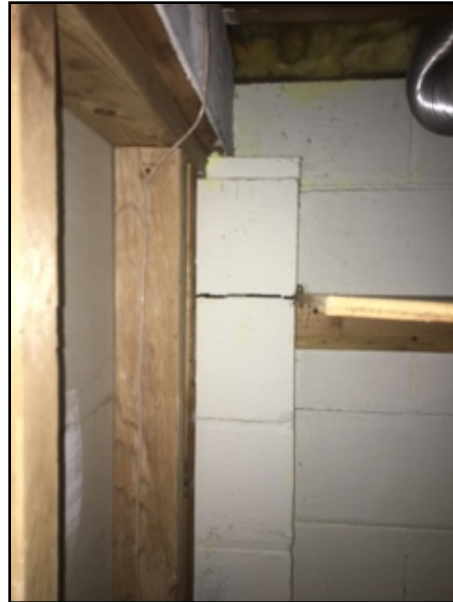
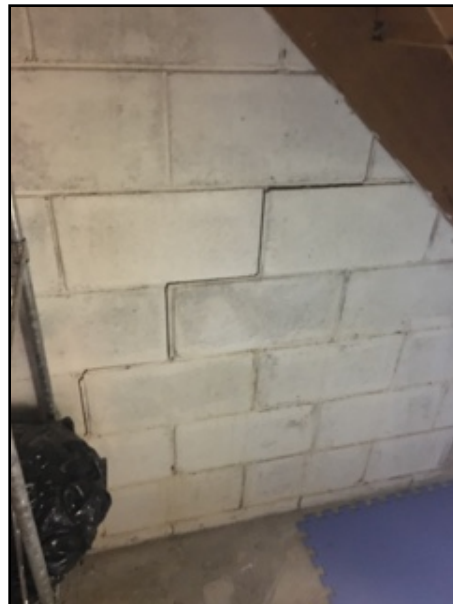
Although the north and east foundation walls are finished, there are signs that these walls may be bowed. The West foundation wall is visibly bowed and the north foundation wall below the stairs is also visibly bowed with gaps between blocks present greater than 1/4 inch wide. This could indicate foundation movement. Recommend evaluation and repair as necessary by a foundation specialist.

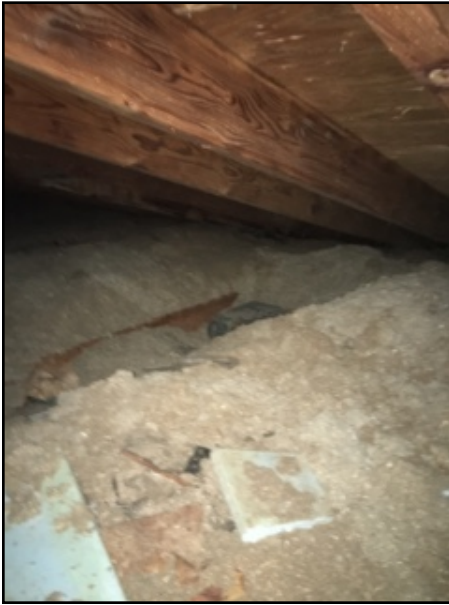
Figure 17-1

The bathroom exhaust fans vent to the attic. This can put moisture into the attic that can lead to mold growth. This also puts heat into the attic that could cause snow and ice to melt down to the soffits on the roof causing an ice dam. Recommend venting the exhaust fans through an insulated exhaust duct to the exterior of the attic.

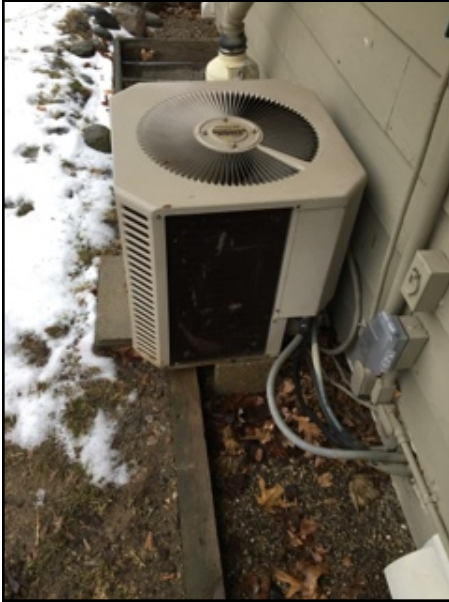
Figure 18-1

The outside temperature is below 60°. A/C systems cannot be operated when the outdoor temperature is below 60 degrees Fahrenheit. Operation not tested.

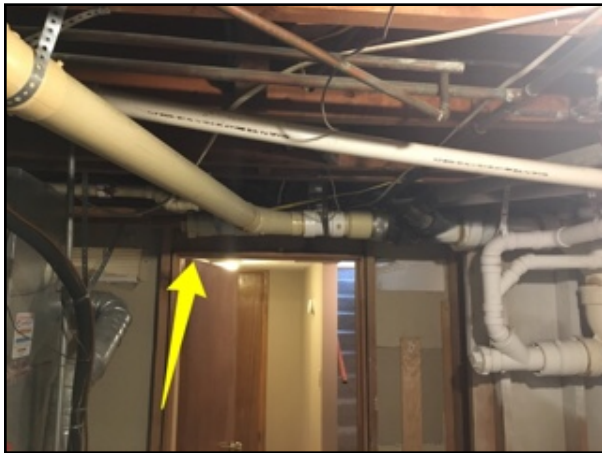
Figure 19-1

Some of the drain plumbing in the utility room appears to be graded in the wrong direction. This could allow water and solids to build up in these areas. Recommend further evaluation by a plumber.

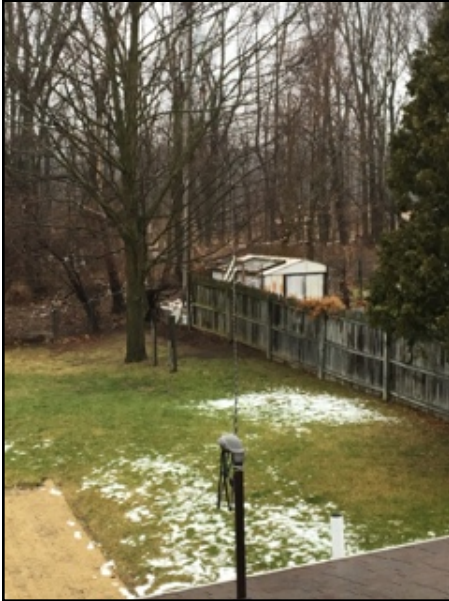
Figure 20-1

The Electric service line between the drip loop on the house and the telephone post is resting on tree branches. This is a potential hazard. Recommend consulting with the electric company to trim the branches back away from the service line.

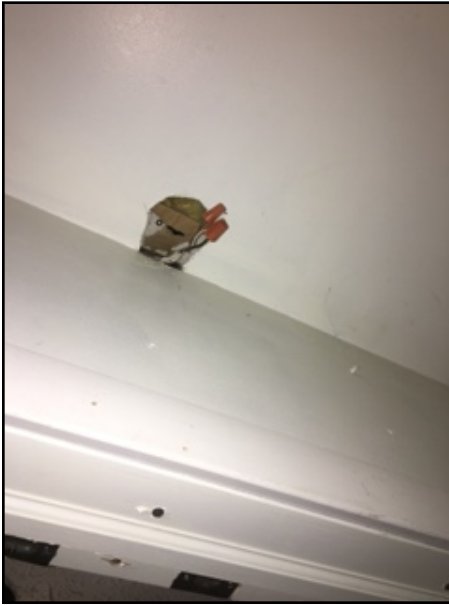
Figure 21-1

There are electrical terminations and connections that are not in covered junction boxes. Recommend evaluation and repair by an electrician.

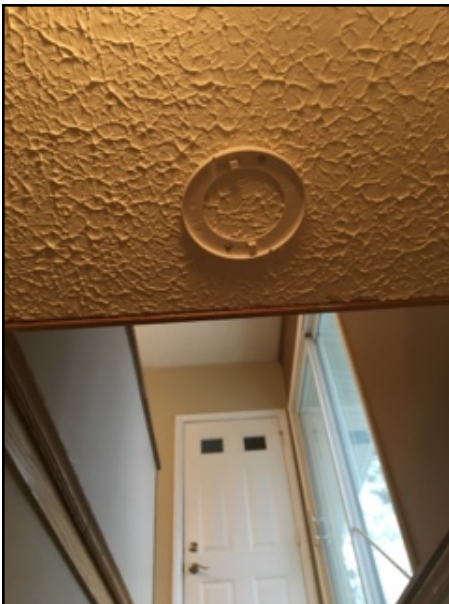
Figure 22-1

Some of the smoke detectors in the house are missing. Recommend replacement.

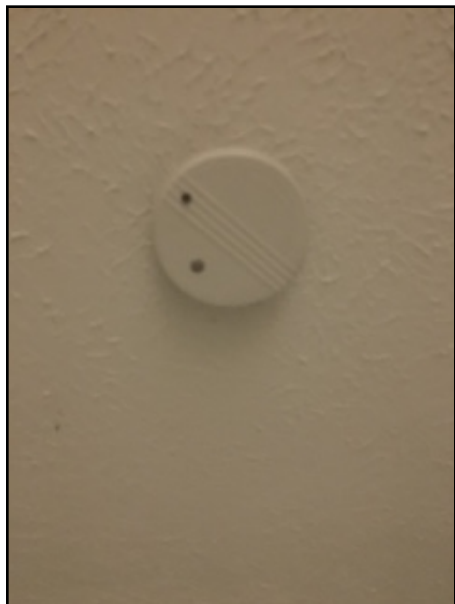
Figure 23-1

Some of the batteries are dead or missing in the smoke detectors. Recommend replacing the missing batteries.
