Inspection Report

Any Home Buyer

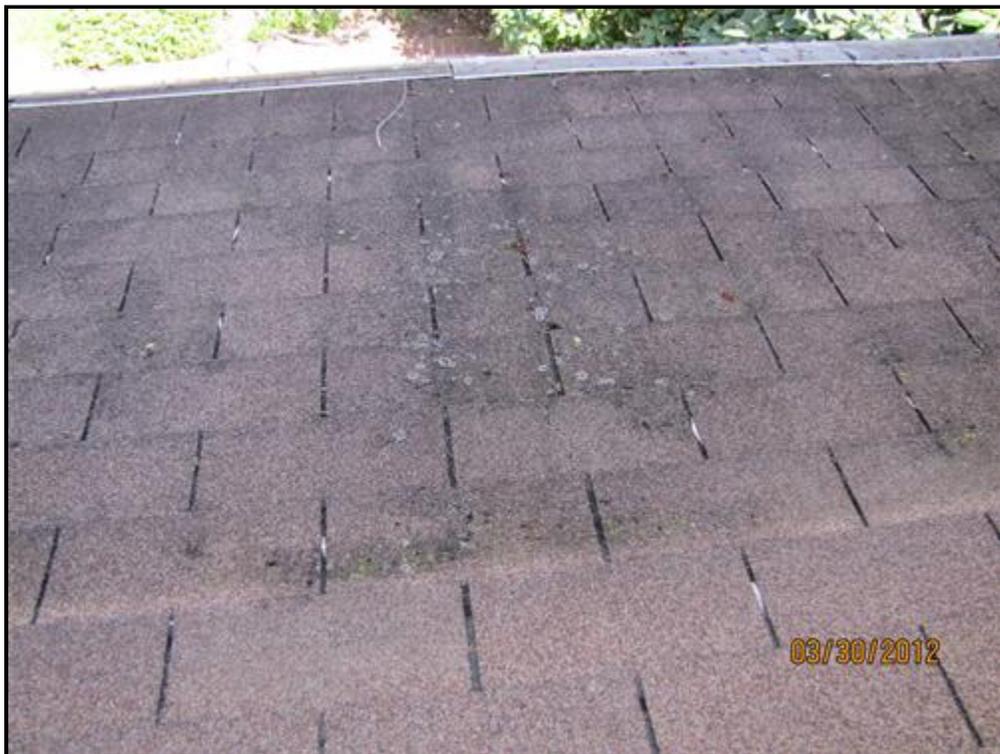
(2) Moss on roof. This can lead to the premature failure of the roof and subsequent leaks. Recommend treating moss during its growing season (wet months) with a moss killer. For information on various moss treatment products and their pros and cons, visit <http://bryophytes.science.oregonstate.edu/page24.htm>

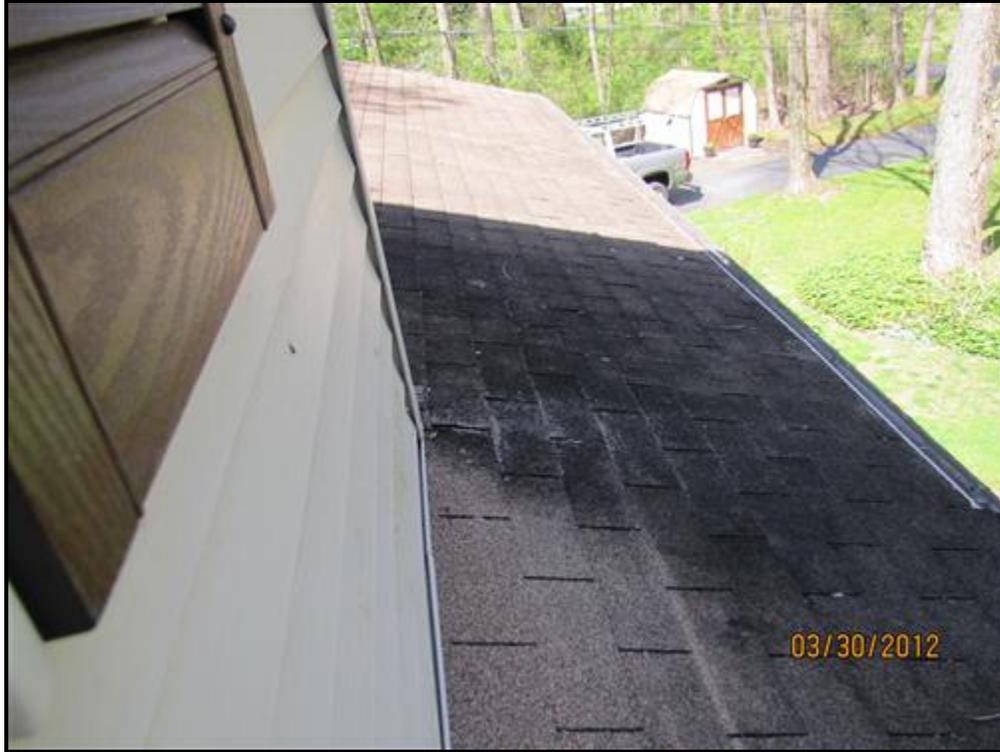
material" by most shingle manufactures. Higher quality shingles are manufactured with preventative measures such as copper or zinc containing granules. Several methods exist to prevent and clean infected areas. Installing zinc or copper strips near the roof ridge can prevent further algae growth. Application of bleach (non-chlorine) can aid in removing the stains, as well as many available commercial cleaning products. Some products may harm vegetation beneath roof eaves or near downspout extensions. While many remedies can be performed by the home owner, we recommend the use of qualified professionals.

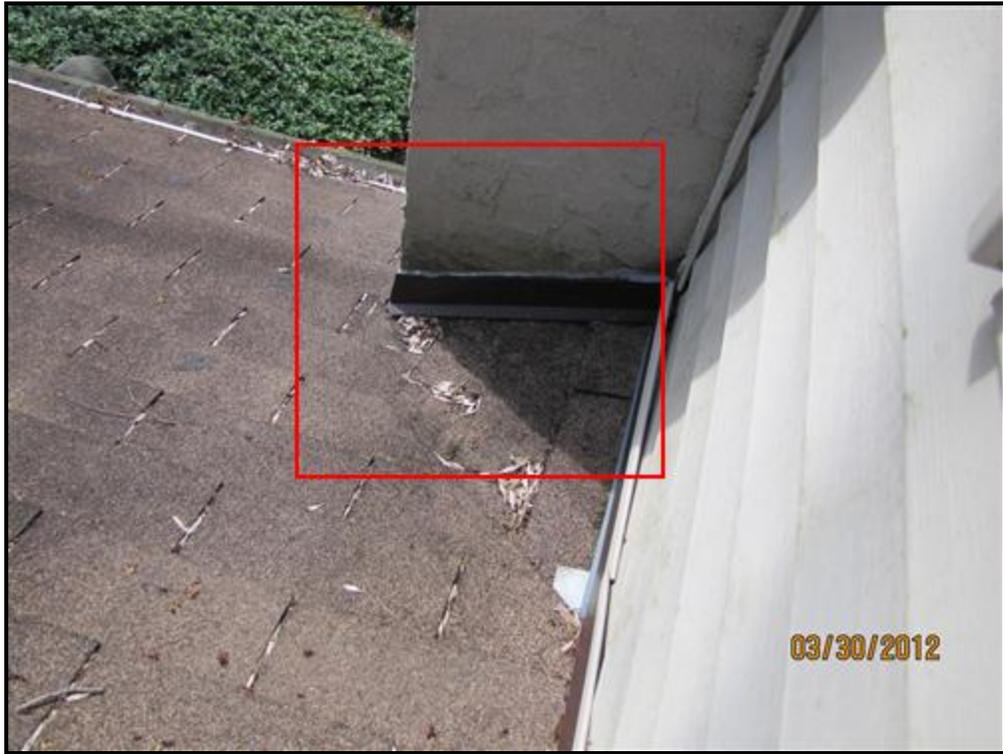
(1) Recommend installing a kickout flashing at the lower edge of the chimney to divert water into the gutter system and prevent conditions conducive of moisture intrusion at the side wall below.

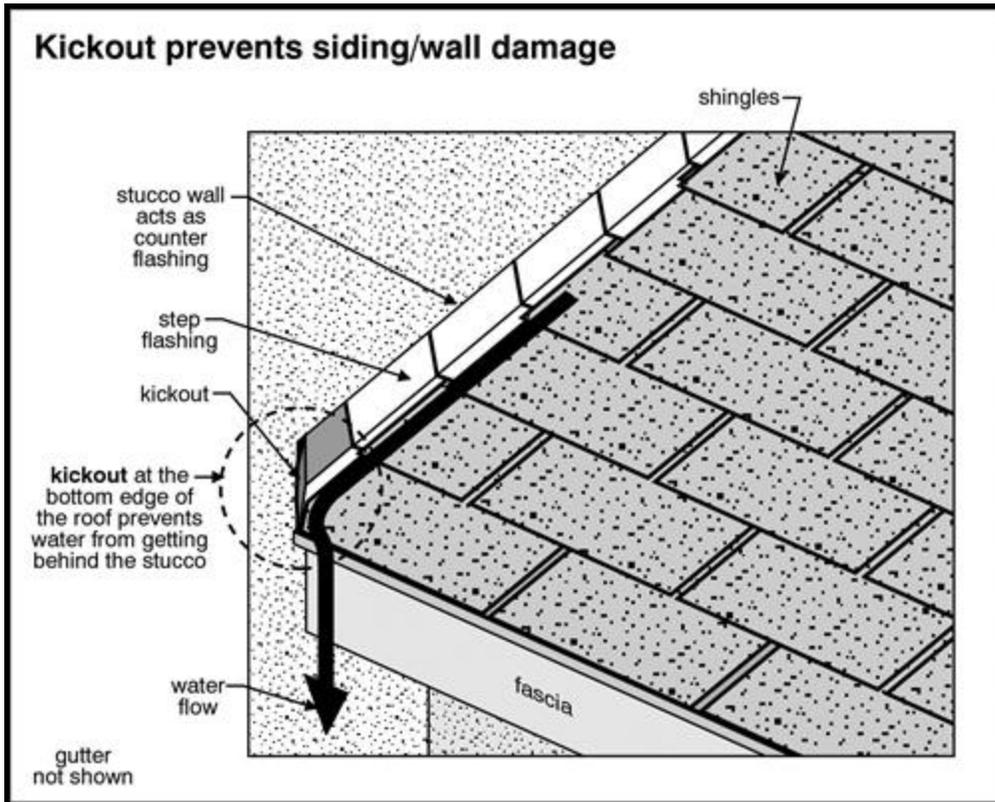
(2) A kick-out flashing is a small piece of sheet metal that is required to be installed where a lower roof edge, rain gutter, and upper wall intersect. Its purpose is to direct the flow of rainwater from the roof into the rain gutter and away from the adjacent wall. Missing or improper kick-outs can allow rainwater to flow against the siding and possibly inside the wall itself.

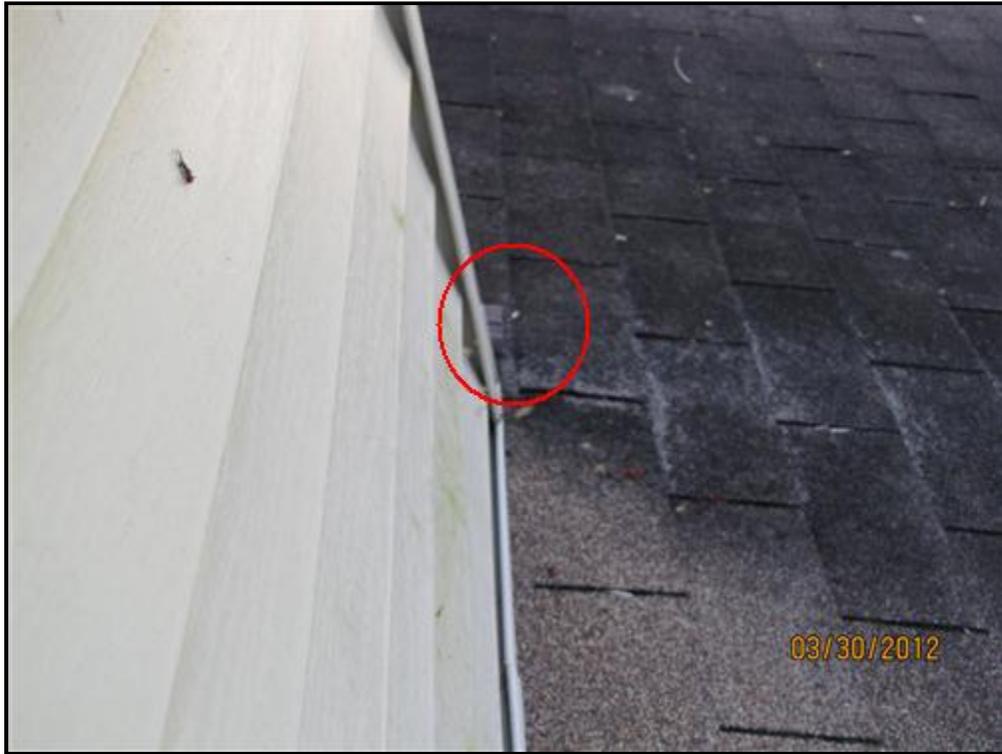
(1) The downspout for roof drainage systems on the roof above were noted as discharging directly onto a lower roof surface. This can cause premature wear and tear on the shingles and create conditions conducive of moisture intrusion. It is recommended that the downspout be extended to discharge into the next lower gutter system by a qualified contractor.

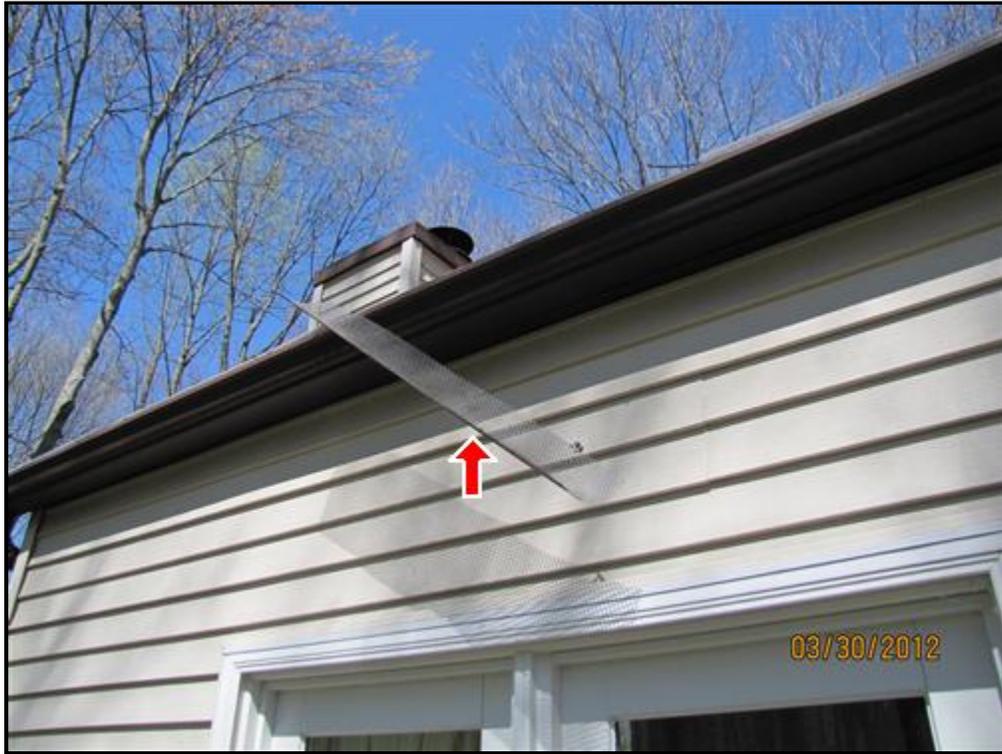
(2) The gutter screens is loose at the rear of home. If gutter screens are not properly in place, leaves can contribute to a clog which can cause deterioration of fascia, soffit or roof edge. It can also cause gutters to pull loose and lead to possible water intrusion. A qualified person should repair or replace as needed.

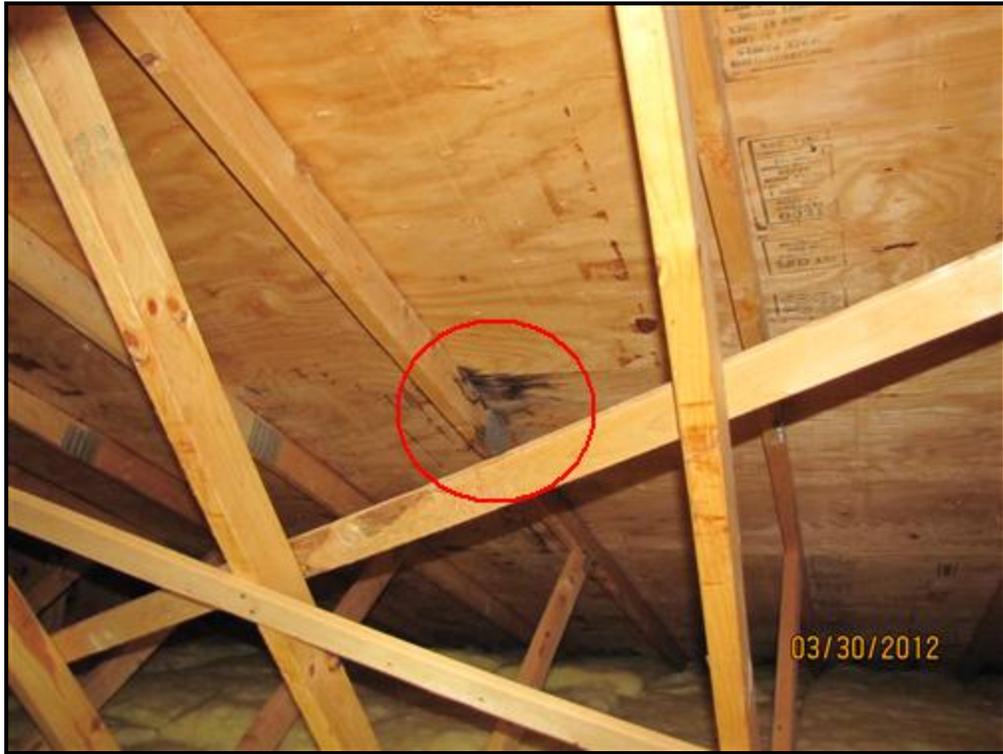
(1) Evidence of a previous roof leak was observed on the underside of the sheathing in the attic space over the addition. The dark stain was on the rear side of the roof. The area was not readily accessible at the time of inspection and it could not be determined if the spot was actively leaking. The dark staining is most likely wood decay or rot formation on the sheathing which can progress over time. It is recommended that this are of the roof be repaired by a qualified roofing contractor.

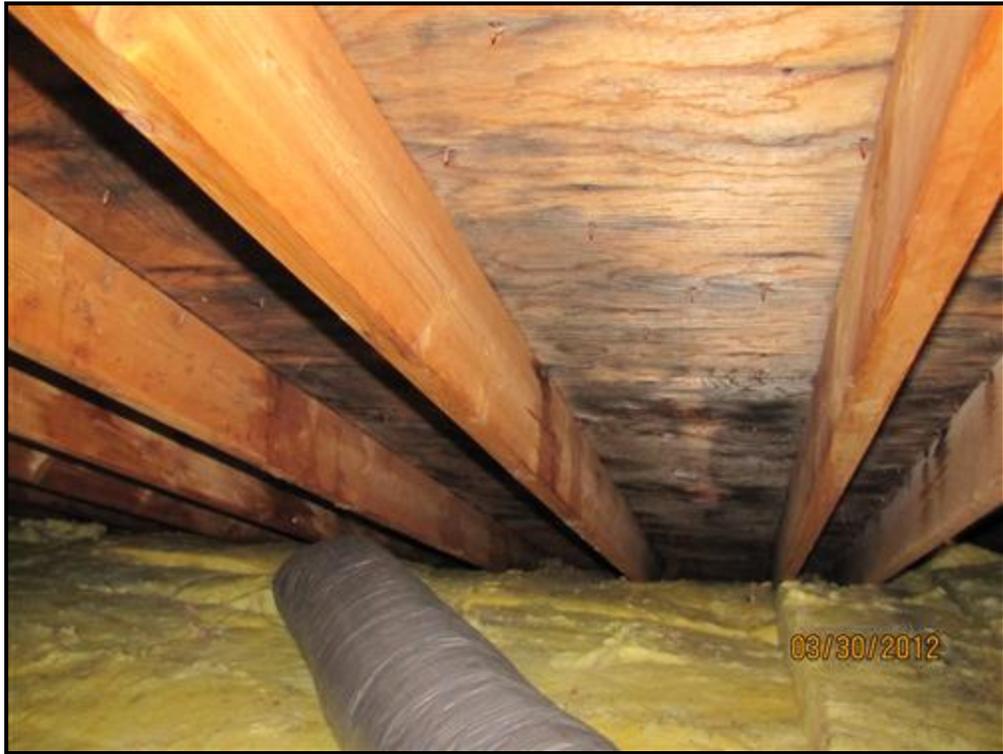
(2) The underside of the sheathing in the main attic space over the original structure was noted as being heavily stained and shows evidence of long term moisture accumulation or possible intrusion. Dark staining in some areas appears to be visible mold growth which can result in significant health issues especially after prolonged exposure. Other areas appear to show evidence or wood rot or decay. It is recommended that the sheathing be replaced by a qualified roofing contractor. Precautions should be taken to eliminate possible mold contamination by having a professional mold remediation contractor contain the attic space during any demolition processes to prevent contamination of the entire home.

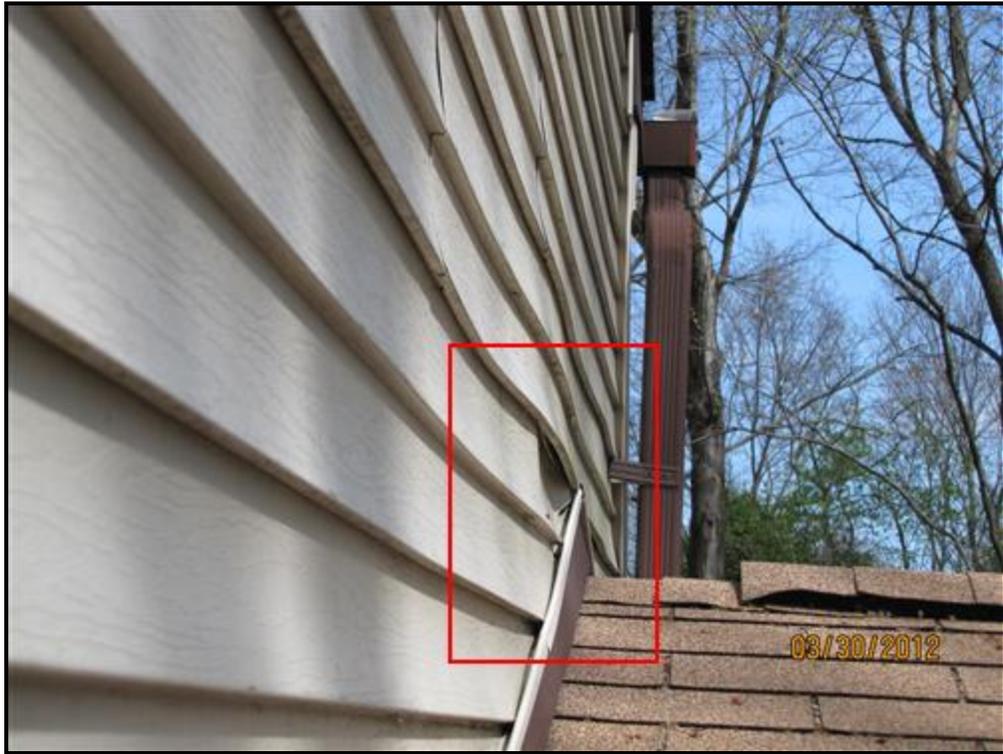
(1) An area of vinyl siding was noted as being damaged where the ridge of the addition meets that side wall of the original structure. This can create conditions conducive of moisture intrusion that can damage the underlying structural materials and interior finished surfaces. Recommend repair by a qualified contractor.

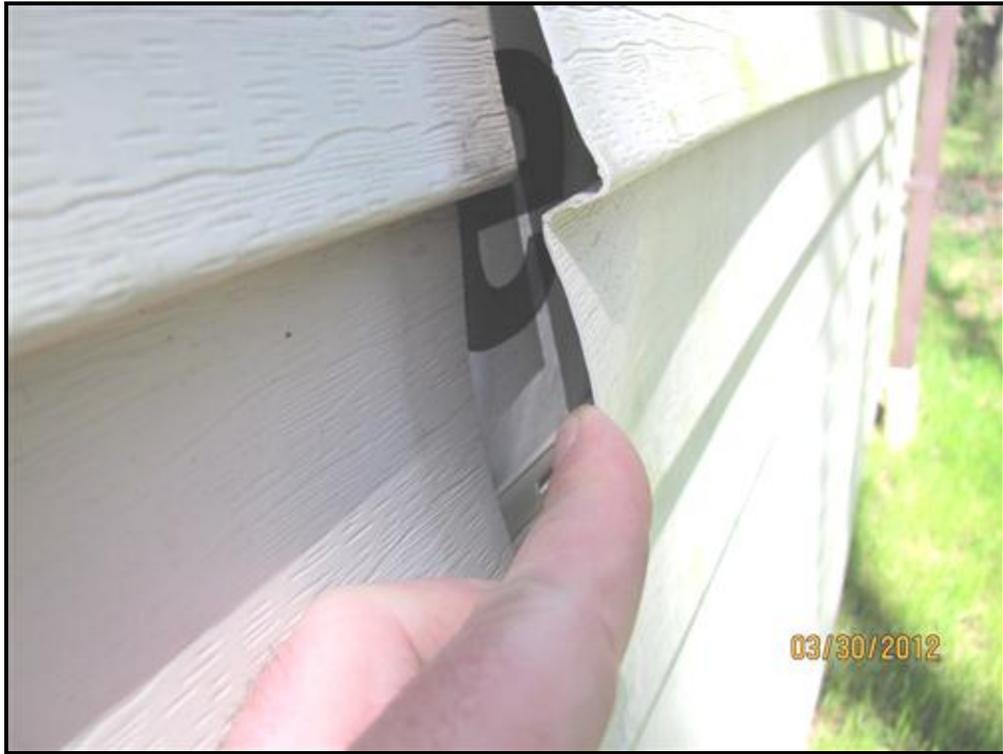
- ✔ (2) A section of the vinyl siding was lifted and the underlayment was inspected. A layer of moisture barrier was noted as being installed in the area inspected. Because it is not possible to determine the extent and condition of the vapor barrier without observing it after it was completely installed, no guarantee can be made that the layer is uniform and consistent on the exterior of the home. Lack of a vapor barrier in most areas can result in conditions conducive of wood decay or rot formation on the exterior sheathing. It is recommended that you monitor the interior and exterior of the home for any evidence of moisture intrusion that is causing damage to the structure. Typical signs would include moisture staining on the interior or bulging or wavy siding on the exterior.

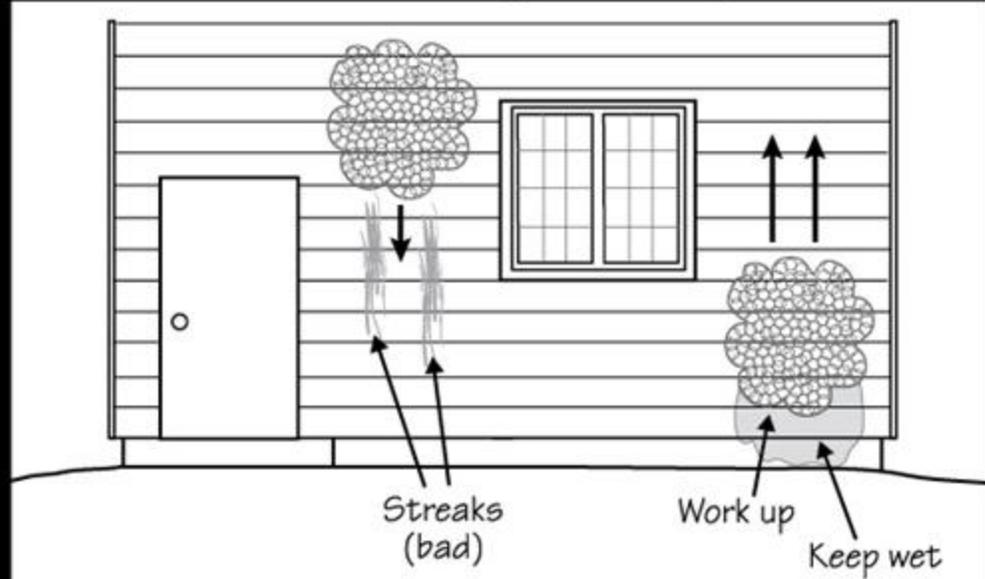
Always work "bottom up" when washing vertical surfaces and keep the lower area damp. This prevents streaks and stains from dirty wash water on a dry surface.

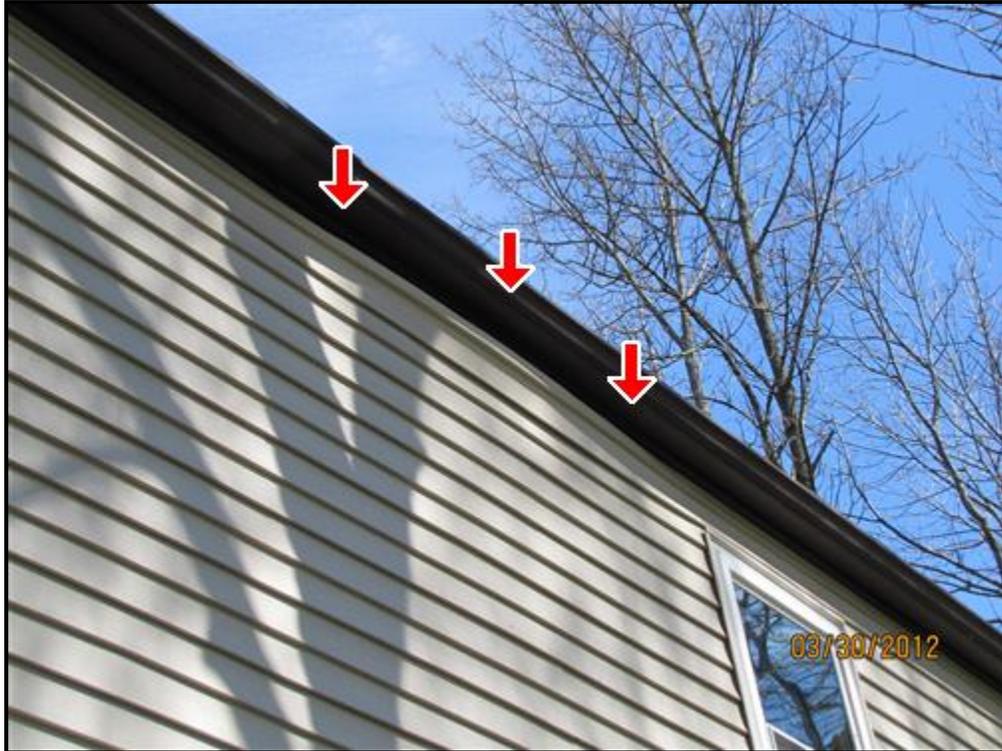
(4) There was a section of siding at the rear of the property that was pulling away from the main structure. This can allow for conditions conducive of moisture intrusion that can damage the underlying structural materials and interior finished surfaces. Recommend repair by a qualified contractor.

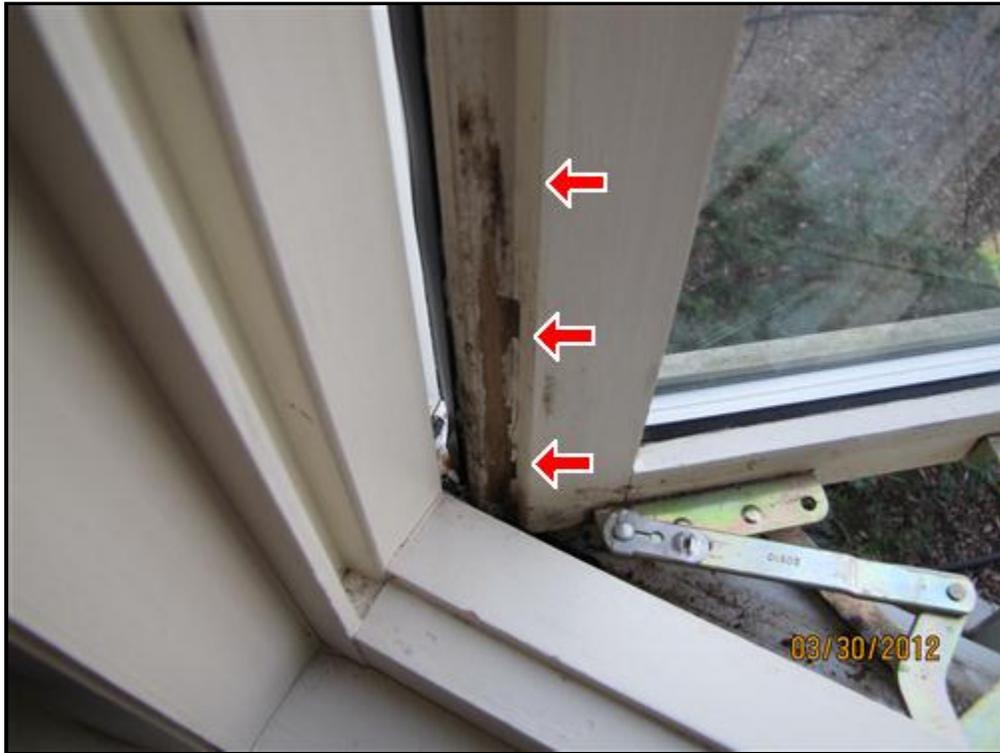
🔧 Peeling paint was observed on the sides of the casement windows at the rear of the home. This can allow for conditions conducive of wood rot formation if water manages to come in contact with the exposed wood. It is recommended that any peeling paint be scraped, sealed, and painted to prevent further damage.

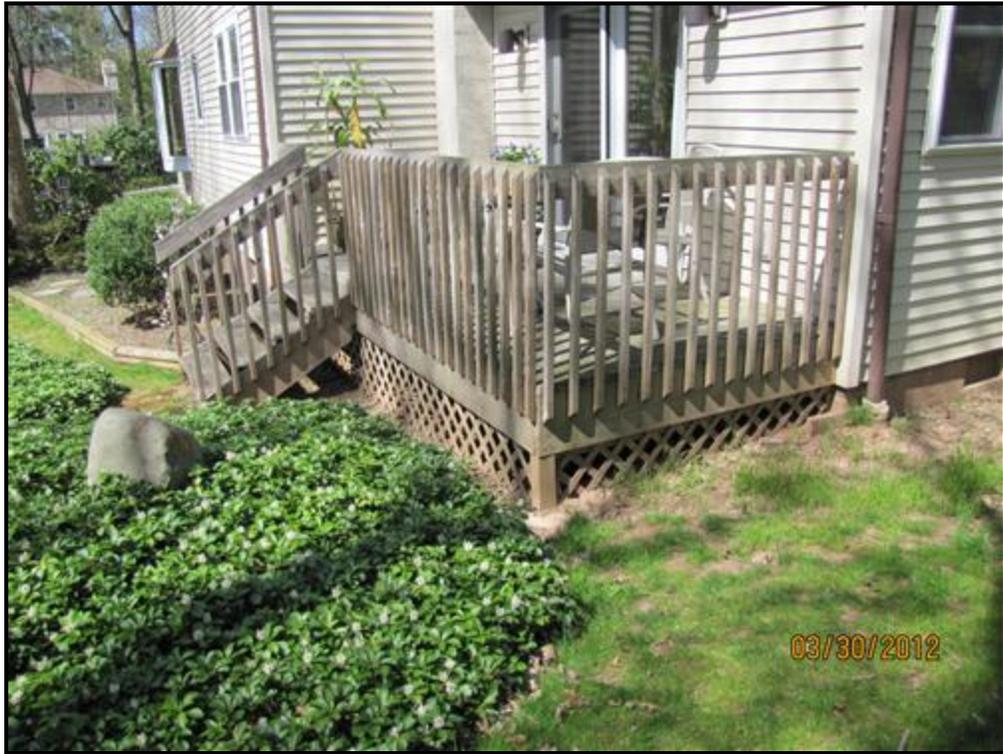
🔒 (1) Access underneath the deck off the rear of the addition was prevented by permanently installed skirting under the deck. Support attachments to the main structure could not be evaluated at the time of inspection. Recommend further evaluation by a qualified contractor was the area has been made accessible.

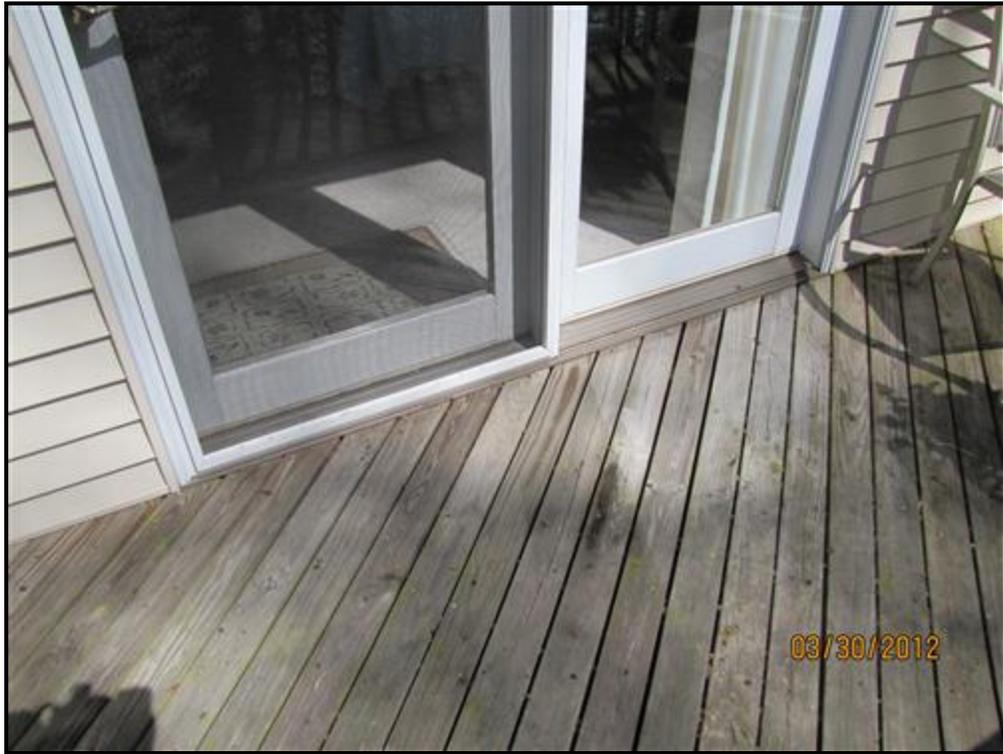
(2) The exterior deck surface was noted as being installed at the same level as the interior floor level. This can allow for conditions conducive of moisture intrusion under the door threshold that can damage the underlying structural materials and interior finished surfaces. Best building practices suggest that a minimum of 4 inches be maintained between the deck and interior floor levels, with 7 inches being ideal to prevent potential trip and fall hazards. It is recommended that the deck be replaced if there is any evidence of moisture intrusion that occurs.

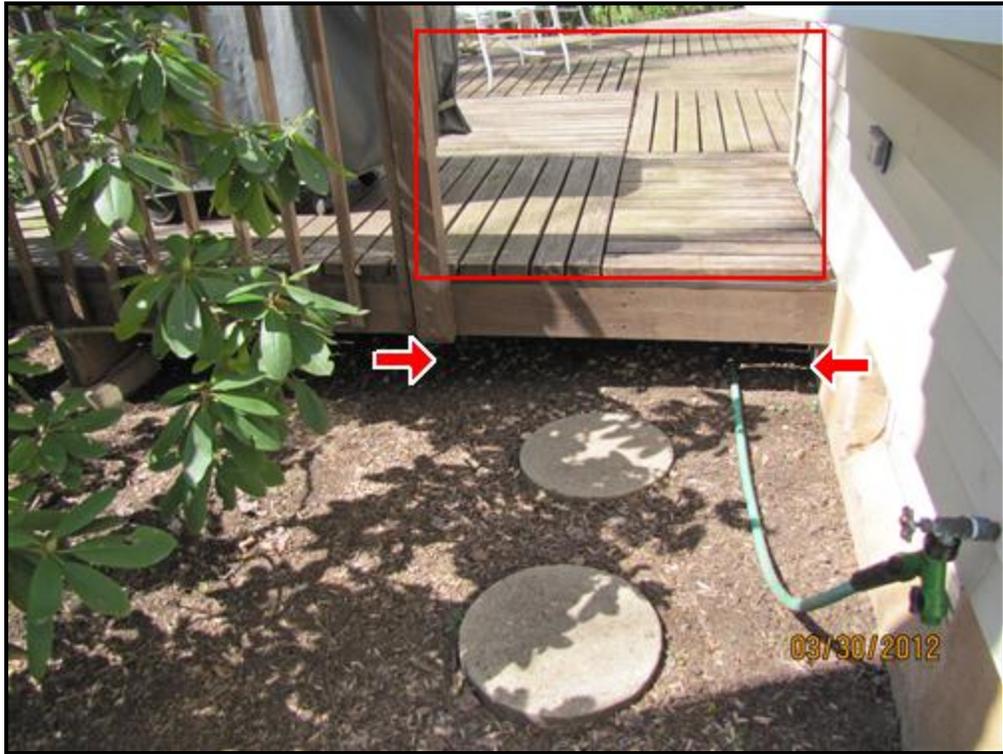
(3) The rear deck off the main structure was noted as having a section where there were missing guard rails. This can result in potential trip and fall accidents. The one side of the deck can have an additional step installed to allow for access to the pathway at the rear of the property. The other sections at the rear of the deck should have additional guard rails installed for safety reasons.

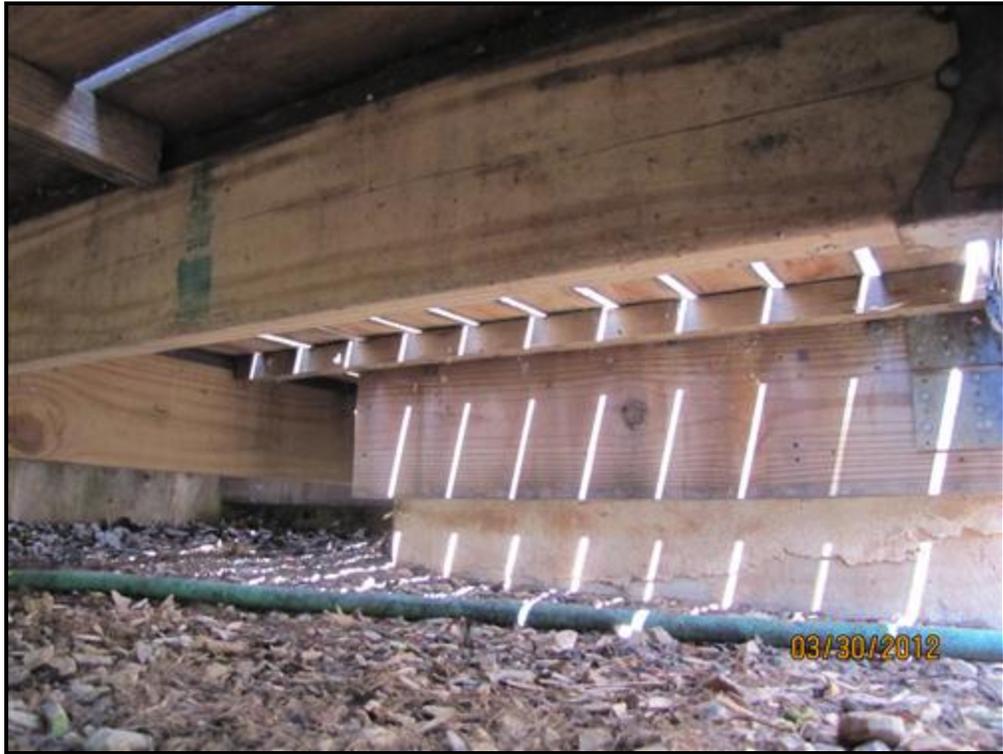
(4) The ledger board attaching the rear deck to the main structure was noted as not being sufficiently secured with the appropriate hardware or at the recommended intervals. This can result in the deck pulling away from the main structure over time or creating conditions conducive of moisture intrusion or other damage to the foundation walls. It is recommended that the deck be properly attached by a qualified contractor.

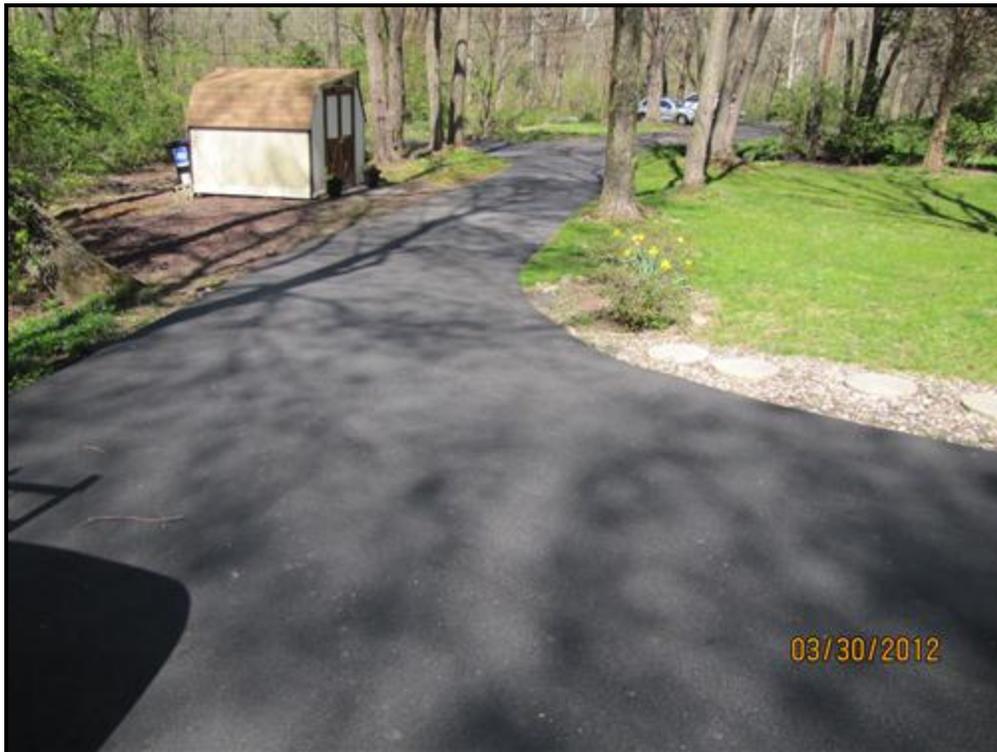
- ✓ (1) The main driveway was noted as being in good condition with no obvious signs of cracking observed in the asphalt.

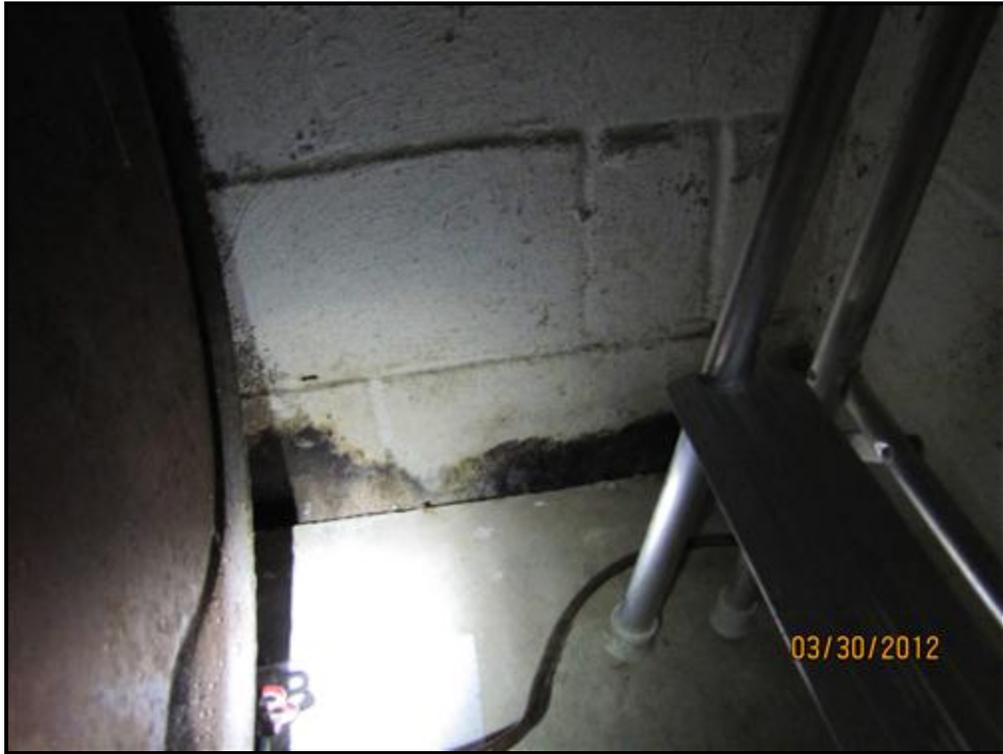
(1) The basement foundation walls were noted as having a black discoloration present at the time of inspection in the area of the French drain. This can be possible mold growth due to repeated moisture intrusion. Mold growth can result in significant health related issues and illnesses especially after prolonged exposure. It is recommended that the substance be sampled and sent to a laboratory for analysis and confirmation of mold growth. It is recommended that the substance be removed qualified mold remediation contractor if identified as mold growth.

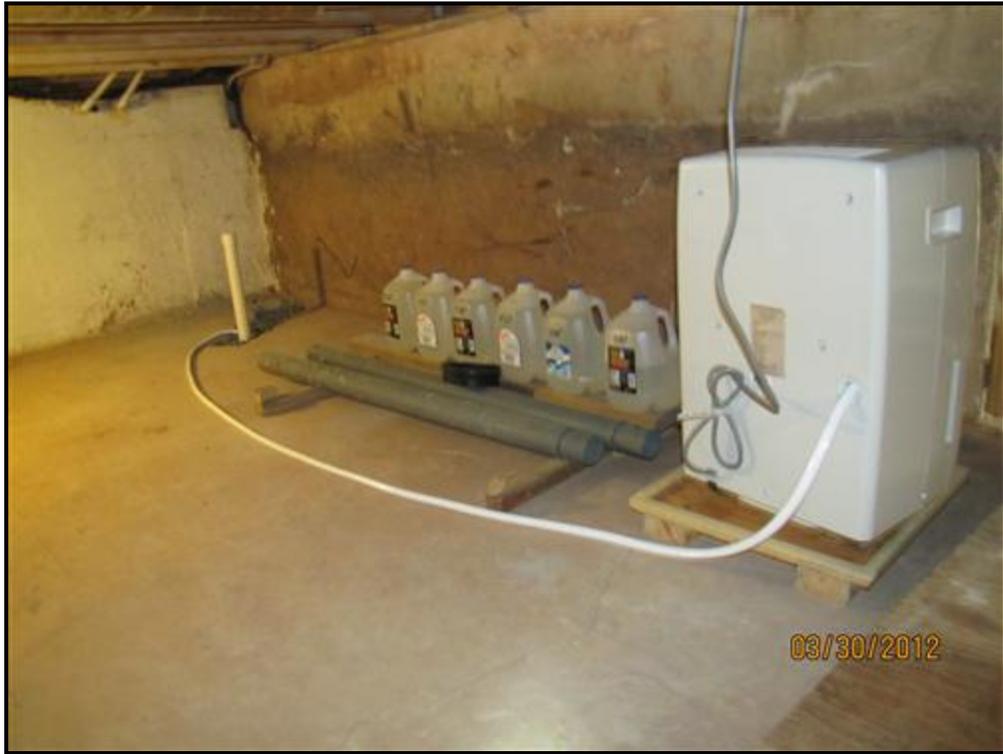
- 🔨 (2) The crawlspace was noted as having a dehumidifier installed which is an indication that the crawlspace has had previous moisture problems in the past. The dehumidifier was noted as discharging into the French drain at the rear wall which does not help to remove the condensation. It is recommended that the vents in the crawlspace be rearranged to allow for better air circulation and the dehumidifier be plumbed to discharge to a condensate pump that is routed to the exterior or a nearby drain.

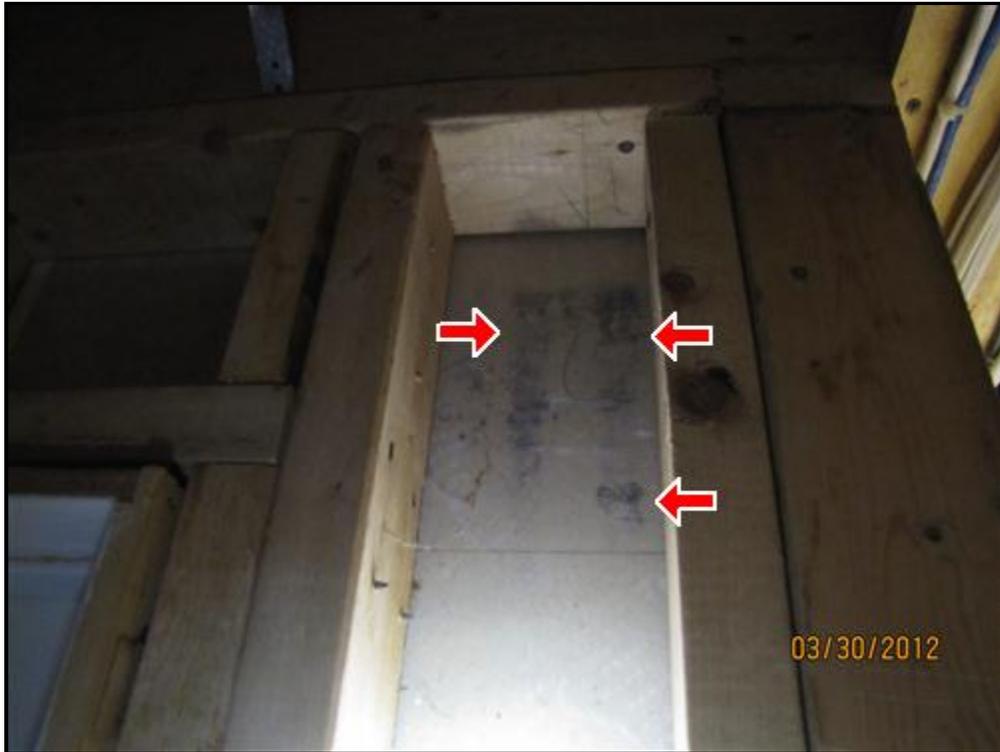
laboratory for analysis and confirmation of mold growth and removed by a qualified mold remediation contractor based on positive results.

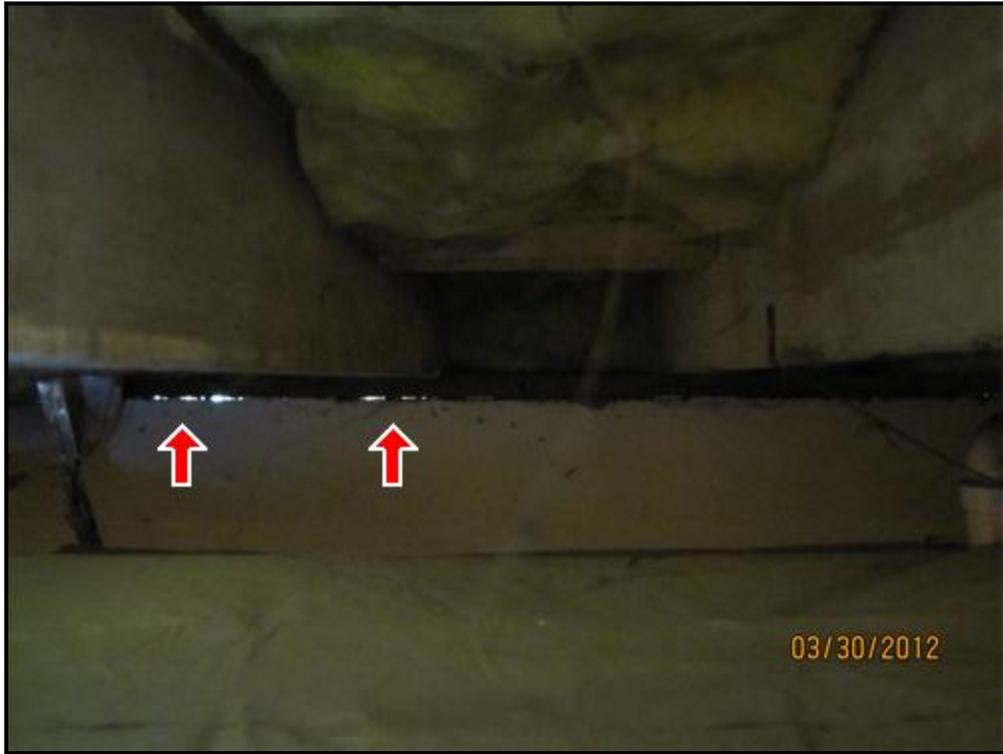
- 🔨 (2) There was visible daylight observed at the bottom plate from inside the crawlspace. The exterior sill was flashed, however it does not appear to have been sufficiently sealed. There was no vapor barrier strip installed between the bottom plate and the foundation wall which can allow for conditions conducive of wood rot formation at the bottom plate. The gaps can allow for pests to enter such as wood destroying insects and moisture. It is recommended that the exterior be sealed to prevent any moisture or pest intrusion.

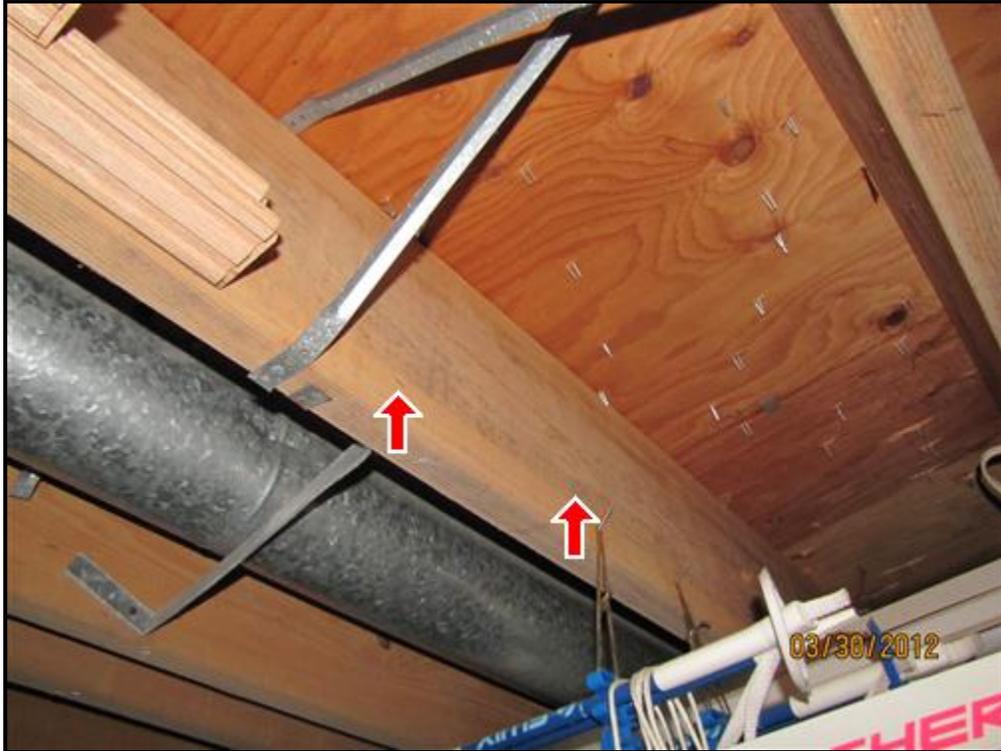
- ⚠ (1) Floor joists in the basement storage area off the laundry room were noted as having a white chalky coating on them which is suspected mold growth. Mold growth resulting significant health related issues and illnesses especially after prolonged exposure. It is recommended that the substance be sampled and sent to a laboratory for analysis and confirmation of mold growth and be removed by a qualified mold remediation contractor based on positive results.

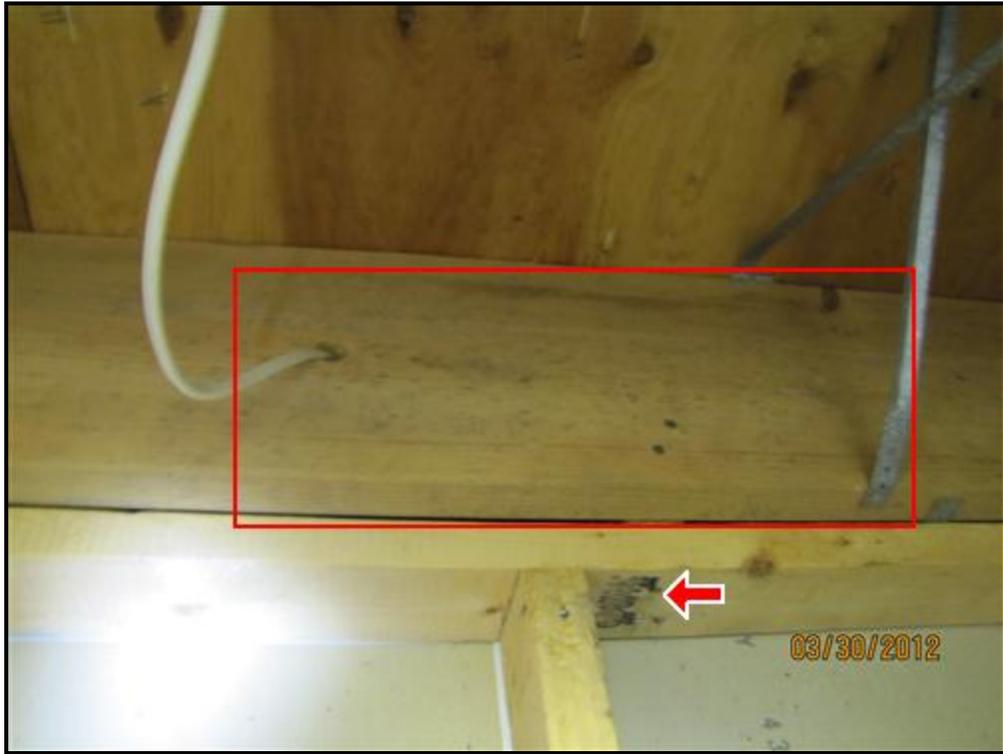
- ⚠ (2) Dark spots were observed on the joists in the unfinished portion of the basement which is typical of visible mold growth patterns. Mold growth can result in significant health related issues and illnesses especially after prolonged exposure. It is recommended that the substance be sampled and sent to a laboratory for analysis and be removed by a qualified mold remediation contractor based on positive results.

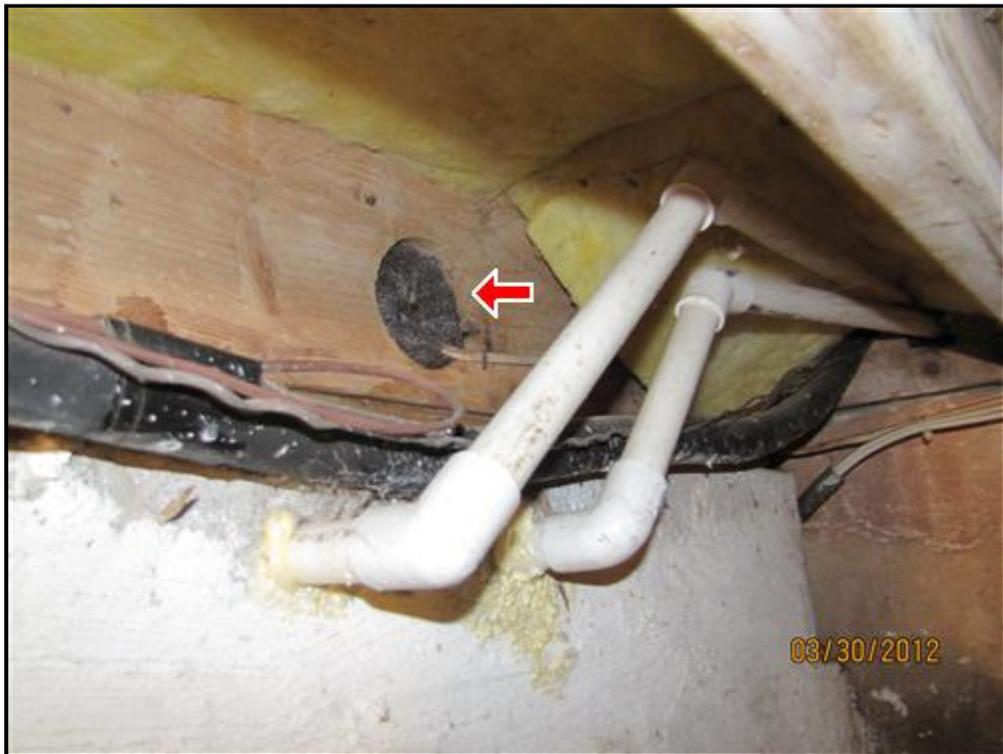
(3) There was a 4 inch hole noted as being cut into one of the joists in the crawlspace at the rear of the property. It has been filled with steel wool and there was a wiring circuit running through it at the time of inspection. It is unknown what the intended use for the hole was, but it does not appear to be causing any structural damage at this point in time. Recommend monitoring the joists for any cracks that may develop over time and repair as needed.

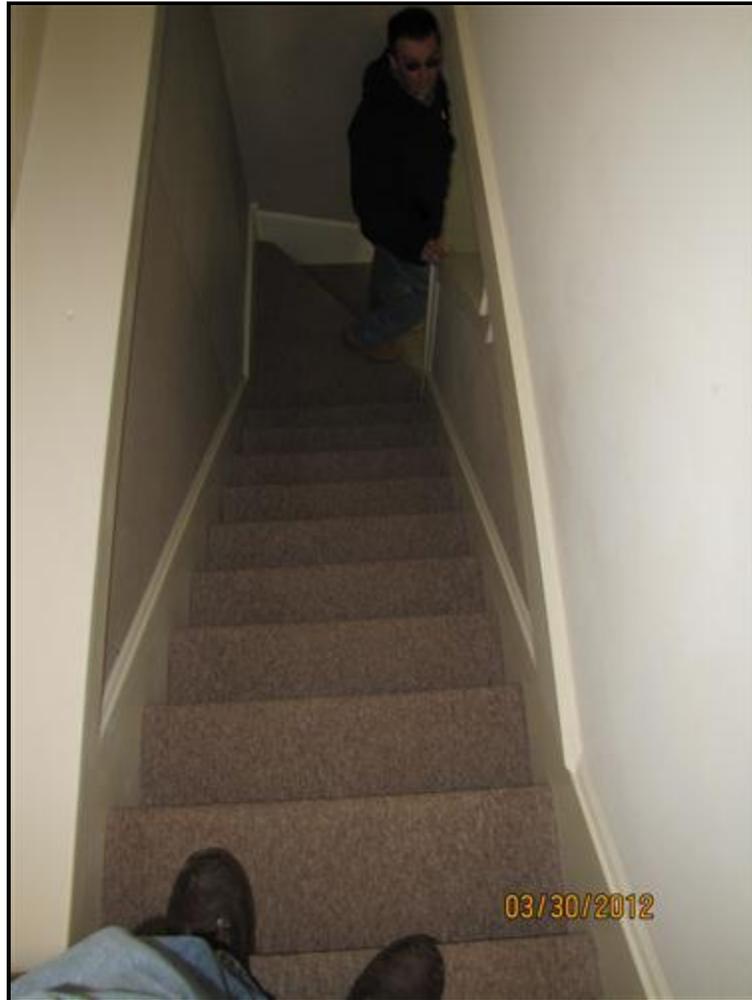
(1) Basement stairs were noted as not having a hand rail installed. This can create conditions conducive of trip and fall hazards. Modern building standards state that stairs with more than 4 vertical risers require a graspable hand rail to be installed. It is recommended that one be installed by a qualified contractor for safety reasons.
