Inspection Report

Any Home Buyer

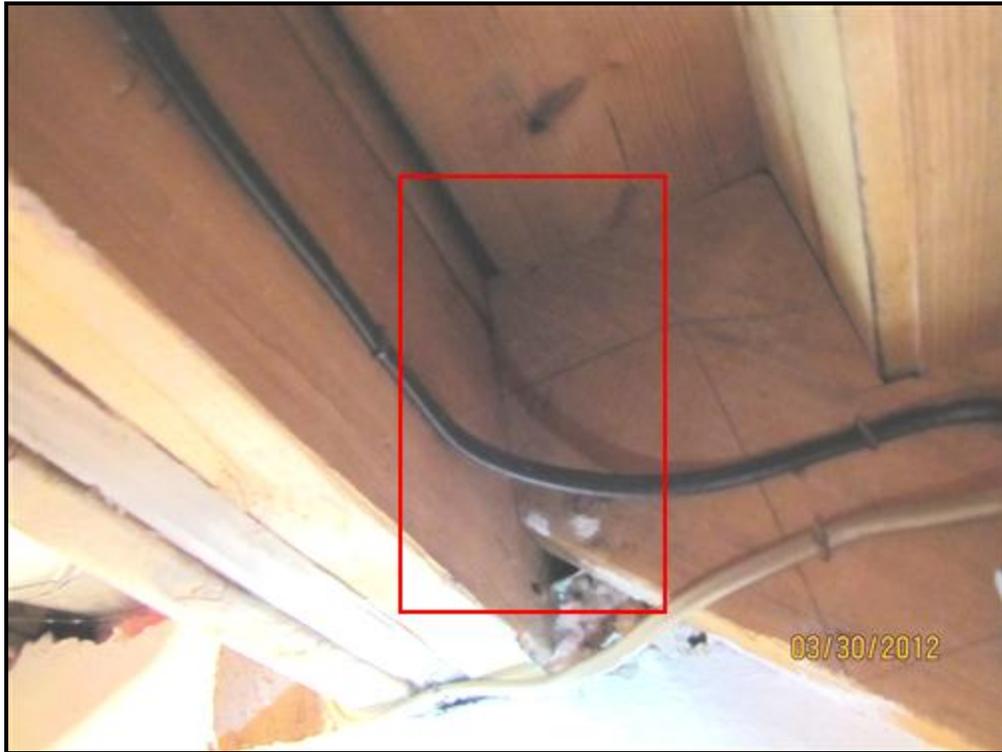
(2) Basement stair stringers were noted as not having support brackets installed. This can result in settlement of the steps over time. Recommend installation of additional support hardware by a qualified contractor.

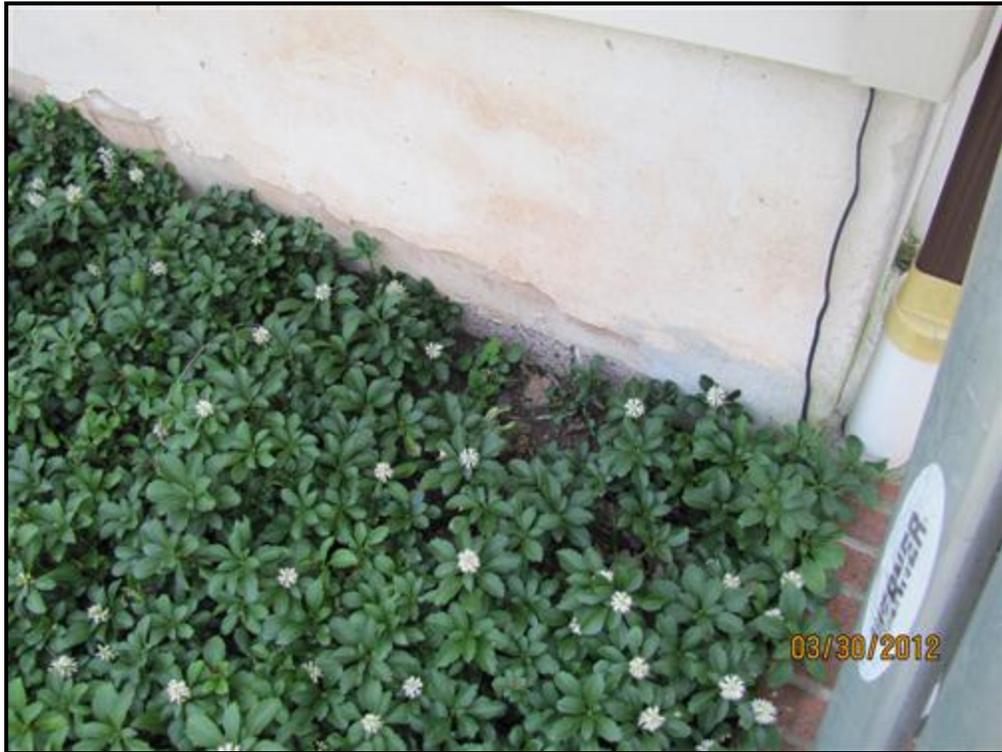
The exterior foundation walls were noted as having exposed concrete block in areas. No evidence of damp proofing was observed. Concrete masonry block can allow for moisture intrusion. Determining if damp proofing is present on foundation walls requires digging next to the foundation which is outside of the scope of a home inspection. It is recommended that this be further evaluated once permission is obtained from the seller to dig next to the foundation.

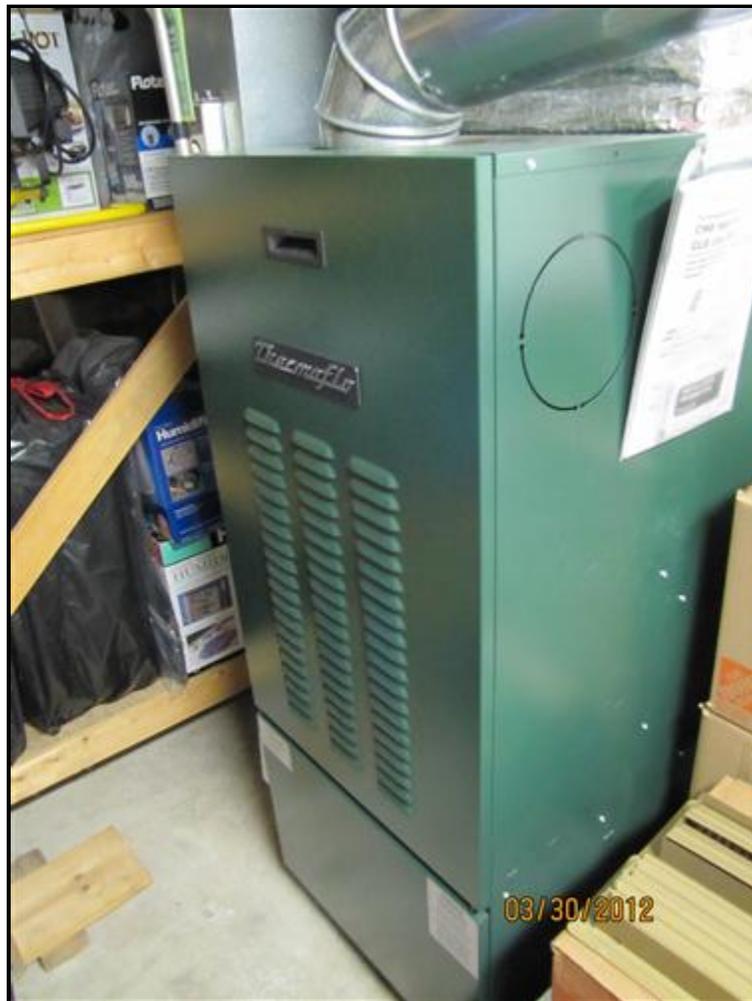
- ✓ The heating system in the basement was inspected and found to be in relatively new condition. The system could not be operated due to the fact that the oil tank was empty at the time of inspection. It is recommended that the system be further inspected once oil has been added to the tank in order to operate the system.

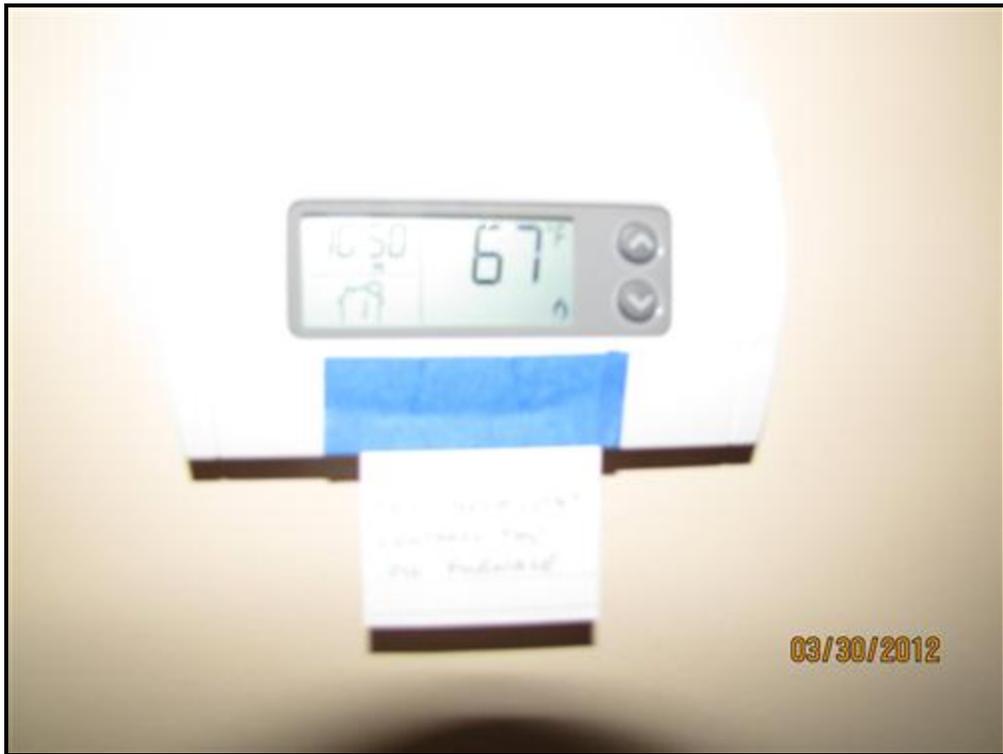
- ✓ Inspected with no obvious signs of defects observed at the time of inspection.

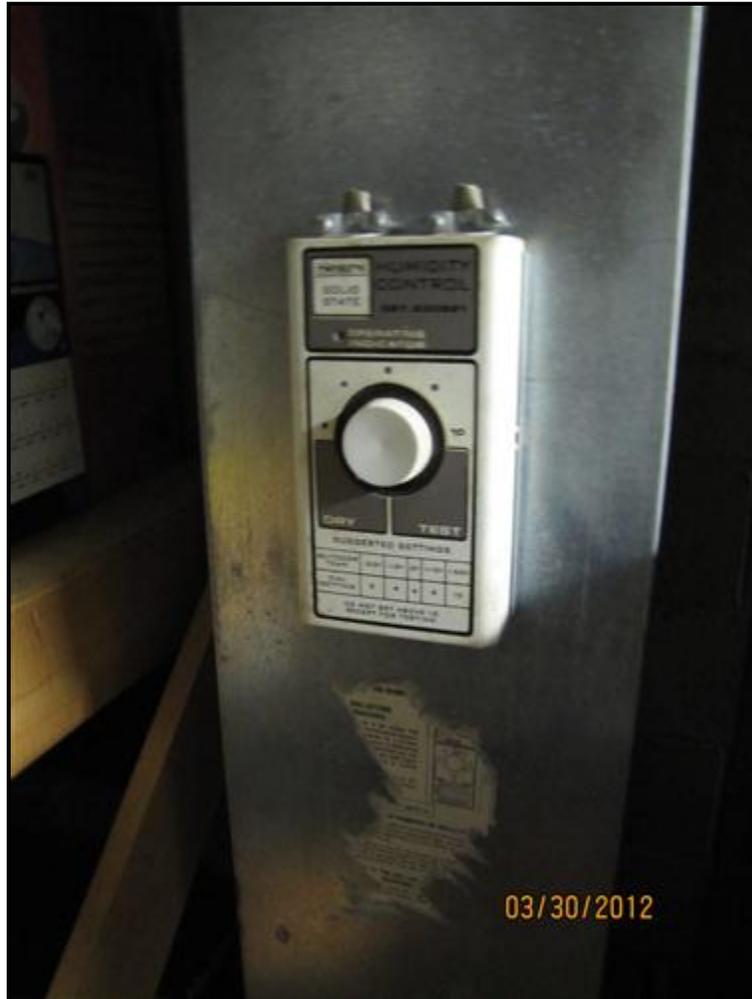
The heating system used to have a humidistat and humidifier installed which appears to have been removed. Oil fired forced air heating systems can produce a significant amount of dry air which can cause dehydration of wood building materials inside the home that can result in splitting or warping. With forced air heating systems it is recommended that a humidifier be installed and be properly maintained. Recommend replacement by a qualified HVAC contractor.

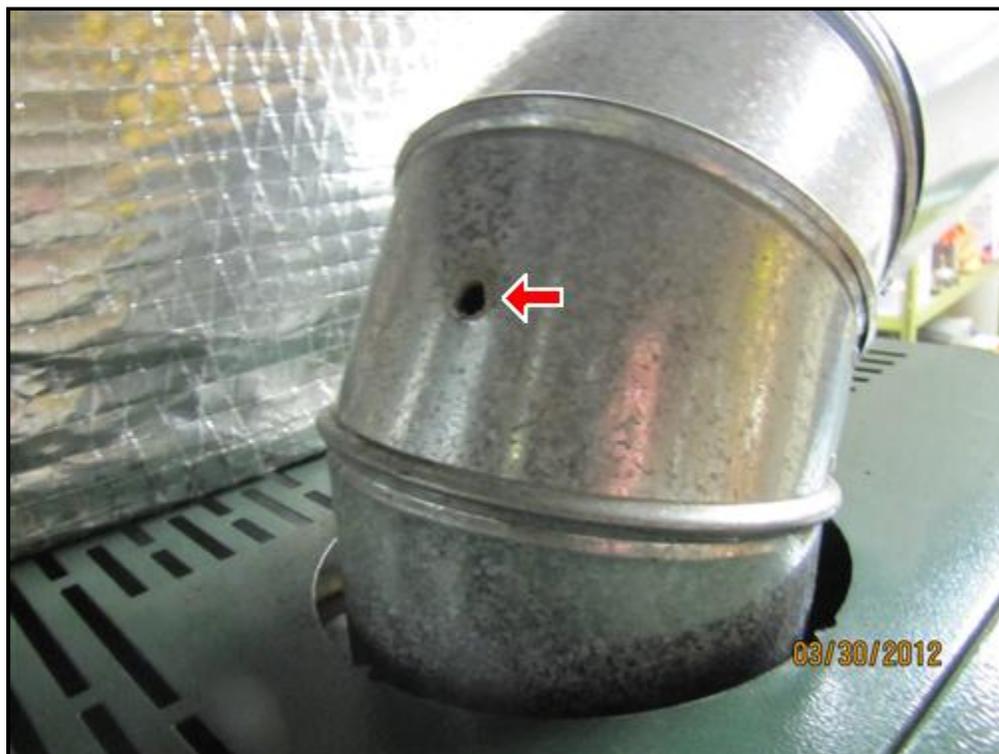
(2) The heating system has a small hole drilled in the vent from where a combustion analysis was performed. This small can result in combustion fumes leaking into the basement which can contain dangerous gases such as carbon monoxide. It is recommended that the whole be sealed by a qualified HVAC contractor.

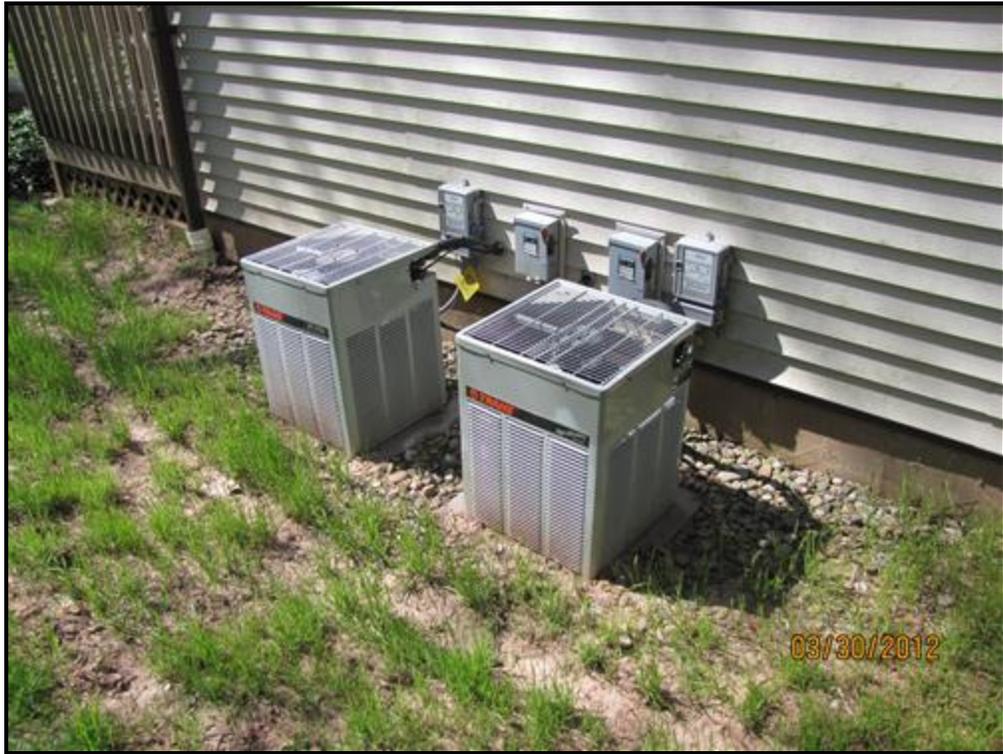
(1) Air-conditioning compressor units on the exterior of the house were noted as being installed at or slightly above grade level. It is recommended that the air-conditioning compressor units be elevated approximately 4 inches above the surrounding soil level to prevent potential flooding during heavy rains.

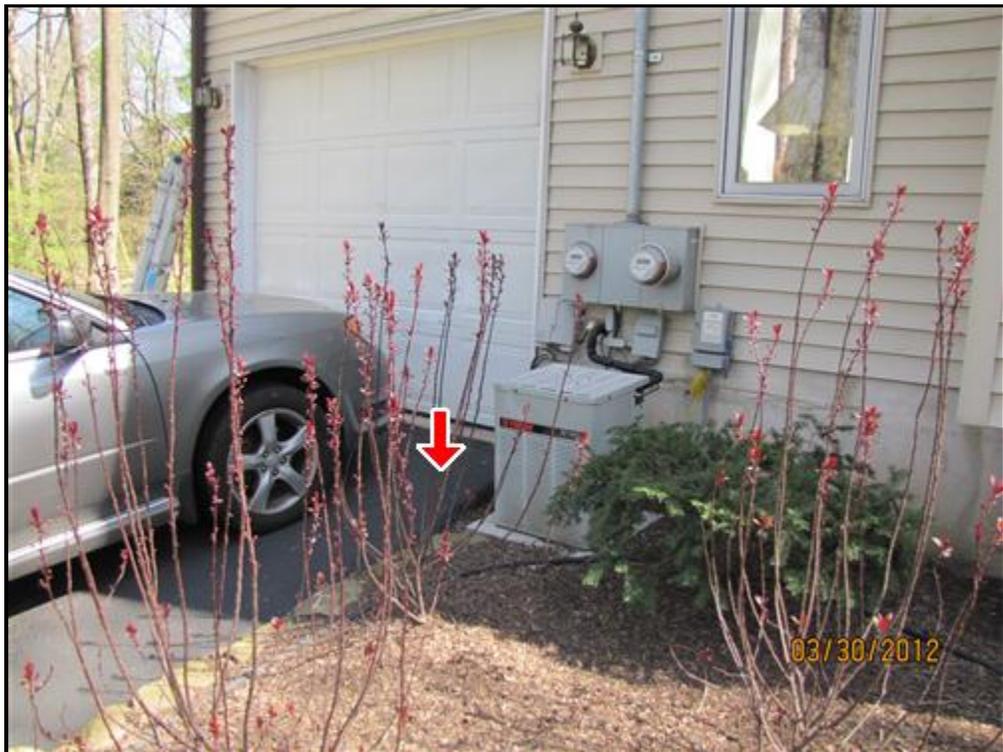
(2) The air conditioning compressor unit by the driveway was noted as being in a vulnerable position where it can be easily damaged by a car or by moving items into or out of the garage. It is recommended that some sort of barrier be installed to protect the unit or it be relocated to a more suitable location. The unit was also noted as not being level which can cause wear and tear on the compressor motor and fan assembly. Ideally, units should be level but as much as a 4 degree slope is acceptable. Anything more can cause damage to the unit over time.

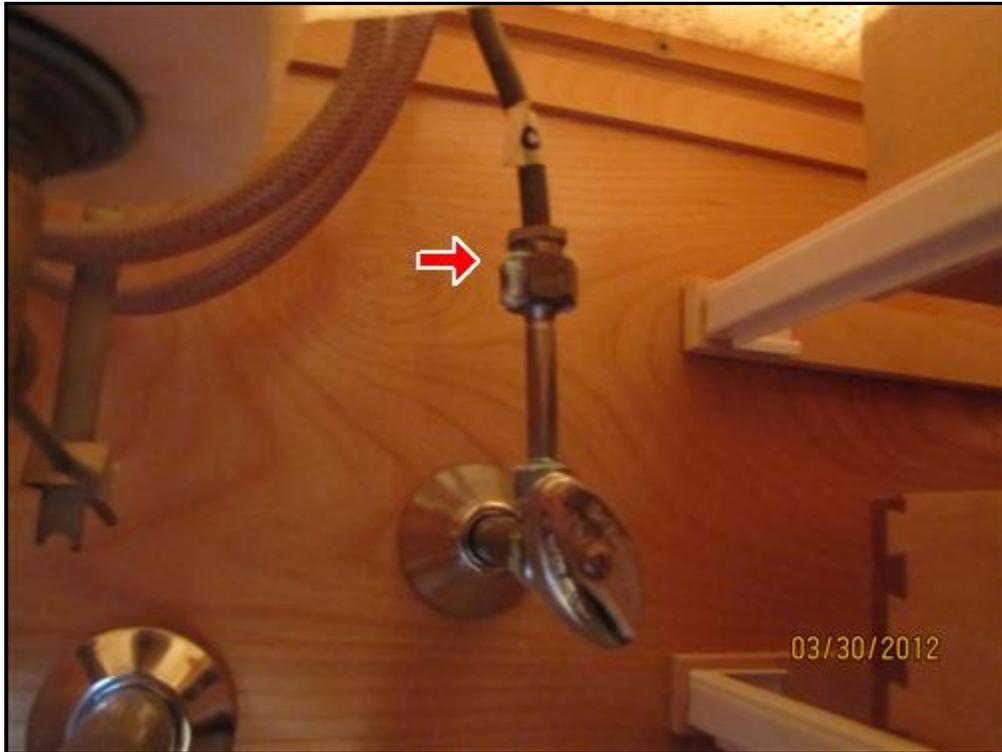
again without notice. Recommend further evaluation and any necessary repairs be conducted by a qualified plumbing contractor.

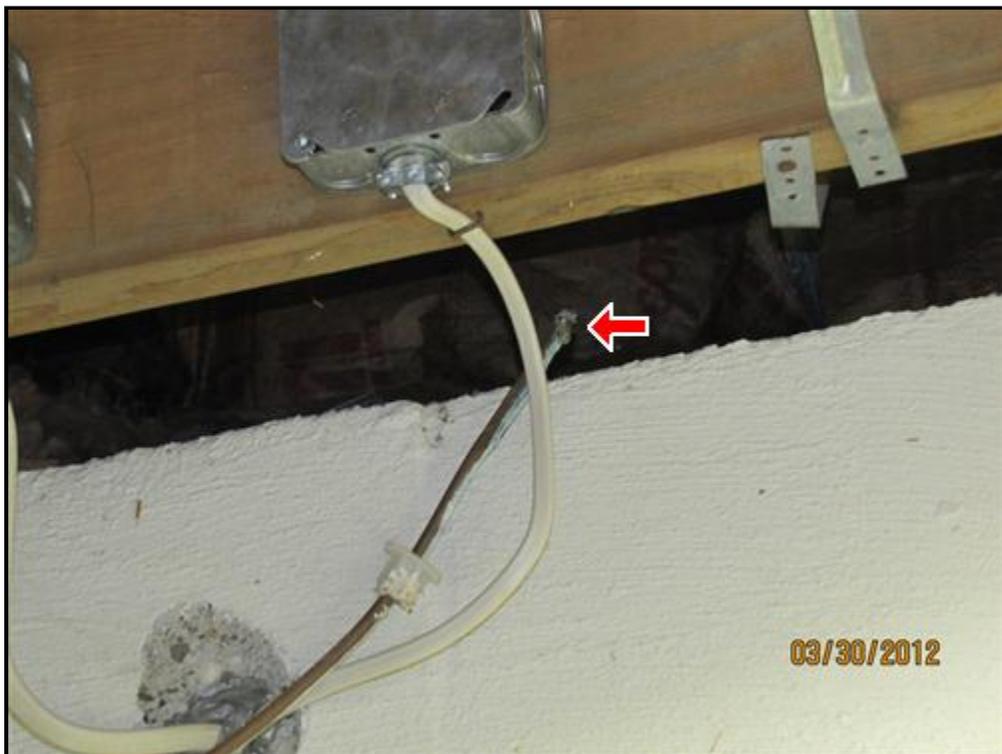
(2) Water supply lines for a previously installed humidifier unit at the HVAC system in the basement was noted as being improperly terminated. This can result in leaks developed over time. It is recommended that any abandoned plumbing lines for a humidifier be removed by a qualified plumbing contractor.

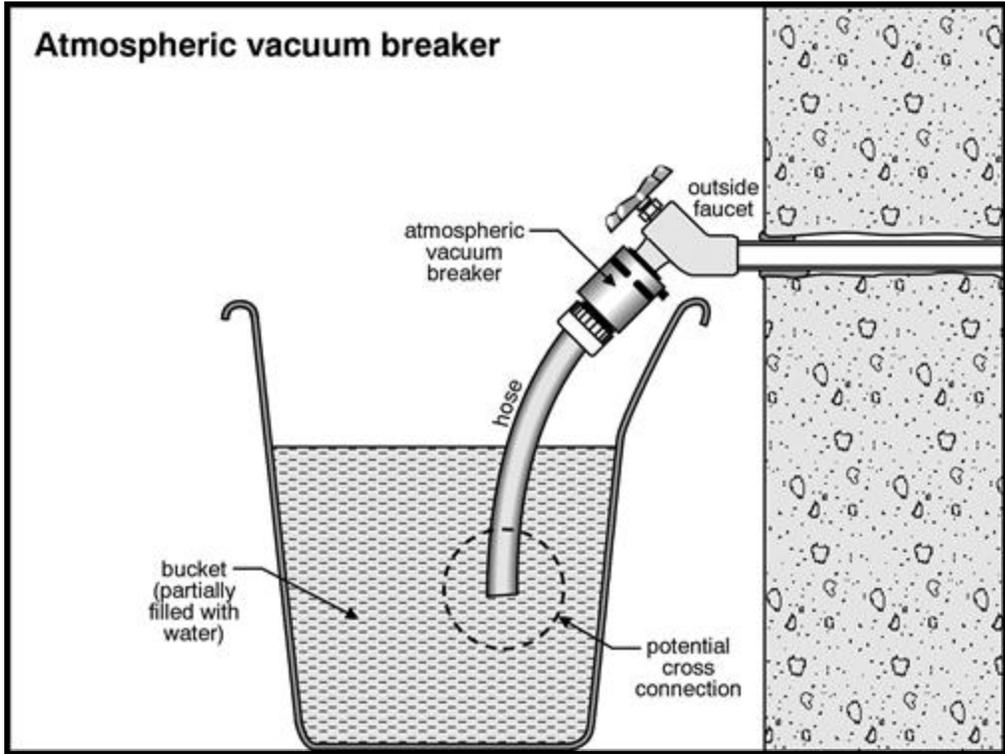
(3) A backflow preventer was noted as not being installed on the exterior hose bib. These devices prevent against potentially contaminated water from flowing back into the home's drinking water supply in the event there is a pressure differential that occurs when there is a higher demand for water at the interior fixtures. This is known as a cross connection and devices are required to prevent this from happening in many municipalities. These devices are readily available at most home improvement centers and the average person should be capable of installing them.

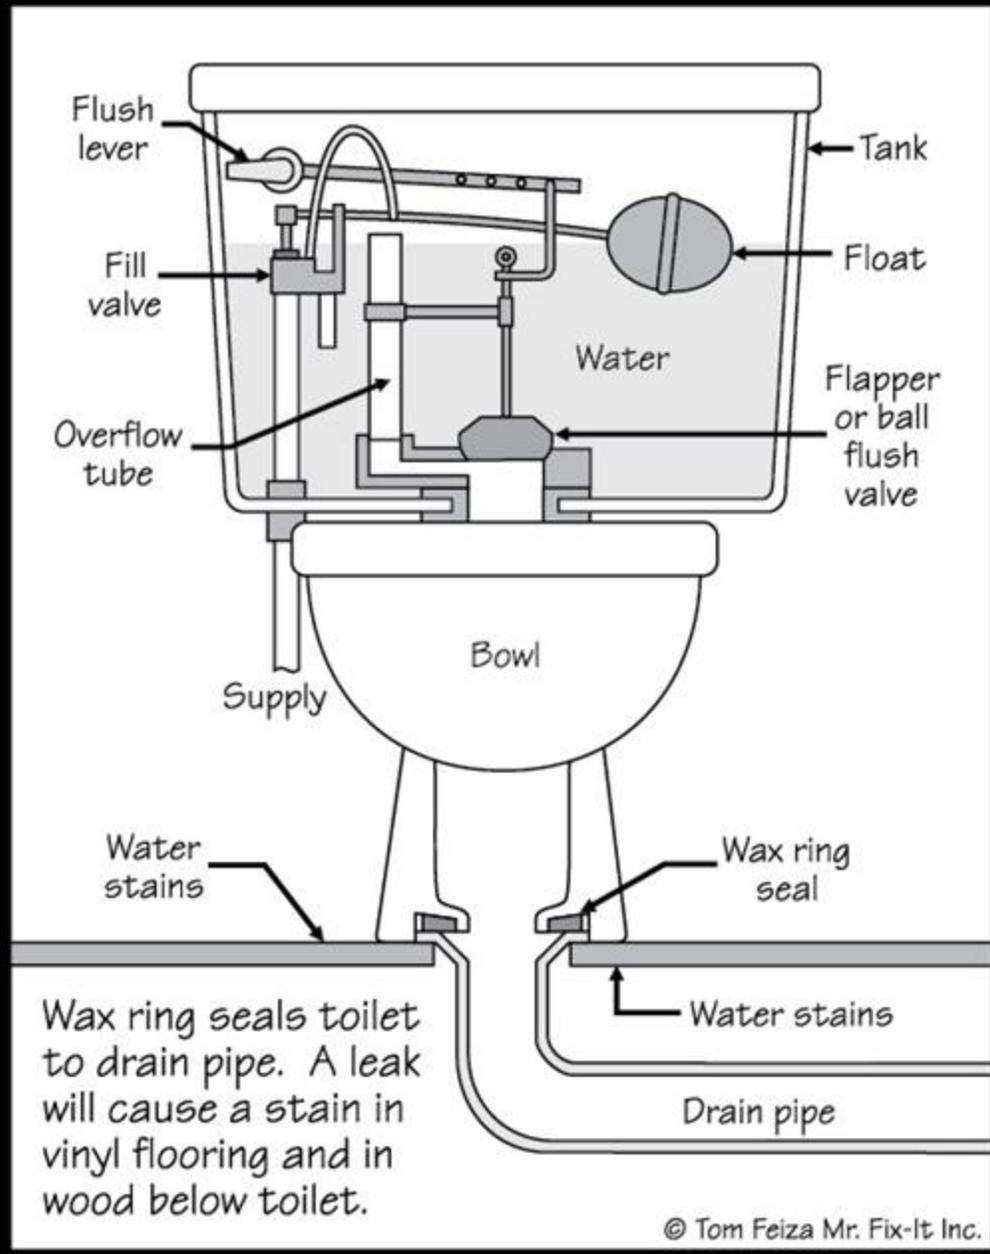
Toilet Leak at Floor

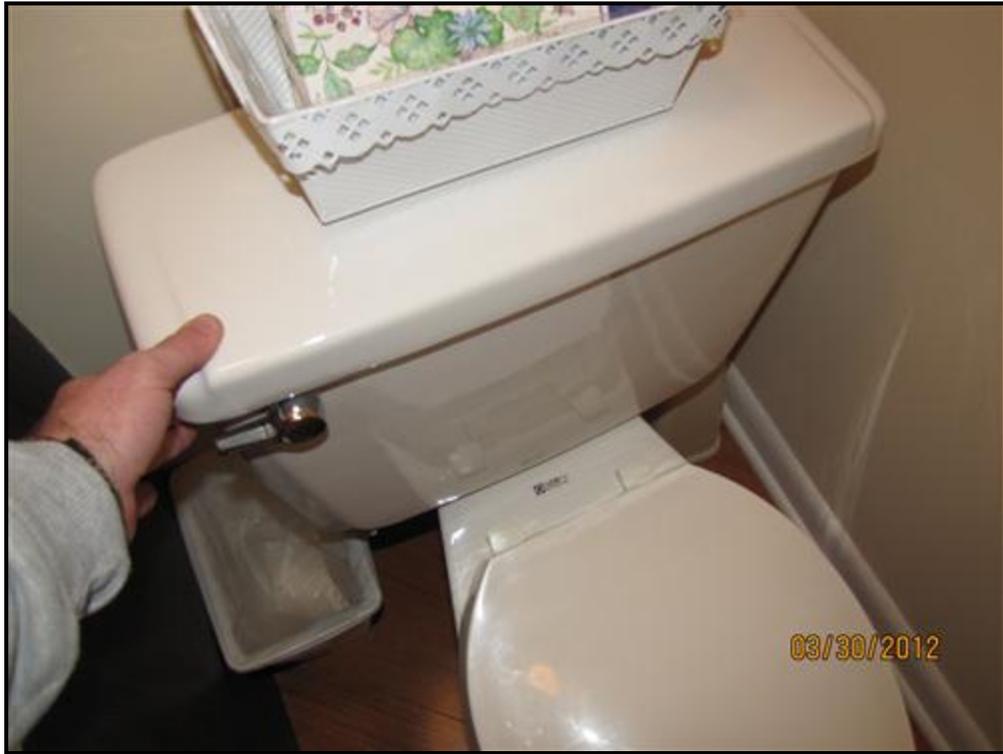
🔨 (2) The toilet reservoir tank was noted as being loose at the tank to bowl connection. This can allow for leaks to develop at the tank to bowl connection. Leaks can contribute to conditions conducive of mold growth and cause damage to the underlying structural materials. It is recommended that the tank be tightened by a qualified plumbing contractor. Repairs may involve replacing the bolts or gasket. If these repairs are undertaken by the home owner, it is important to remember not to overtighten the mounting bolts because the plaster tank or bowl can crack.

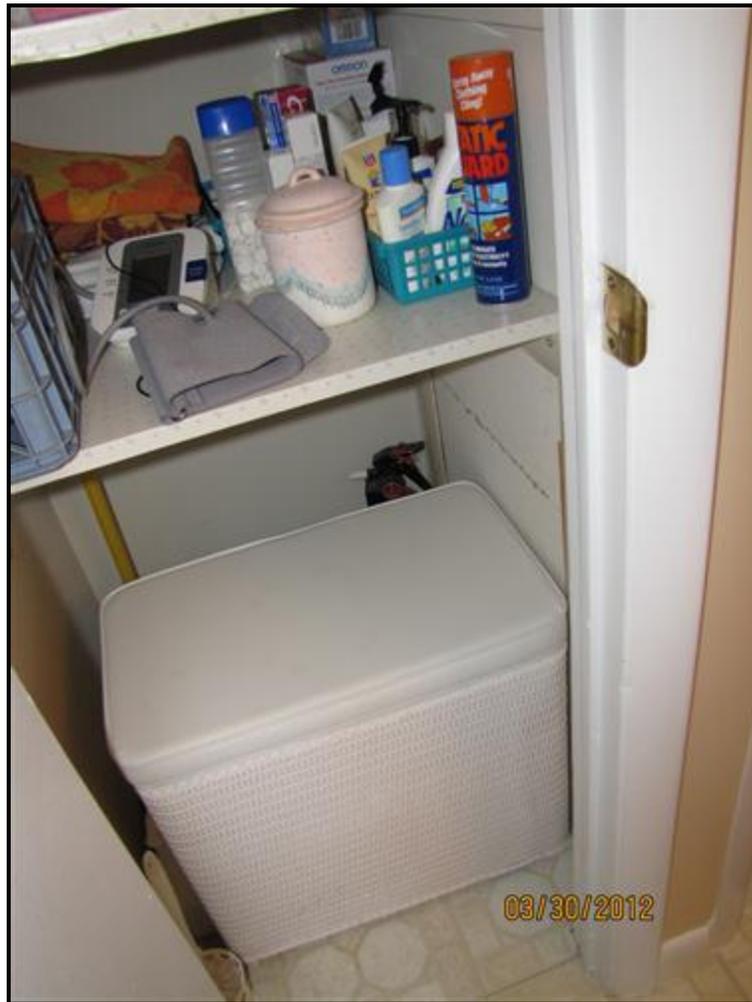
The access panel for the second floor master bathroom tub could not be removed at the time of inspection because of stored items blocking access at the time of inspection. Recommend further evaluation and any necessary repairs be conducted by a qualified contractor once the area has been made accessible.

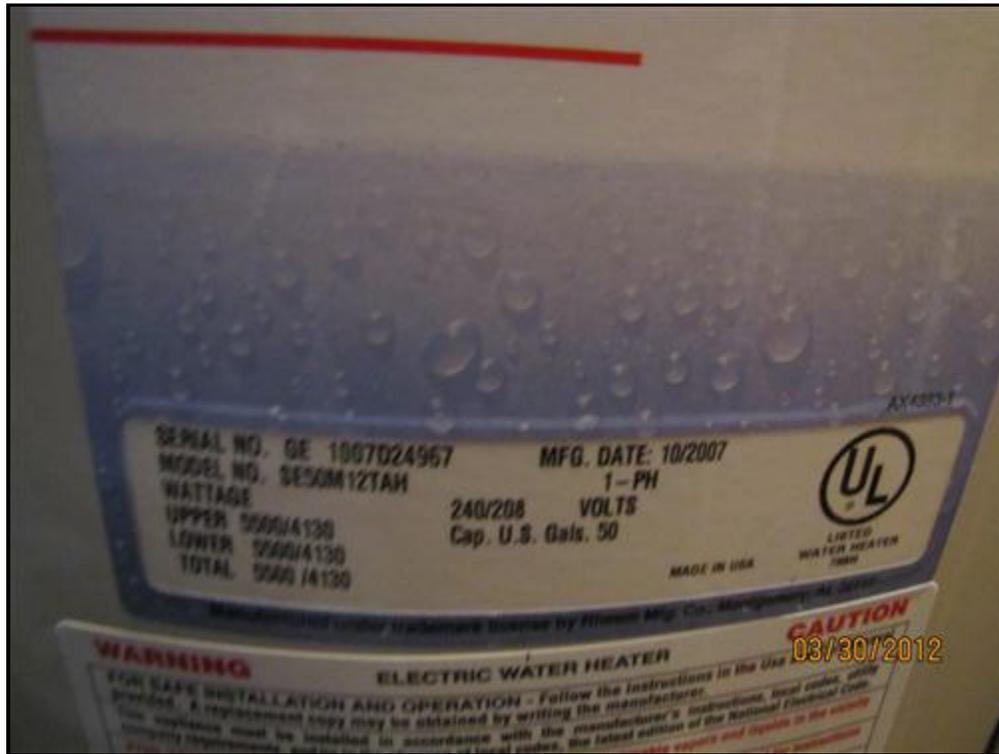
- manufacturer
- model and serial number.
- date of manufacture (often coded into the serial number)
- tank capacity in gallons

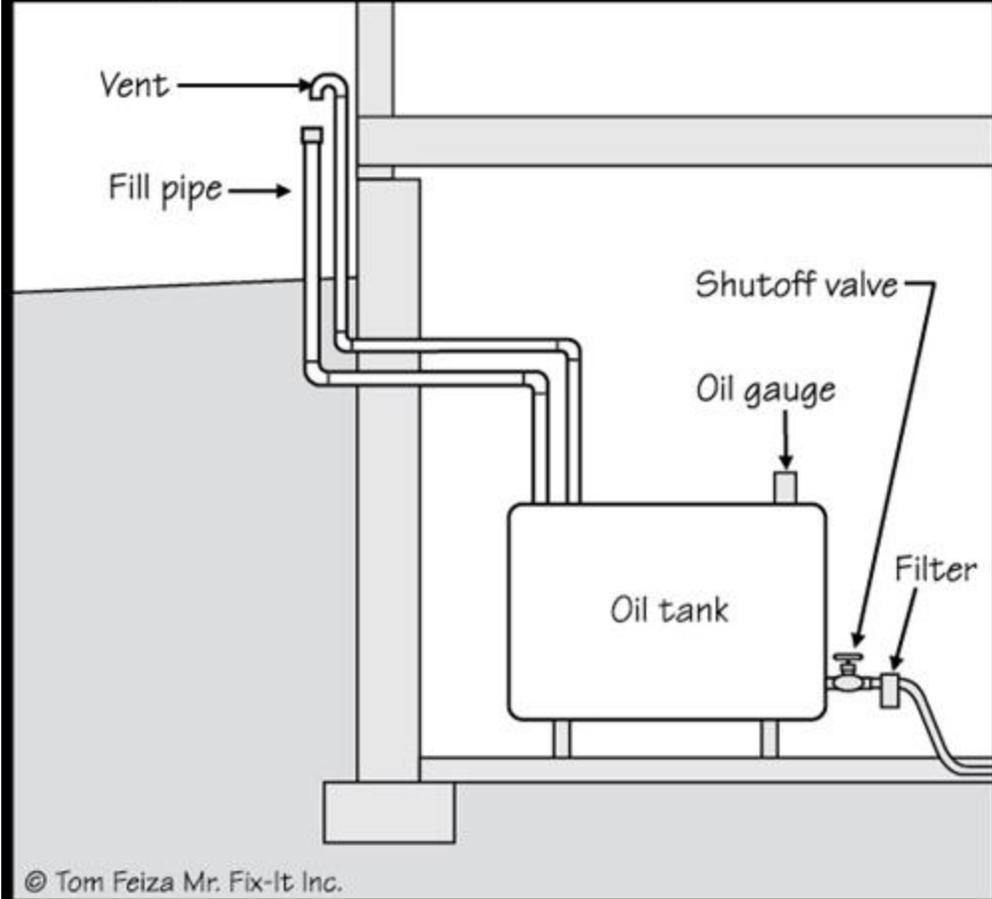
Typical Fuel Oil Tank in Basement

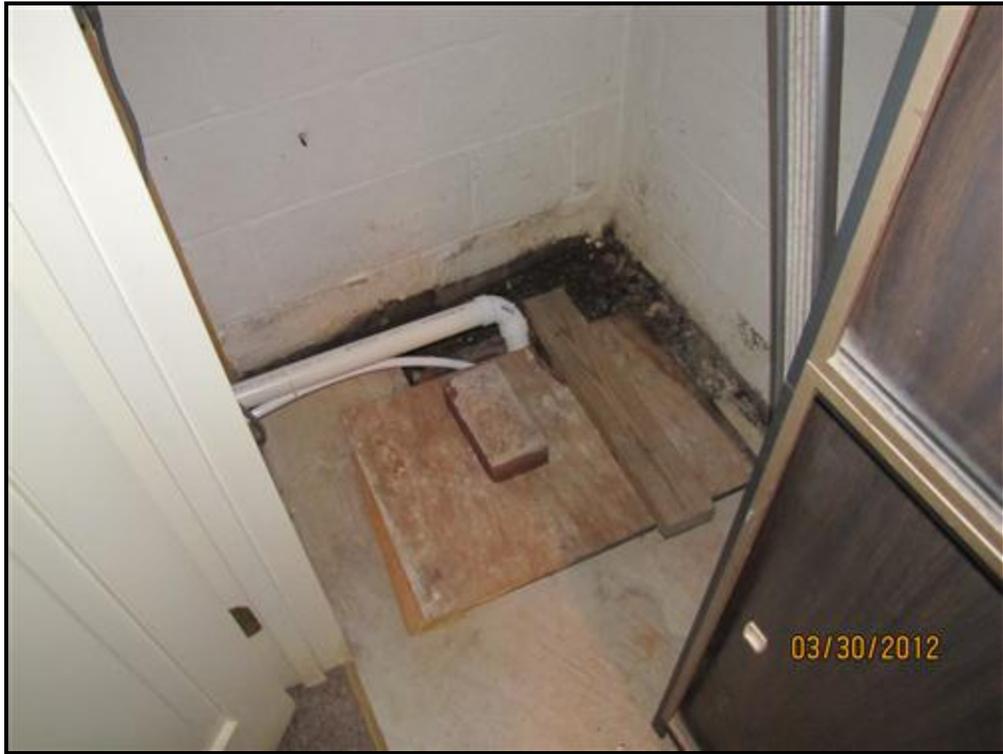
A sump pit was noted as being installed at the rear corner of the basement, however there was no pump present to evacuate the water. There was approximately 4 inches of water in the bottom of the pit at the time of inspection. The lid was noted as being pieces of plywood which can allow for conditions conducive of mold growth on the material. It is recommended that a sump pump with a battery backup system or water driven pump be installed to evacuate the water to the exterior of the house and a new lid be installed that does not support mold growth.

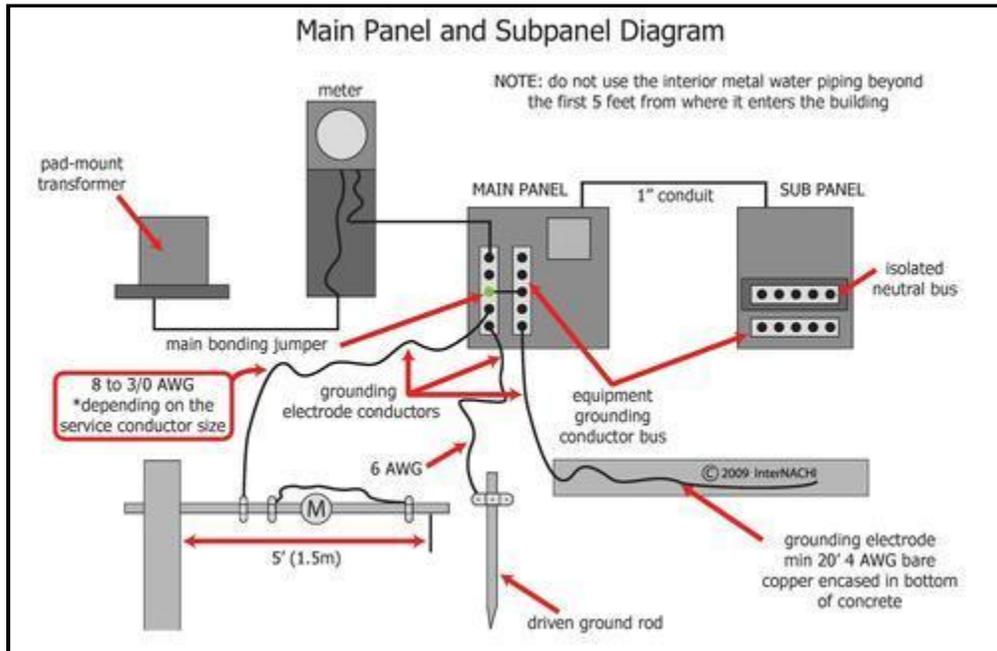
The secondary distribution panel was noted as being wired incorrectly and can present a hazardous situation. The neutral and grounding bar was noted as not being removed which is allowing the two bus bars to be bonded together. The panel bonding screw was also noted as being torqued down which is bonding the panel to the bus bars. This is an incorrect installation. According to modern electrical safety standards, the neutral bus bar should be isolated from the ground in any secondary distribution panel. It is recommended that this be repaired by a qualified electrical contractor.

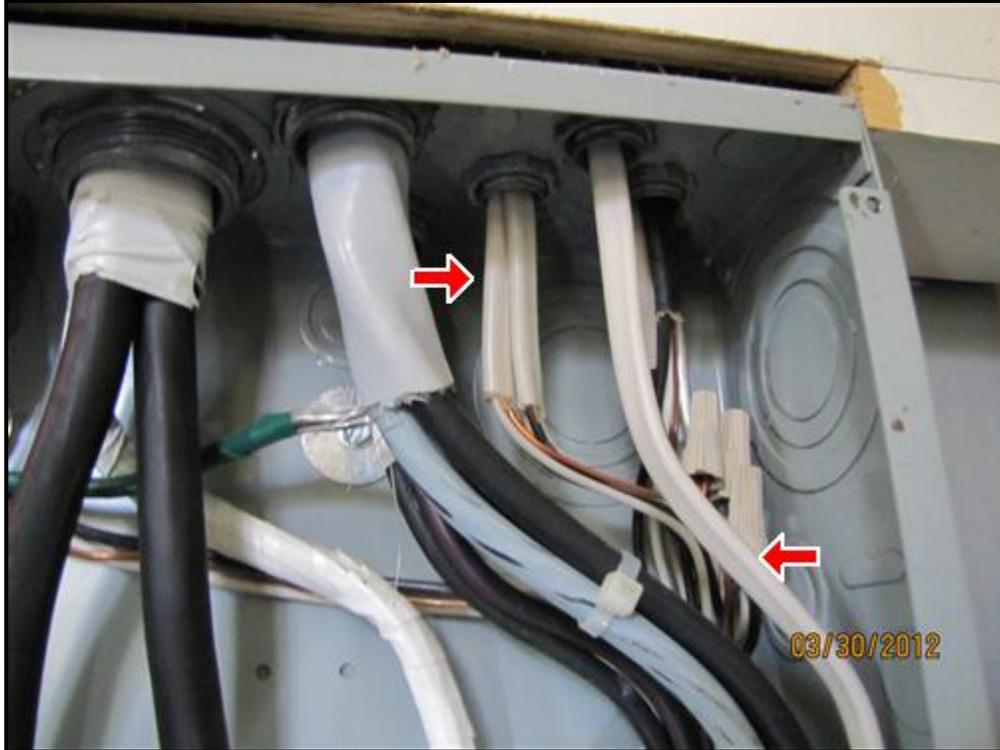
(1) Romex wiring insulation was noted as extending more than 1 inch into the electrical panel. This is a sign of unprofessional workmanship by an unqualified electrical contractor. Excess insulation inside the electrical panel is considered a combustible material and can be a potential fire hazard. It is recommended that the excess insulation material be removed by a qualified electrical contractor.

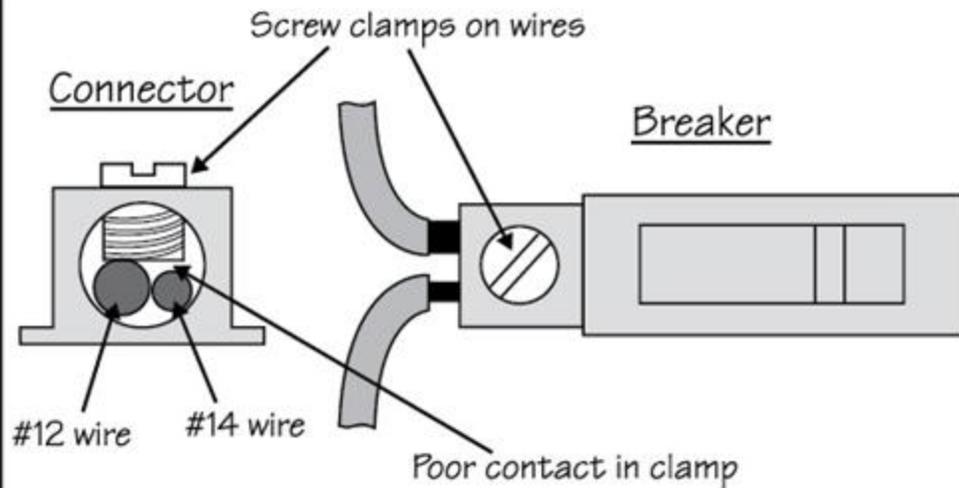
Many breakers do not allow two wires per connection (double tap). Two wires of different wire gauge sizes (diameter) should never be used in one breaker.

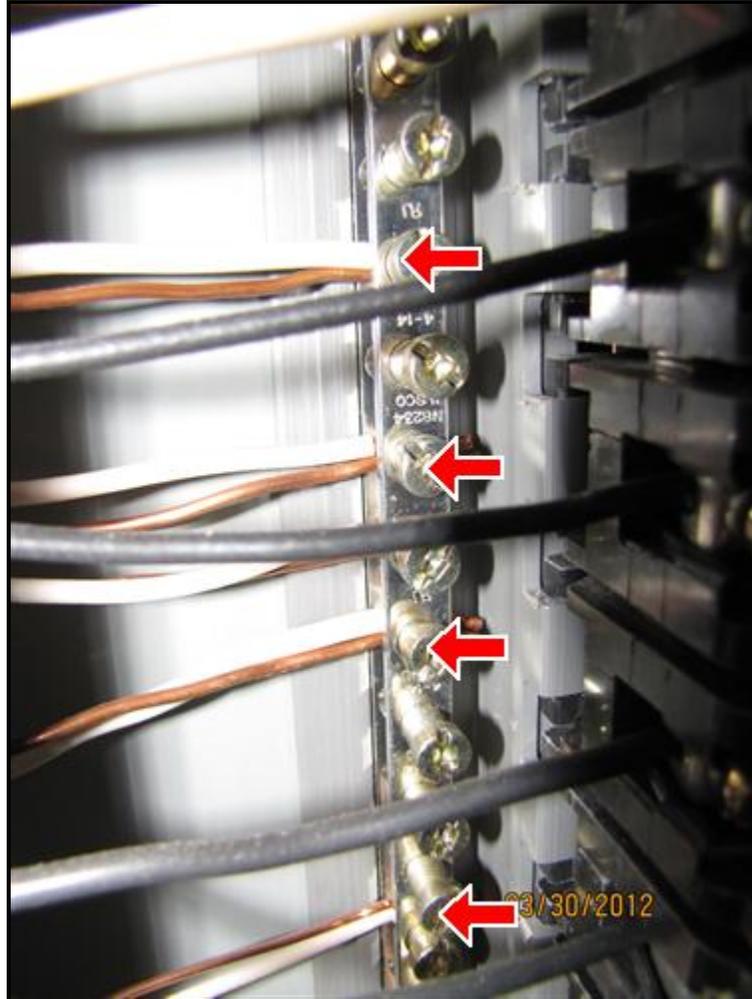
constant subtle heating and cooling of electrical circuits. A loose lug can result in arcing of the neutral wires against the buss bar and present a potential fire hazard. It is recommended that this be repaired by a qualified electrical contractor.

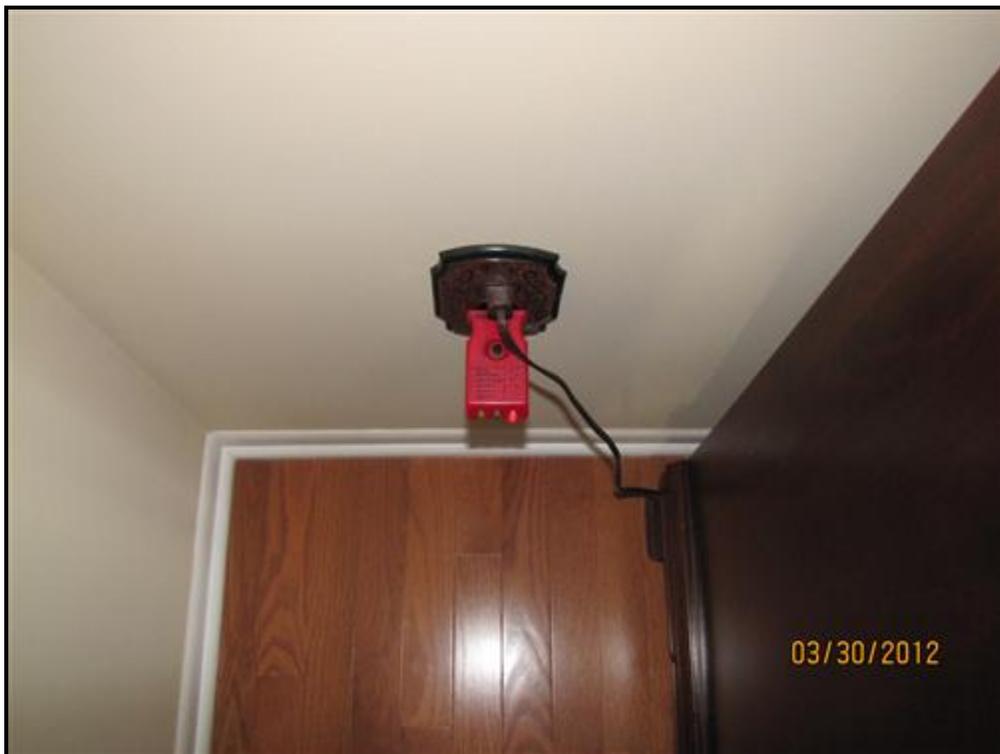
7.4 Picture 1 Intermittent Ground

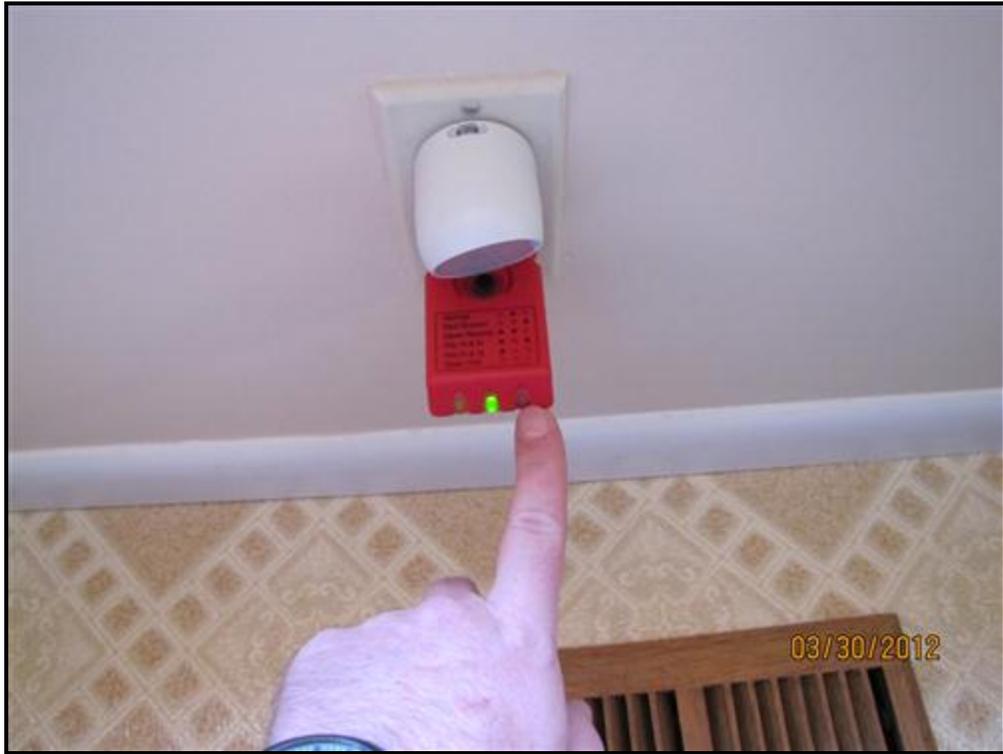
- 🔨 (2) Several receptacles in the home were noted as having intermittent grounds. This typically occurs when a wire is loose at the terminals at the receptacle. It is recommended that all occurrences be identified and be repaired by a qualified electrical contractor.

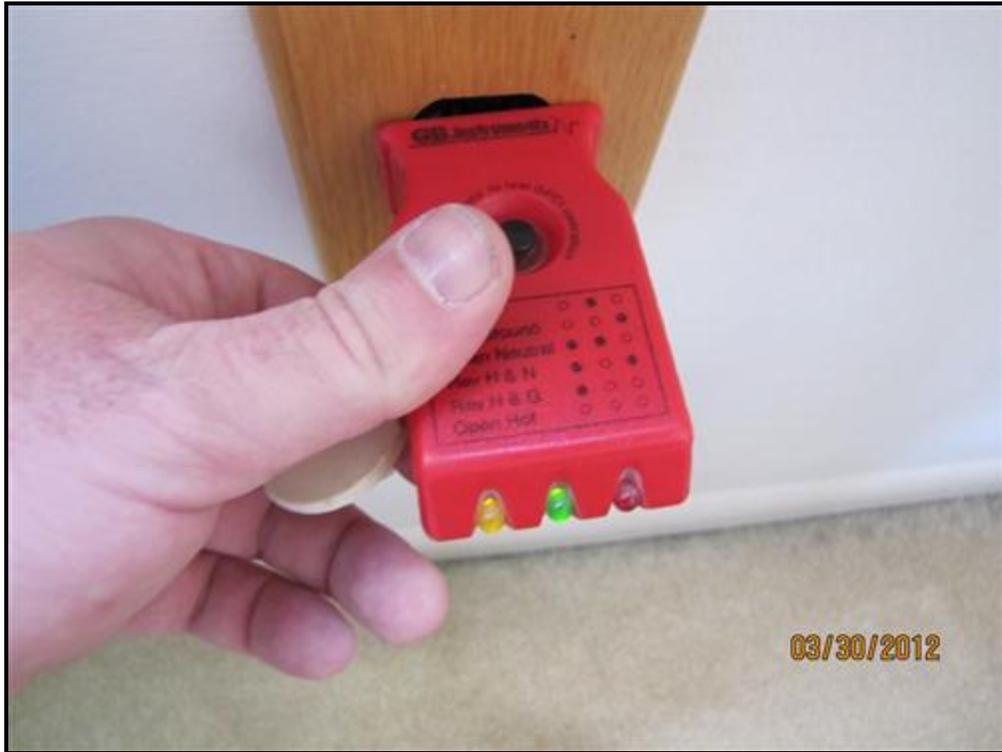
7.4 Picture 3 Family Room

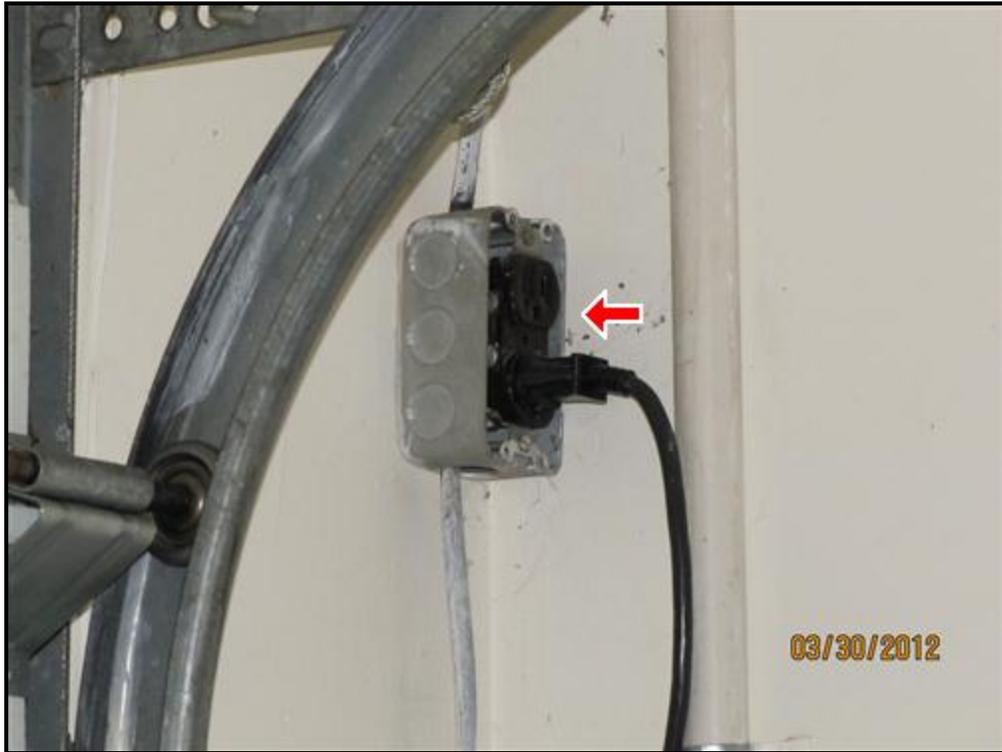
(4) Cover plates missing at receptacles in the garage. This can allow for direct contact with live electrical conductors and present a potential shock or electrocution hazard. It is recommended that cover plates be installed where missing by a qualified electrical contractor. Cover plates for receptacles installed in plastic non-conductive junction boxes should be plastic or some other type of non-conductive material rated for the application. If accommodations for grounding the receptacle are present, metal covers may be used in some instances. A qualified electrical contractor familiar with the current electrical codes should know what types of covers are needed in each location.

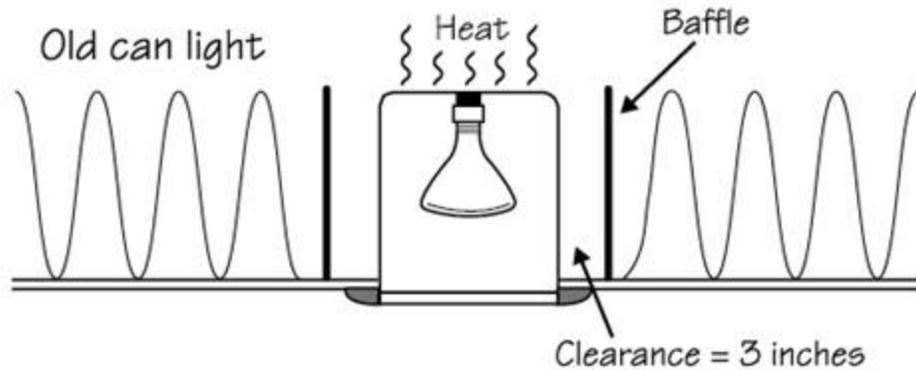
Can Light Fixtures – Heat

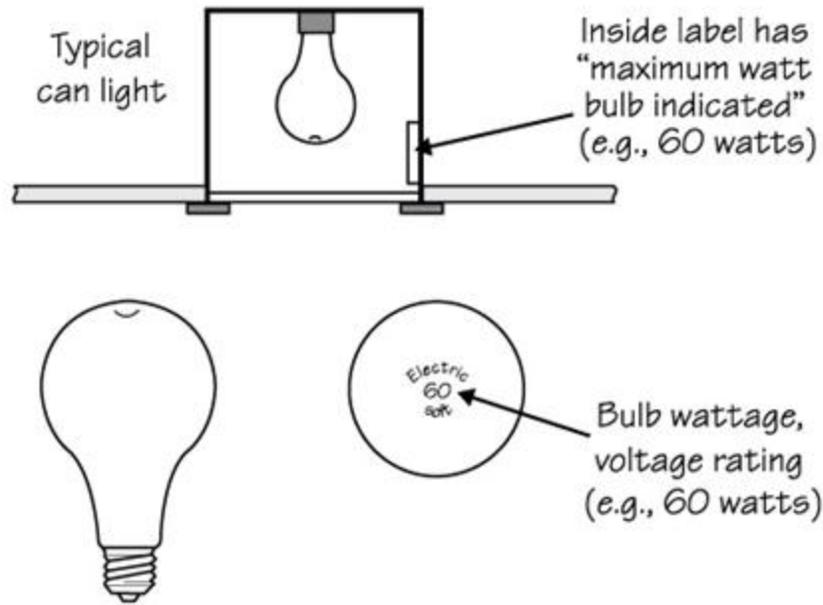
All light fixtures are rated for a maximum wattage bulb. Look for the label. Do not exceed the rating, or the fixtures can overheat and start a fire.

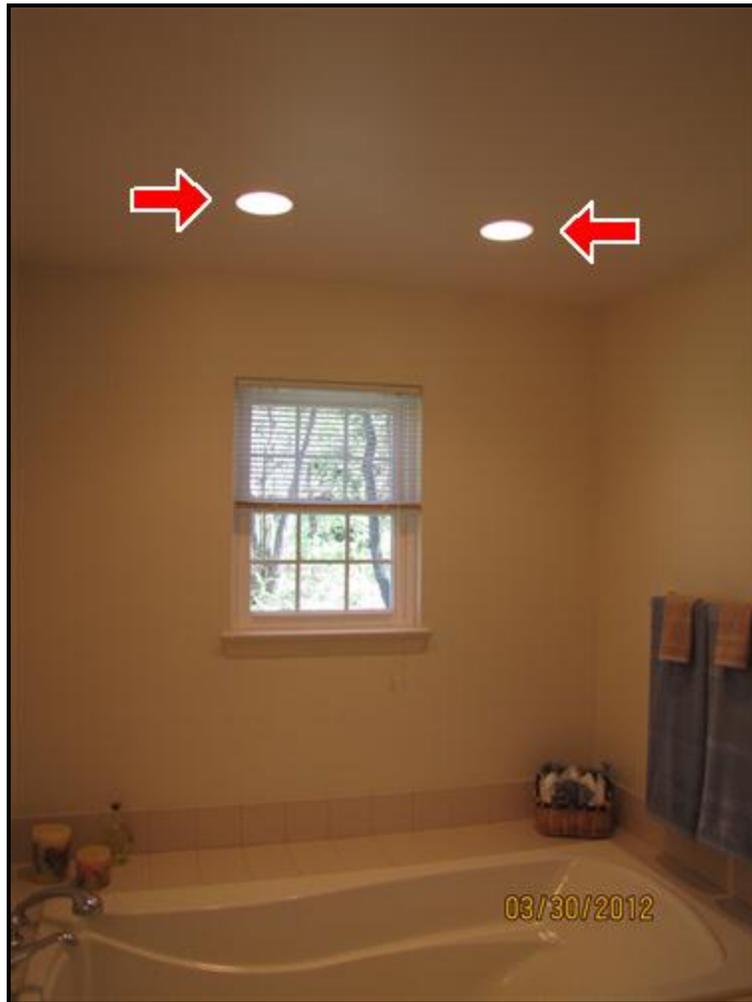
(4) The light fixture in the bathroom was noted as being a standard recessed lighting fixture which has been installed over the bathtub/shower. These types of light fixtures are not rated for this location and can allow for condensation to form on the exposed bulb which can cause it to explode. Light fixtures in this location should be sealed devices with protective glass covering the bulb. It is recommended that this be replaced with the appropriate device by a qualified electrical contractor.
