Inspection Report

Any Home Buyer

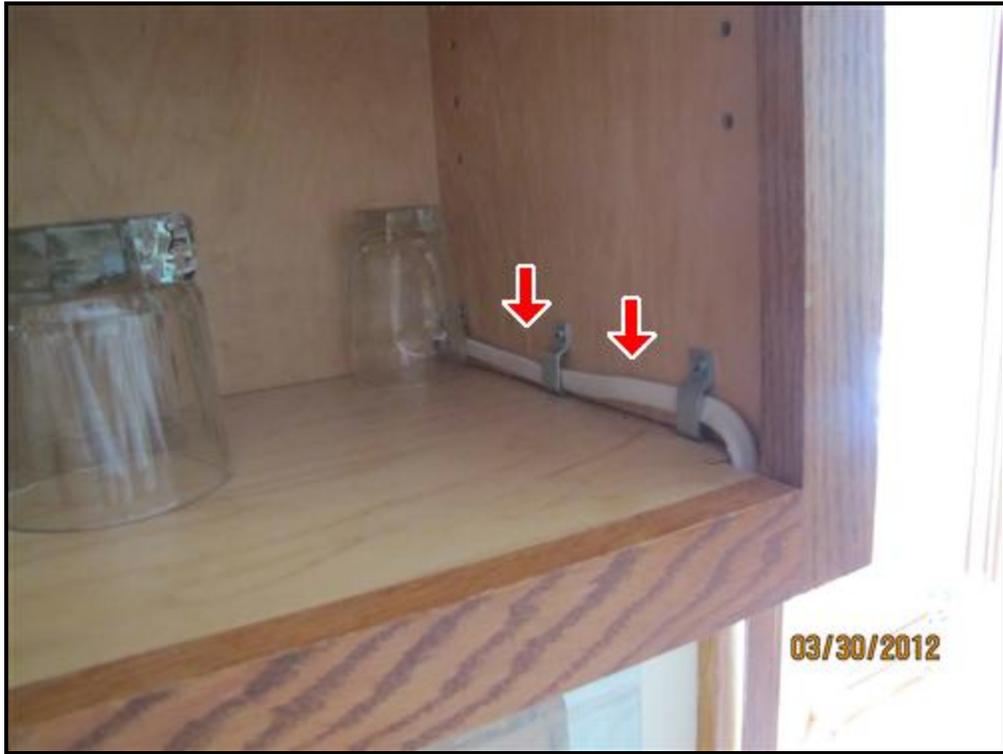
Standard Romex type wiring was noted as being surface mounted to wall or ceiling surfaces in one or more locations throughout the home. This type of wiring is not rated for this type of installation and is required to be concealed within a wall or ceiling cavity where it is protected from damage. This type of installation is typical of unprofessional quality workmanship and it is recommended that this and any other occurrences in the home identified and be repaired by a qualified electrical contractor.

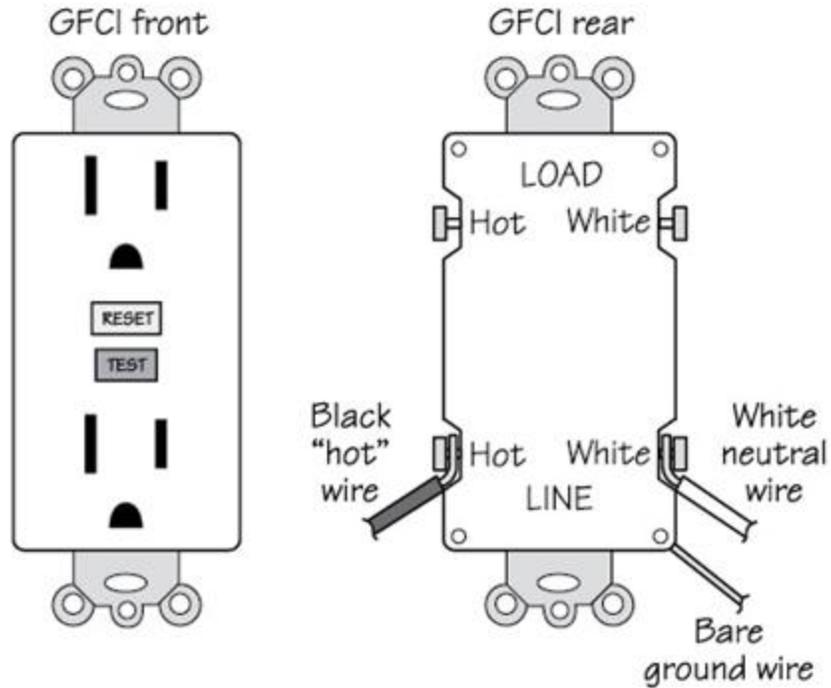
A ground fault circuit interrupter (GFCI) outlet must be wired with the power feed on the "LINE" screws. Downstream outlets must be connected to the "LOAD" screws. If reversed, the GFCI will not trip when tested but will trip when downstream outlets are tested.

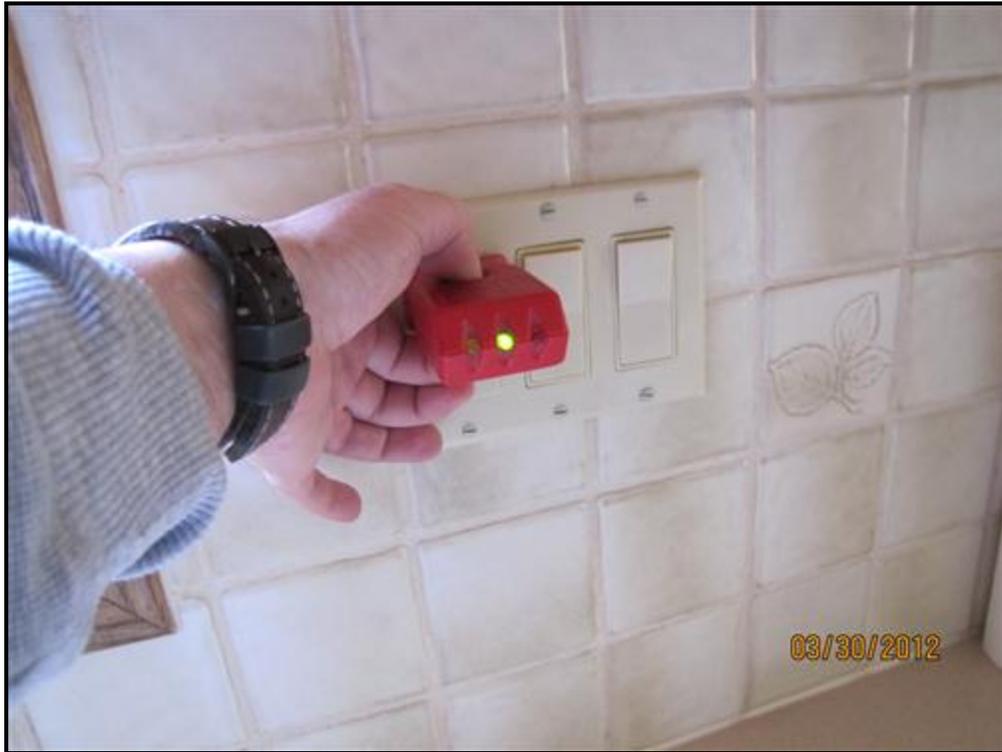
(2) A GFCI receptacle in the kitchen was noted as not functioning as intended at the time of inspection. Recommend replacement by a qualified electrical contractor.

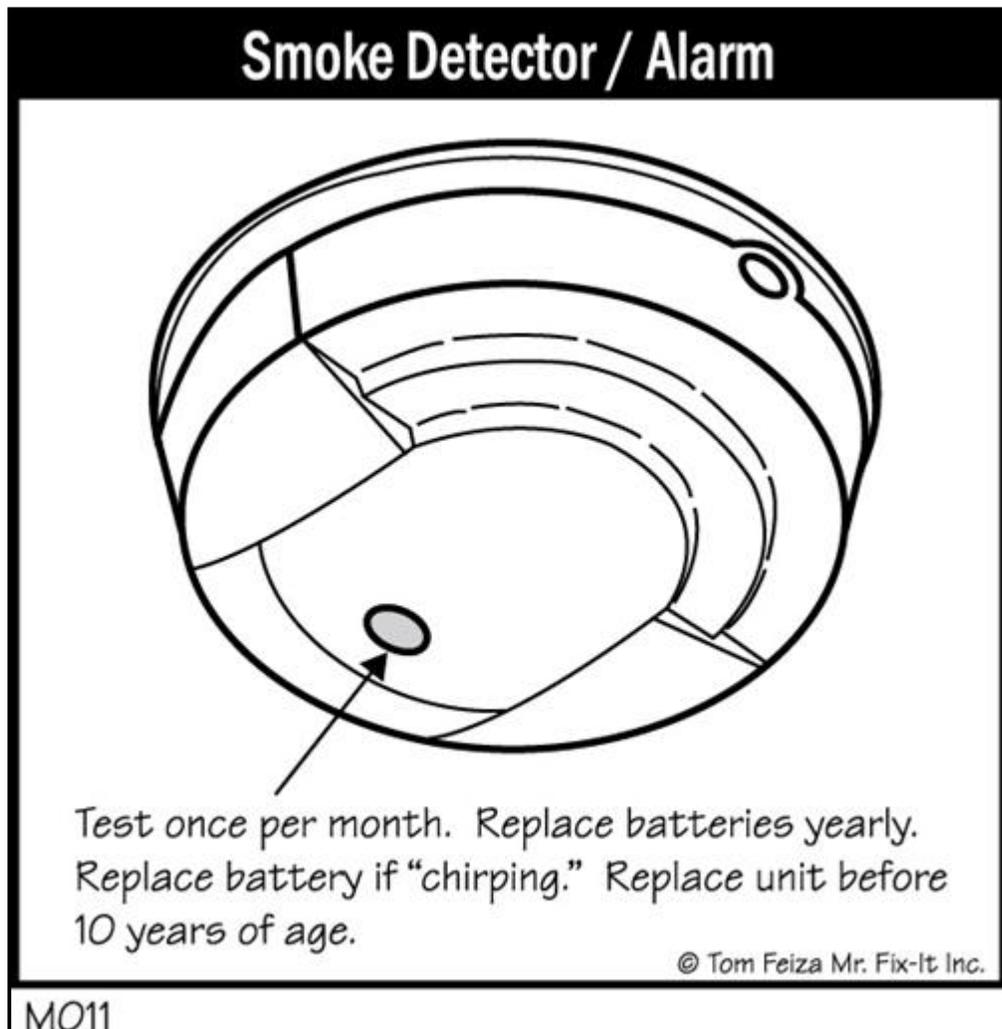
that is needed. Batteries will last approximately one year. If your battery-powered detector begins to emit its low-power warning sound (usually short beeps), remove the weak battery and replace it immediately with a fresh one. Have a new battery on hand always. However, if you neglect these requirements, your detector won't do its job if a fire starts.

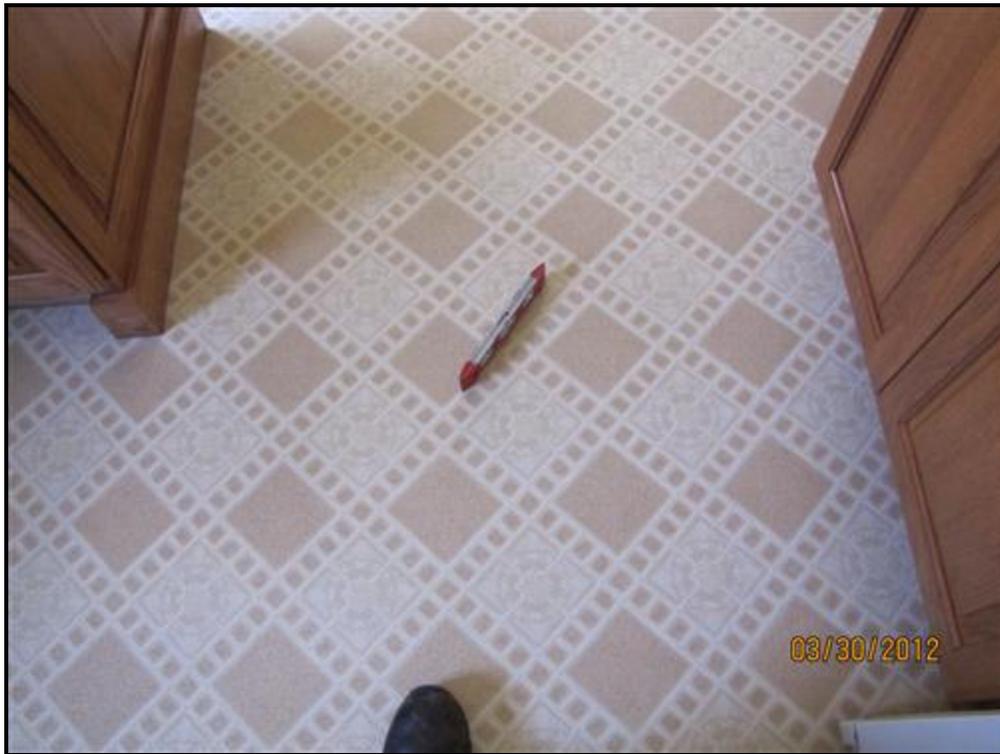
Floor surfaces in the kitchen were noted as being unlevel. The floor has a slight crown to it at the end of the island. This can be a result of settlement in the surrounding framing members over time. It can also be that the crown for that joist was installed upside down when the house was built, but this should have settled over time. It could also be that the subflooring is warped in this area. Without having direct access to the framing underneath, it is impossible to tell what is the cause without doing invasive inspection procedures. The defect does not appear to be causing any cracks on the interior finished surfaces which suggests that it is stable and not moving. It is still recommended that this be further evaluated and any necessary repairs be conducted by a qualified contractor.

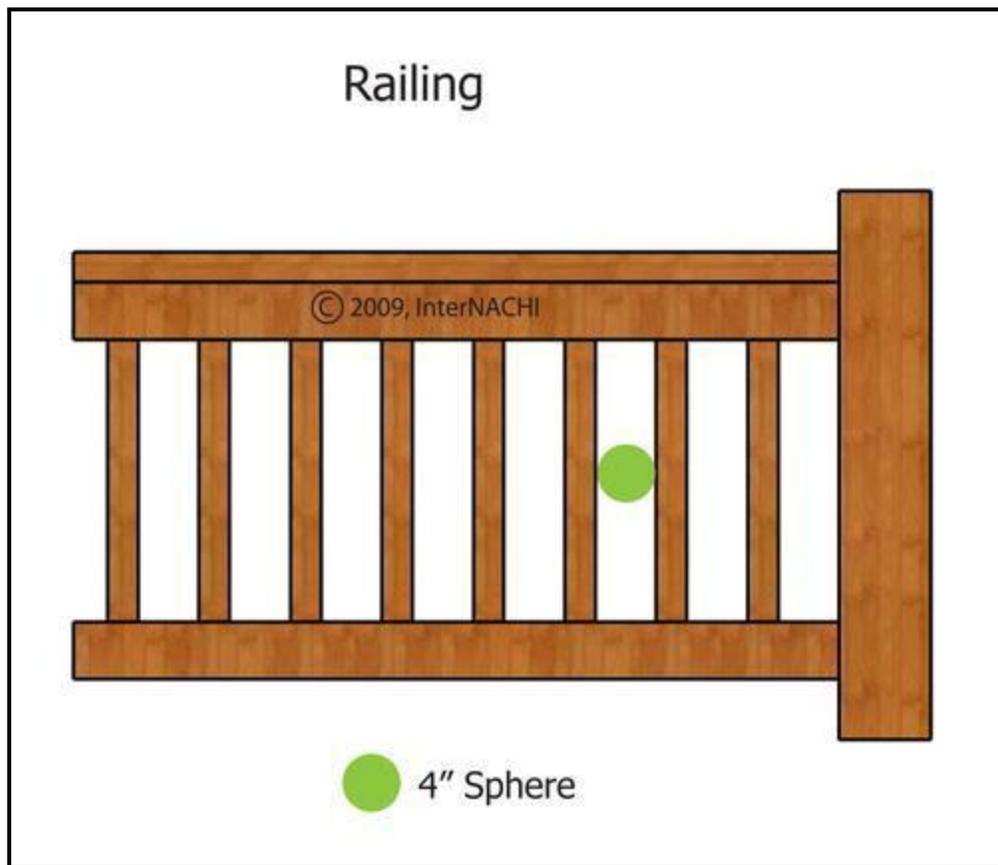
(1) The spacing between the railing spindles was noted as being in excess of 4 inches. This can allow for small children to insert their heads and create an entrapment hazard. Since the home was built before this standard went into effect, it is not mandatory that homes be made to conform to modern standards unless there is a major renovation that takes place. You may want to consider making necessary repairs or replacements from a safety standpoint.

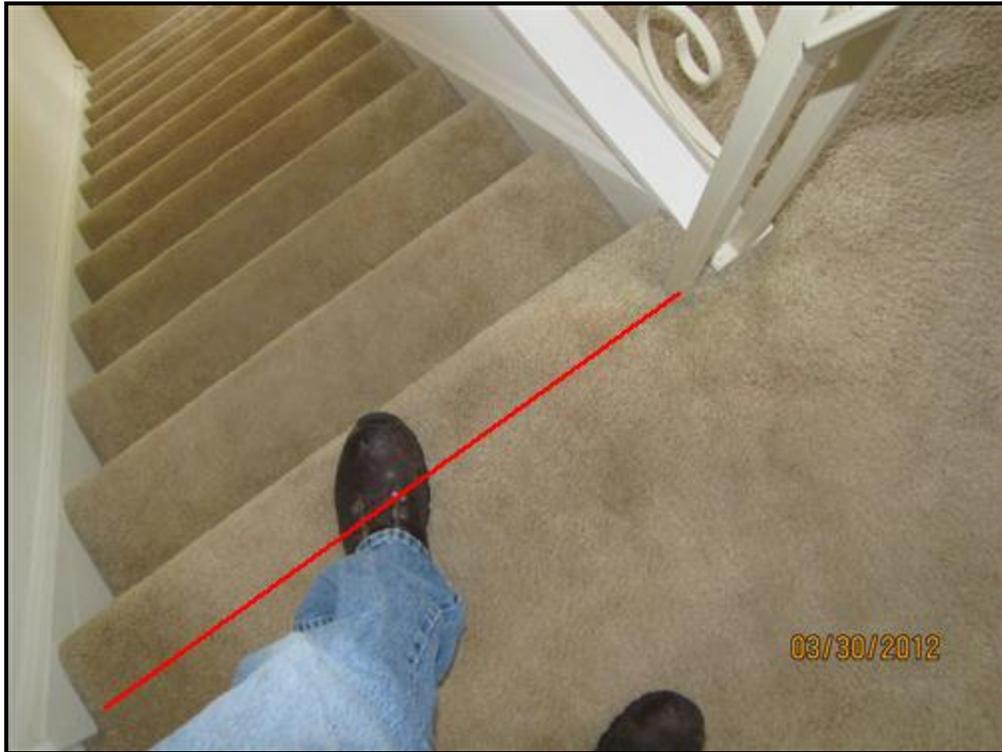
(3) The top of the landing to the second floor was noted as being uneven with the stairs. There is a small area that is raised up which can present a potential trip and fall hazard. It is recommended that this be repaired by a qualified contractor for safety reasons.

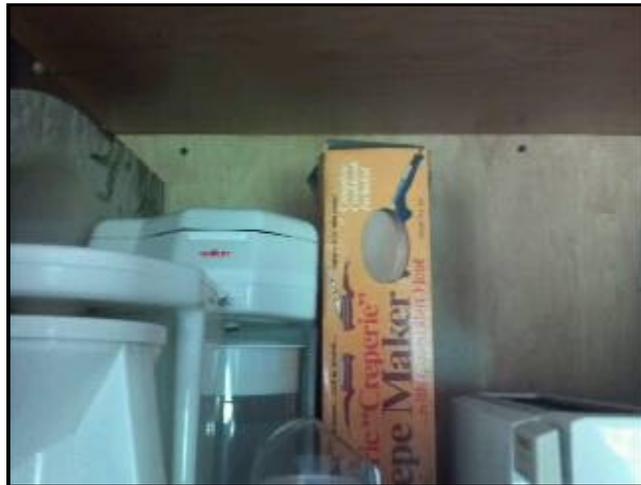
The upper kitchen cabinetry was noted as being attached with common drywall screws. Drywall screws have a low shear rating on them and can easily snap under loads. Stored items in cabinetry such as canned goods, dishes, and cookware can be very heavy. It is recommended that the upper cabinetry be secured with properly rated hardware by a qualified contractor before the close of escrow.

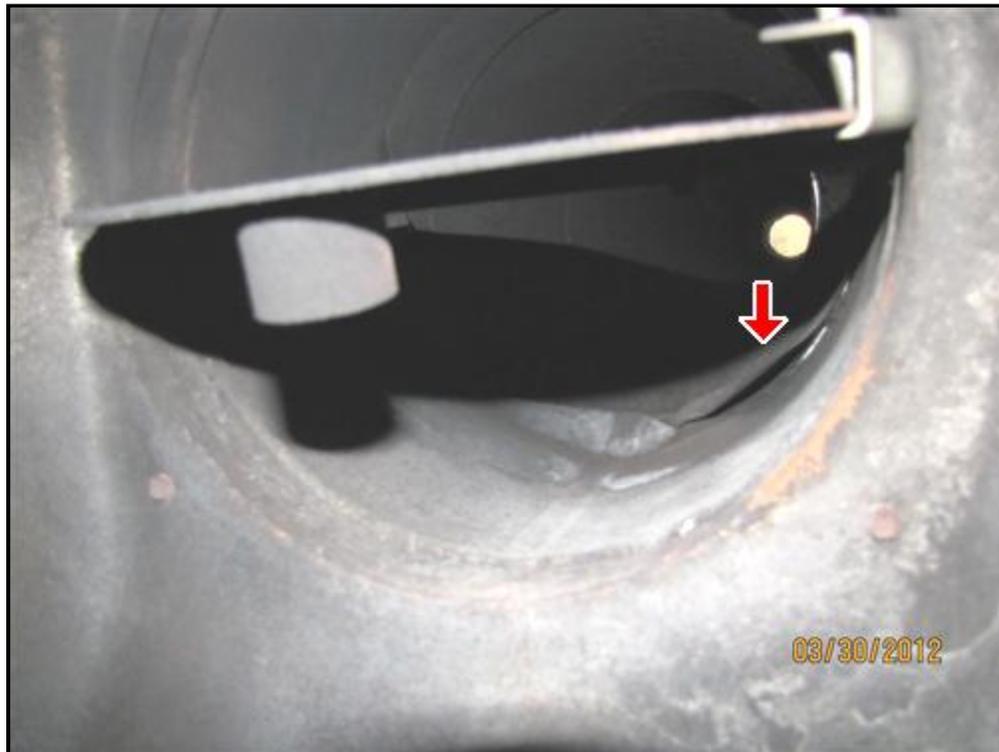
(2) Joints in the liner for the fireplace were noted as having gaps present that can allow for combustion fumes to escape into the wall cavity. This can be a potential fire hazard or allow for carbon monoxide to accumulate inside the wall. It is recommended that the liner be further inspected by a qualified chimney sweep and any necessary repairs be made for fire safety reasons.

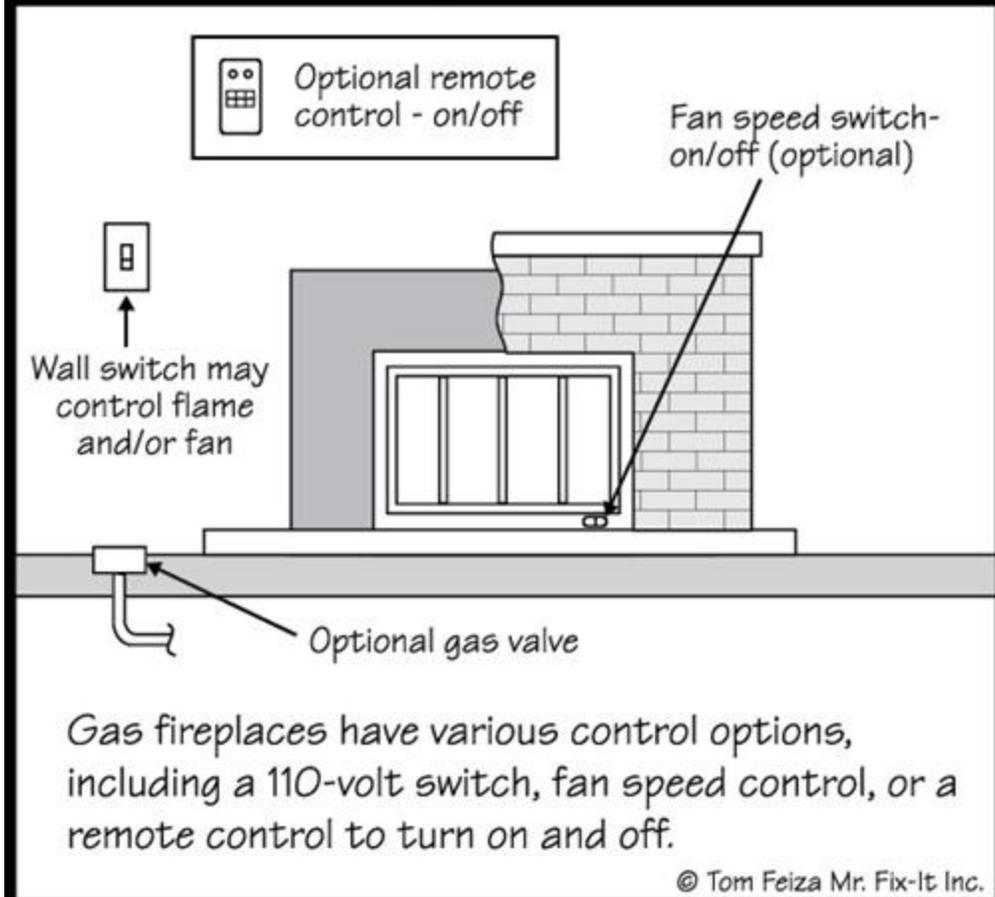
Gas fireplaces have various control options, including a 110-volt switch, fan speed control, or a remote control to turn on and off.

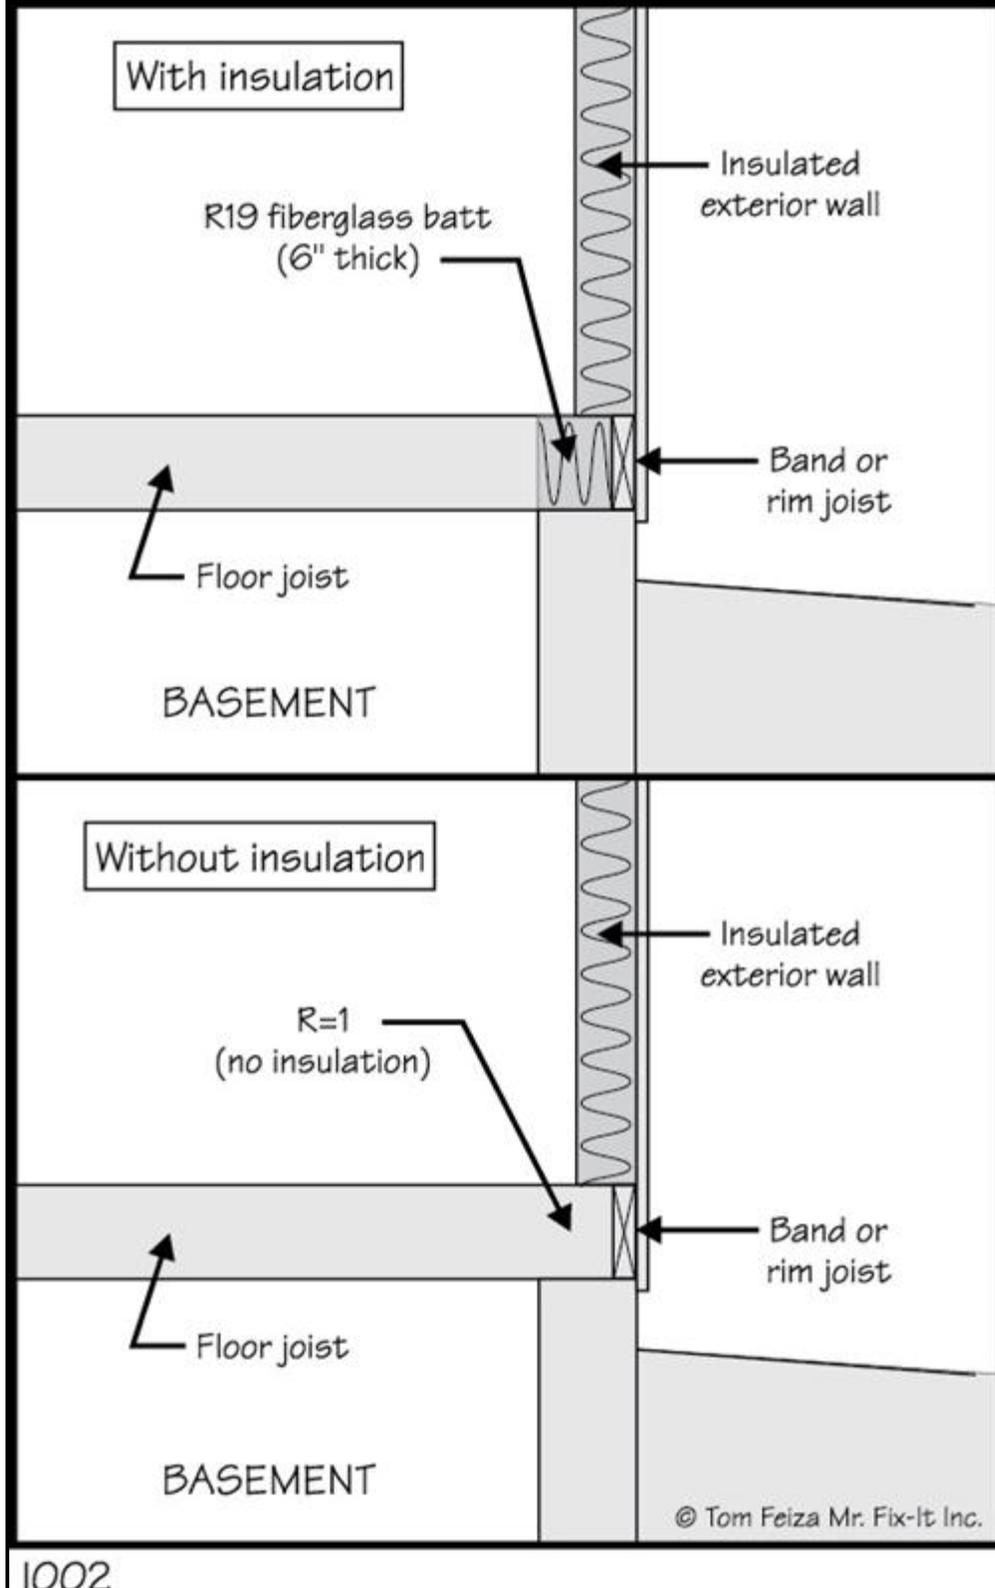
Band Joist Insulation

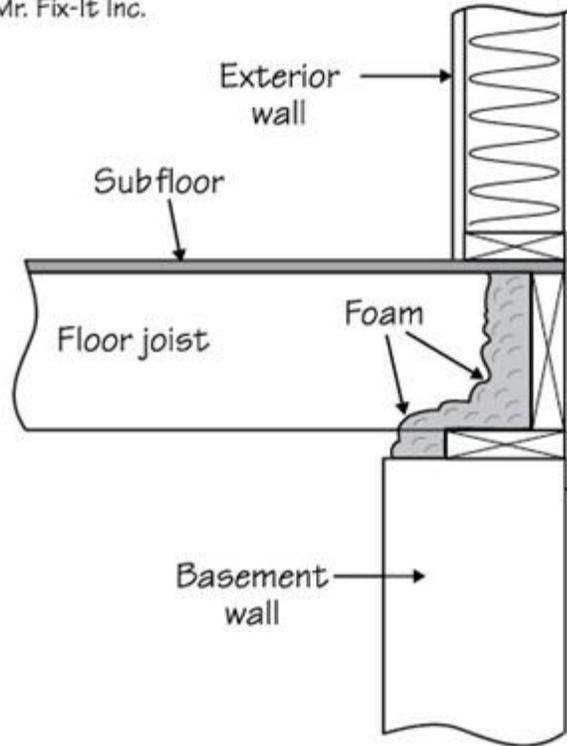
Expanding foam can be used to seal and insulate from the subfloor to the top of the foundation wall. The foam effectively insulates, providing an air seal to components and a vapor barrier.

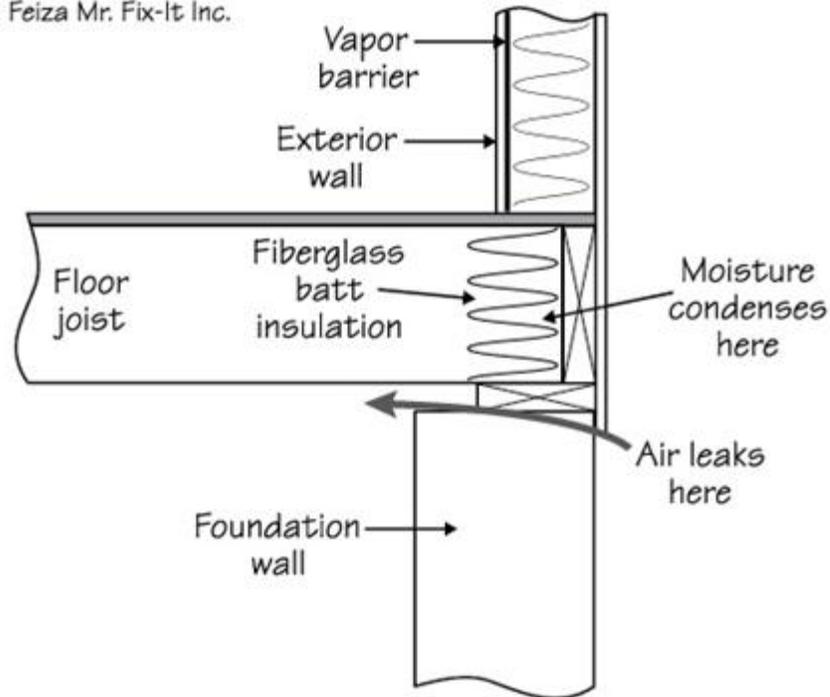
Fiberglass is often used to insulate above a foundation wall at the sill area. Unfortunately, fiberglass does not provide a seal to the surfaces and does not provide a vapor barrier. Condensation on the framing can be a problem in cold climates.

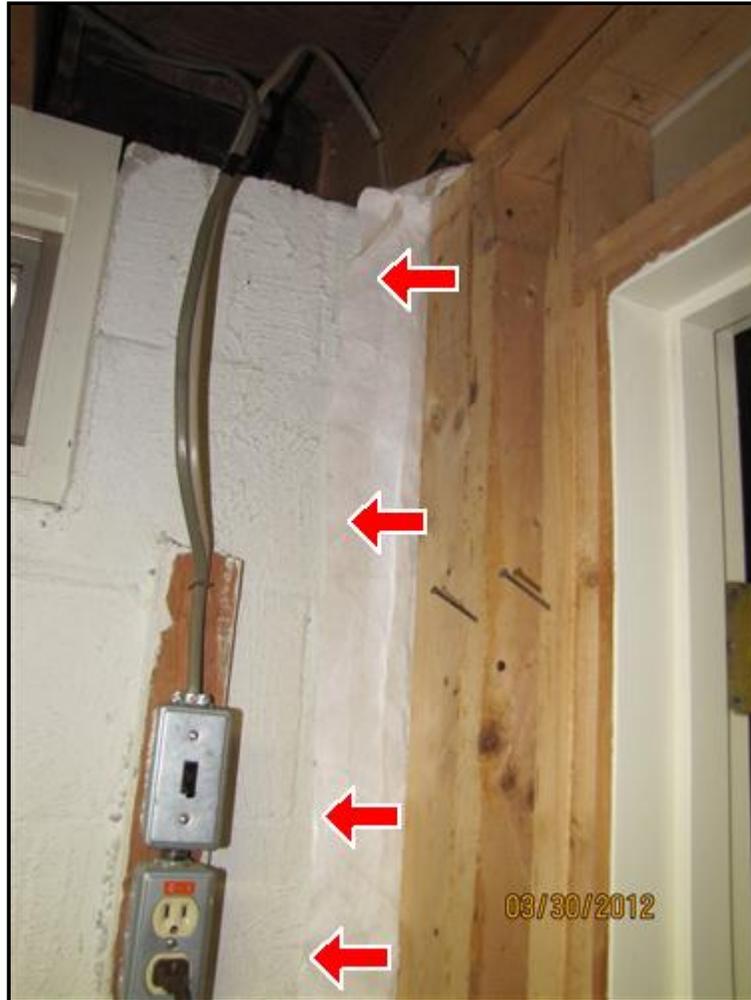
can result in conditions conducive of moisture vapor intrusion to the rear sides of finished the wall structures that can result in conditions conducive of mold growth. This can go undetected because we do not perform invasive inspection techniques during a home inspection. Due to the presence of suspected visible mold growth elsewhere in the basement, it is recommended that mold sampling be performed in the finished portion of the basement to determine if there are elevated mold levels present. It is also recommended that any visible joints or seams in the vapor barrier be sealed by a qualified contractor.

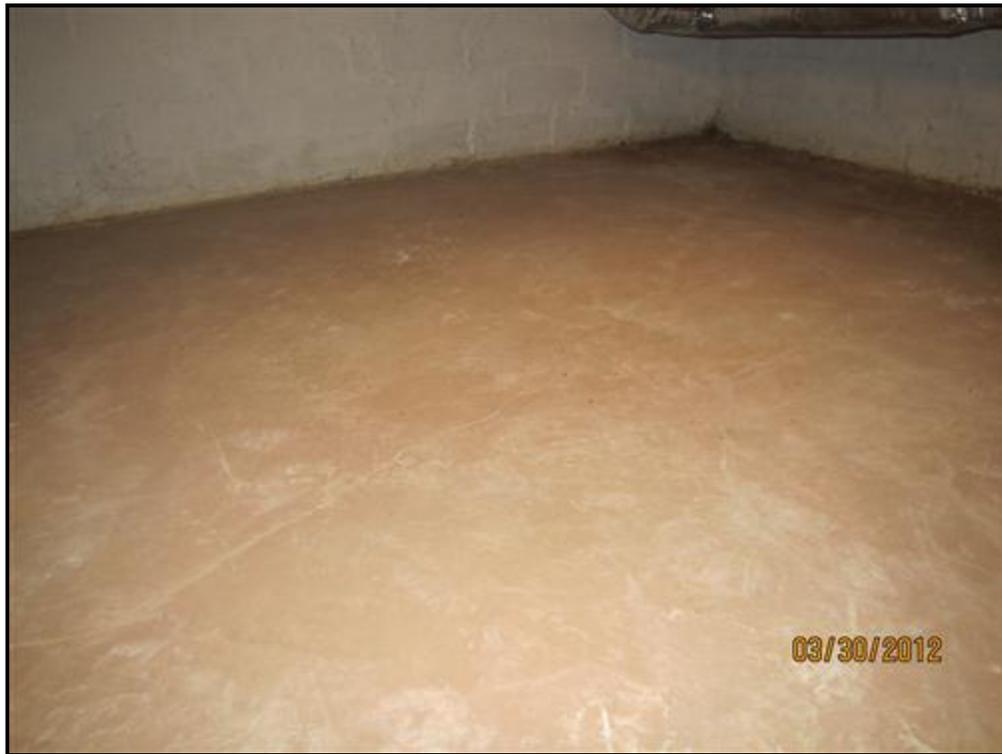
- (2) The crawlspace was noted as having a cement floor that has a few cracks in it that can allow for moisture vapor intrusion. There was no barrier installed that was readily visible. It is recommended that the cracks be repaired and that a layer of plastic sheeting be installed that is sealed at the perimeters to prevent moisture vapor from accumulating in the crawlspace.

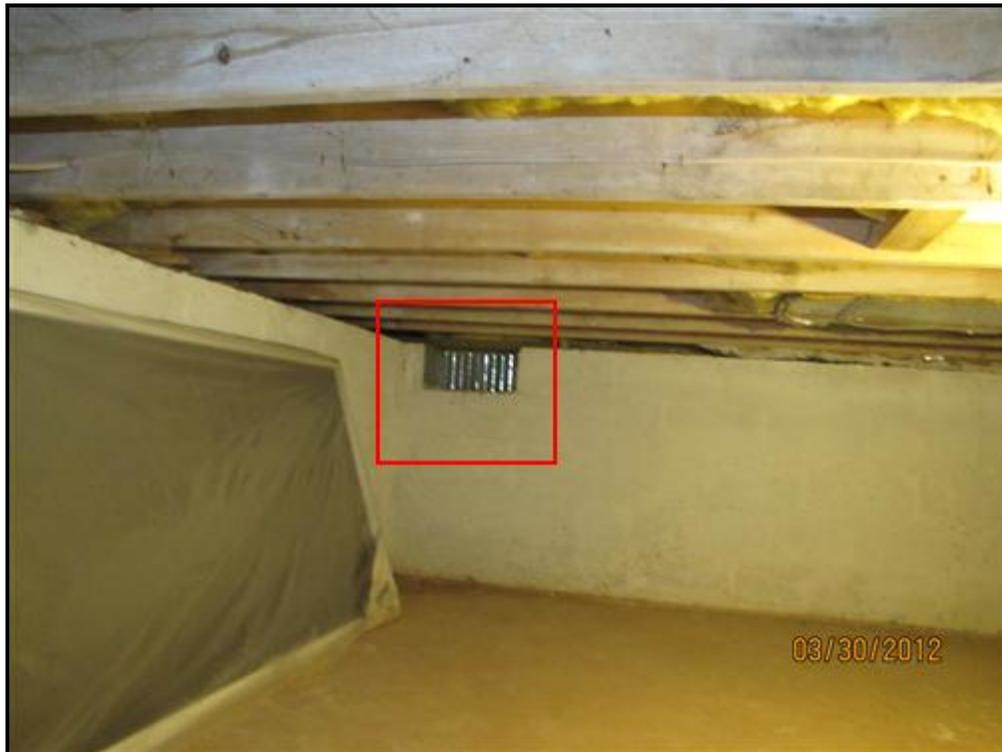
(1) The crawlspace was noted as having two through the foundation wall vents installed however both were positioned on the front side of the crawlspace. This can result in insufficient air circulation to remove any humidity that can lead to mold growth. Fans were noted as being installed in the crawlspace at the time of inspection to help move air through. It is recommended that the vent on the side wall be sealed and an additional vent be installed on the rear foundation wall to allow for cross ventilation of the space. The current configuration can work against itself and allow for excessive humidity levels to accumulate in the crawlspace.

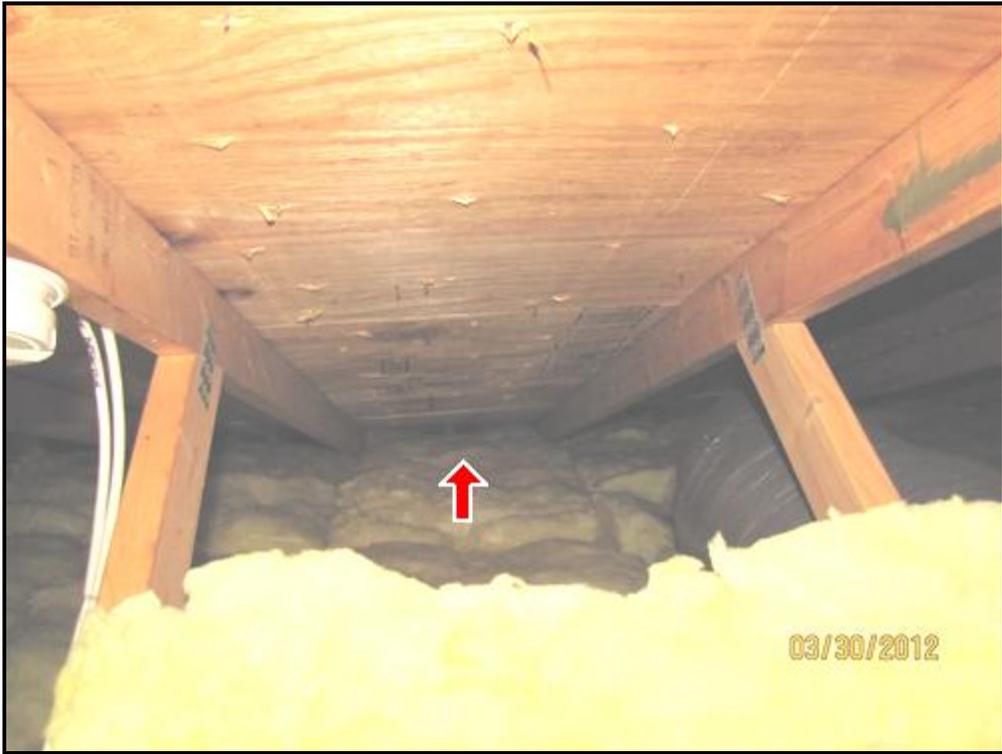
- 🔨 (2) The attic space over the addition was noted as having a gable vent installed on the exterior wall and ridge venting. There were no accommodations for soffit venting in this section of the attic space observed at the time of inspection. Gable vents and ridge vents do not work well together and can result in insufficient air movement through the attic space to draw out the excessive heat. It has been determined that soffit and ridge venting is far superior to gable vents. It is recommended that soffit vents and baffles be installed at the eaves and the gable vent be sealed to allow for better air circulation through the attic space over the addition.

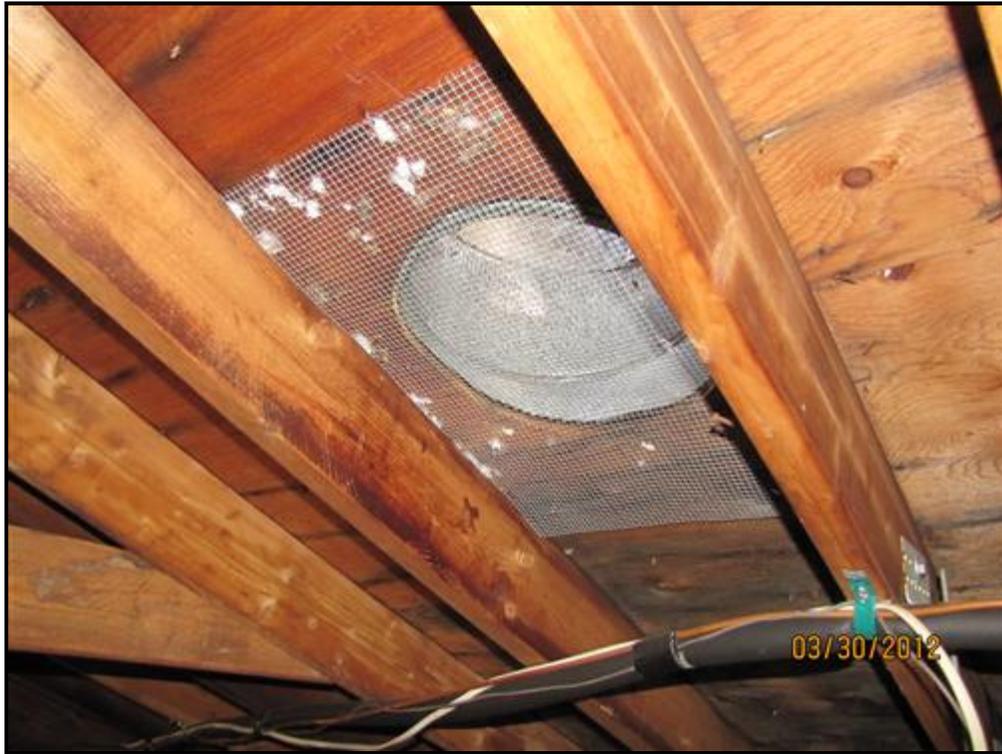
(3) The main attic space was noted as having a turbine exhaust installed on the rear side of the roof. Staining directly below the penetration on the underside of the sheathing is an indication that the vent has leaked in the past. The attic space also has soffit and ridge venting installed in this section of the attic. The combination of multiple types of venting systems can result in the systems working against one another and cause insufficient air circulation through the attic space. Turbine fans are not very effective and can leak over time as suspected. It is recommended that this vent be removed and the sheathing be replaced in this area by a qualified roofing contractor.

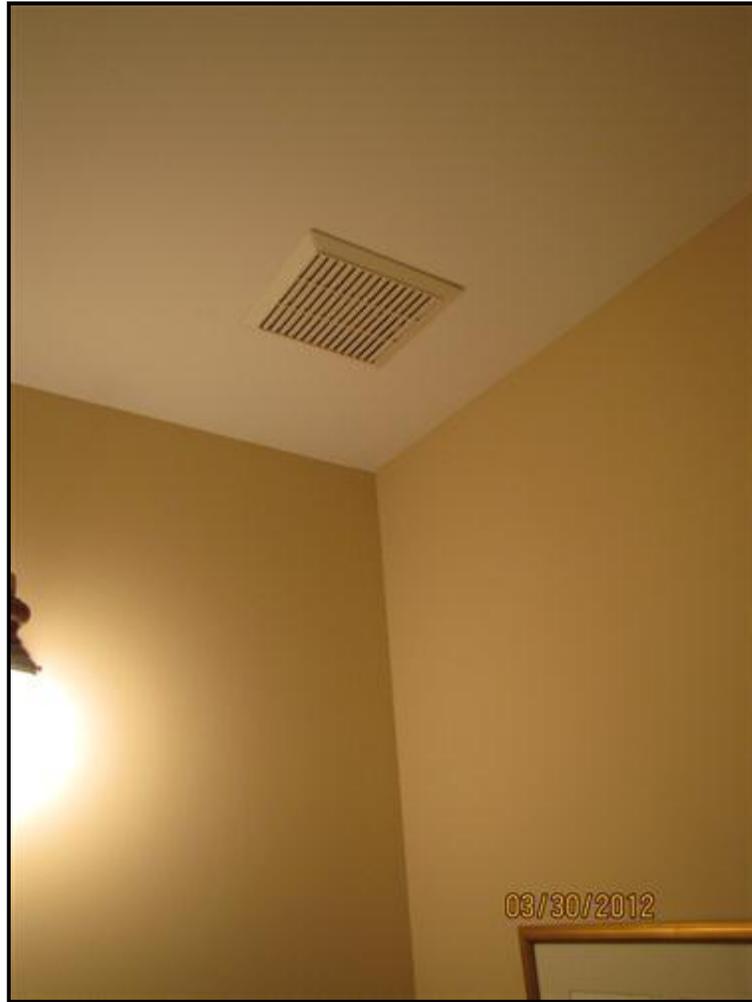
(1) One or more bathroom ventilation fans were noted as not functioning at the time of inspection. This can be as simple as plugging the fan into the receptacle again if it has come out or has been disconnected. It can also be as extensive as replacing the entire fan. Recommend further evaluation and any necessary repairs be conducted by a qualified electrical contractor.

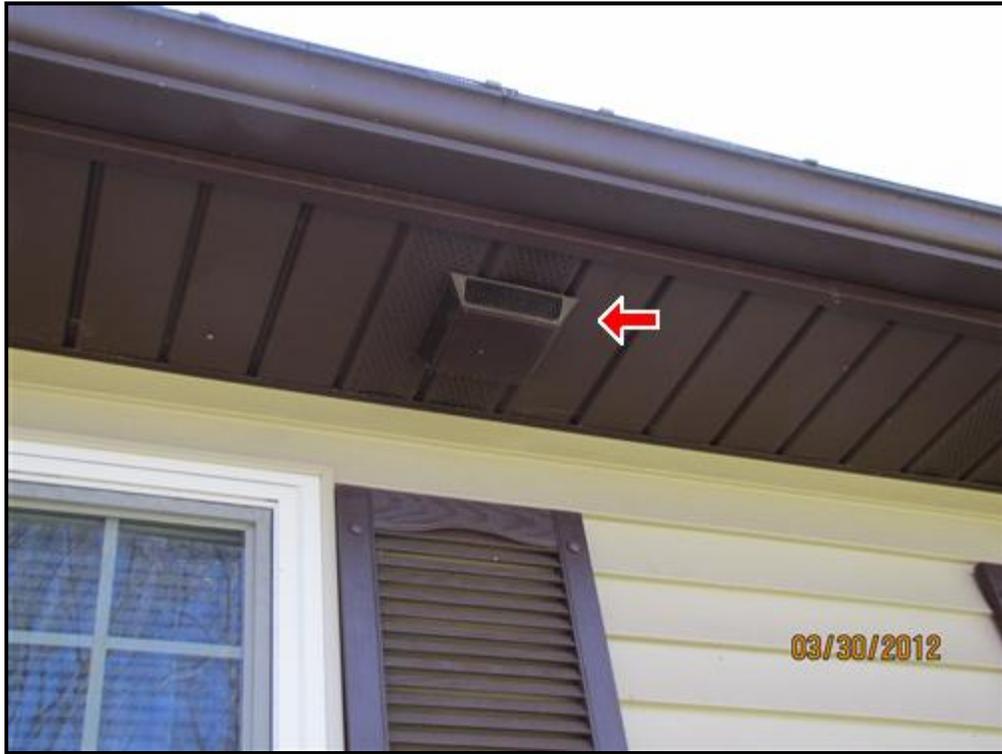
(2) Vent hoods were observed on the exterior of the property, however exhaust fans were not operational at the time of inspection to determine if they were properly vented to the exterior. Recommend further evaluation and any necessary repairs be conducted once the exhaust fans have been made operational by a qualified contractor.

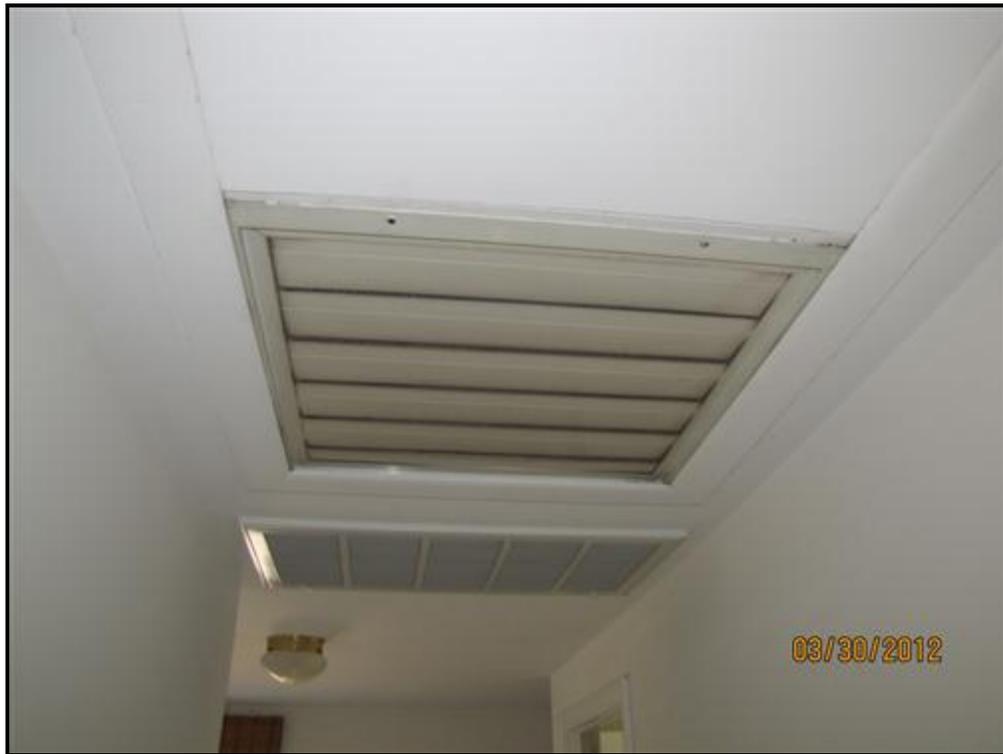
- ⊘ The home has a whole house fan installed in the attic space which draws air through the common hallway on the second floor. The system was not operated at the time of inspection. The system is on a timer switch and it is recommended that you consult with the current owner as to the proper operation of the system. The system appears to have been recently serviced and looks in good condition. It is recommended that the system be thoroughly tested before the close of escrow to ensure proper operation.

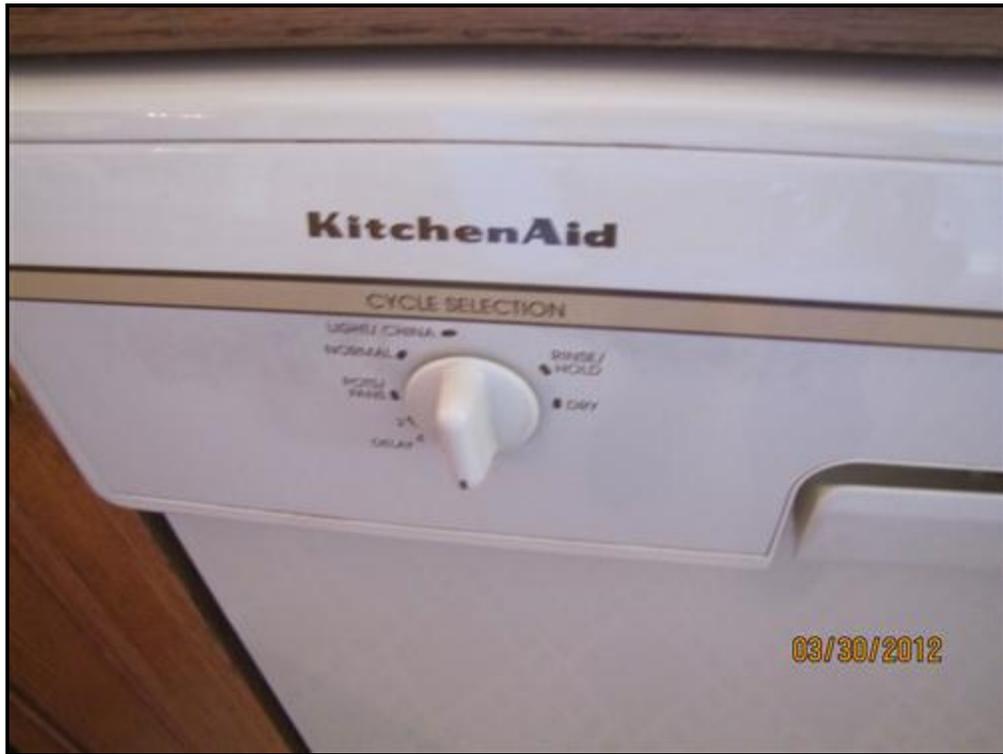
The dishwasher was inspected and found to be operational at the time of inspection. A photograph of the manufacturer's name and data plate have been included in this report to help you in obtaining a user's manual and any warranty information.

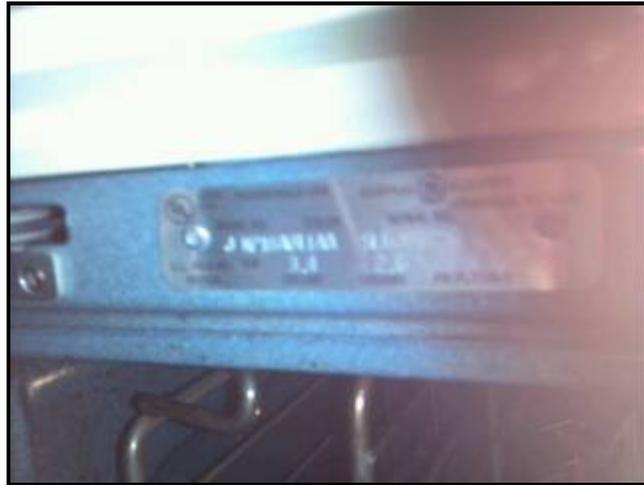
The cooktop and stove were tested and found to be operational at the time of inspection. A photograph of the manufacturer's name and data plate have been included in this report to help you obtain a user's manual and any warranty information.

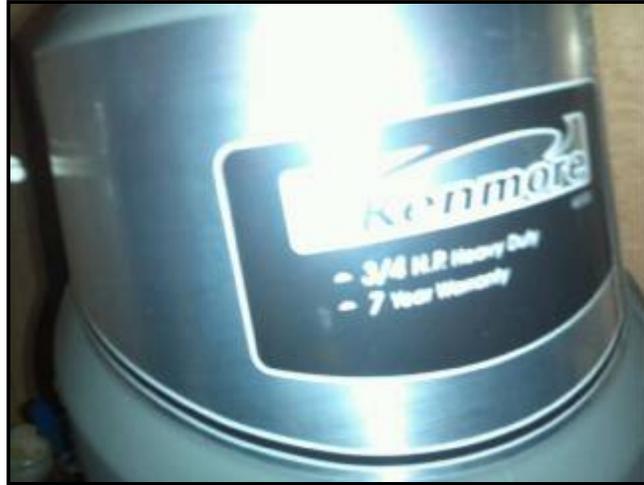
- ✔ The garbage disposal unit was inspected and found to be in operational condition at the time of inspection. A photograph of the manufacturer's name and data plate have been included in this report to help you obtain a user's manual and any warranty information.

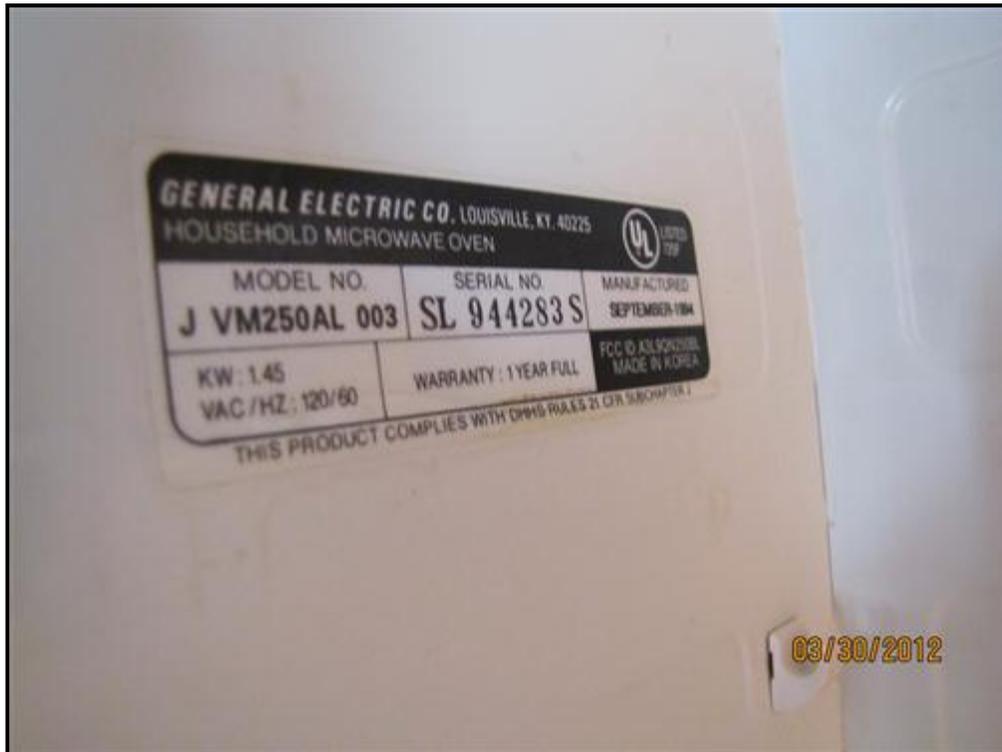
- ✔ The built in microwave was inspected and found to be in operational condition at the time of inspection. A photograph of the manufacturer's name and data plate have been included in this report to help you obtain a user's manual and any warranty information.

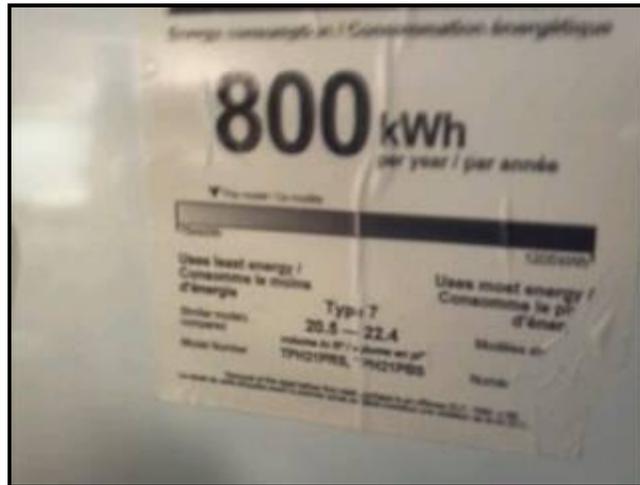
- ✔ The refrigerator was inspected and found to be in operational condition at the time of inspection. A photograph of the manufacturer's name and data plate have been included in this report to aid you in obtaining a user's manual and any warranty information.

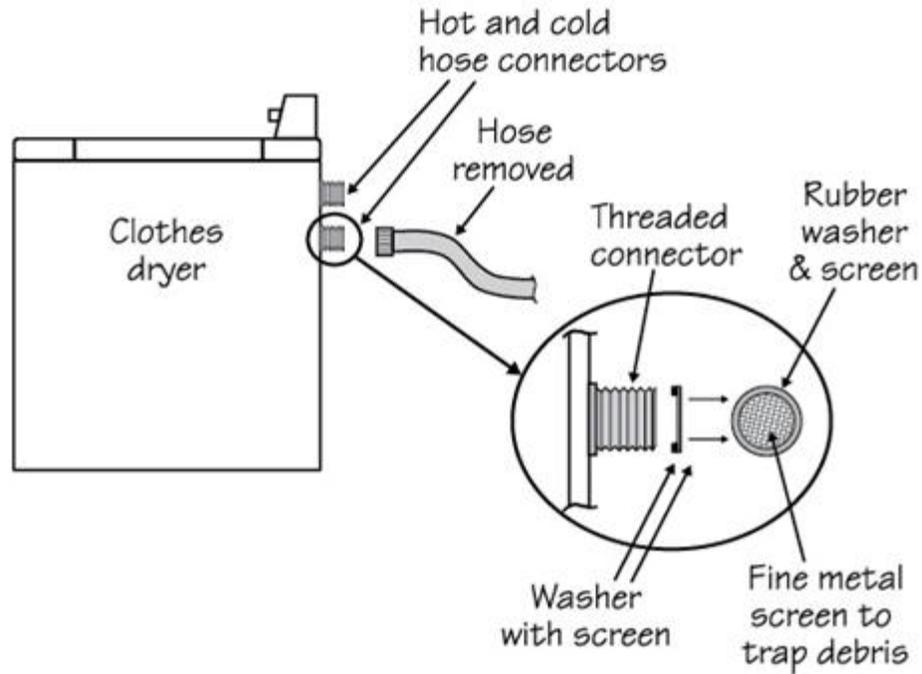
Slow filling clothes washer? Check the small screen at one or both ends of the washer hose. The screen may be blocked with debris.

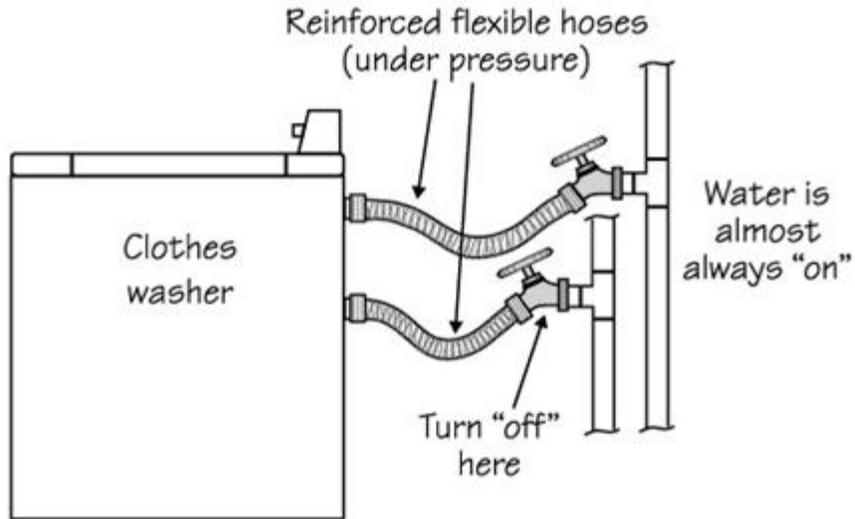
The hoses connected to your clothes washer are always pressurized (unless you turn the valve off.) Use special reinforced hoses or hoses that automatically turn off if they sense a leak.
