Inspection Report

Any Home Buyer

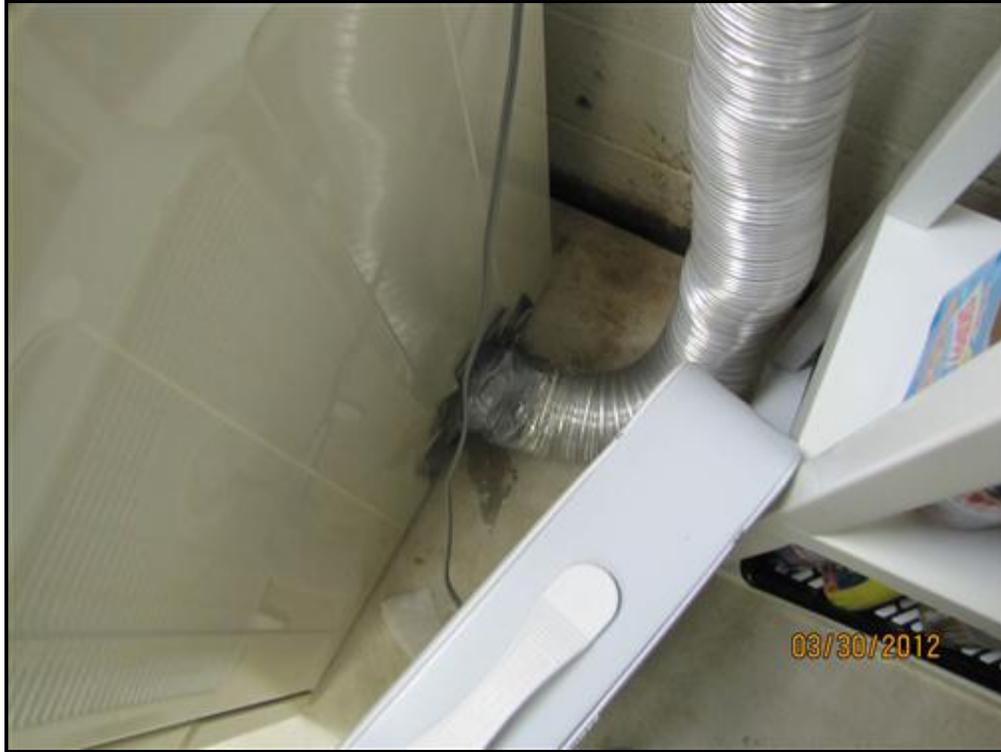
The dryer was noted as being modified to accommodate for the dryer vent being installed on the side of the unit. This may cause malfunctions in the ventilation system that can potentially lead to dryer vent fires. It is recommended that this be further evaluated and any necessary repairs or replacement of the unit be conducted by a qualified contractor.

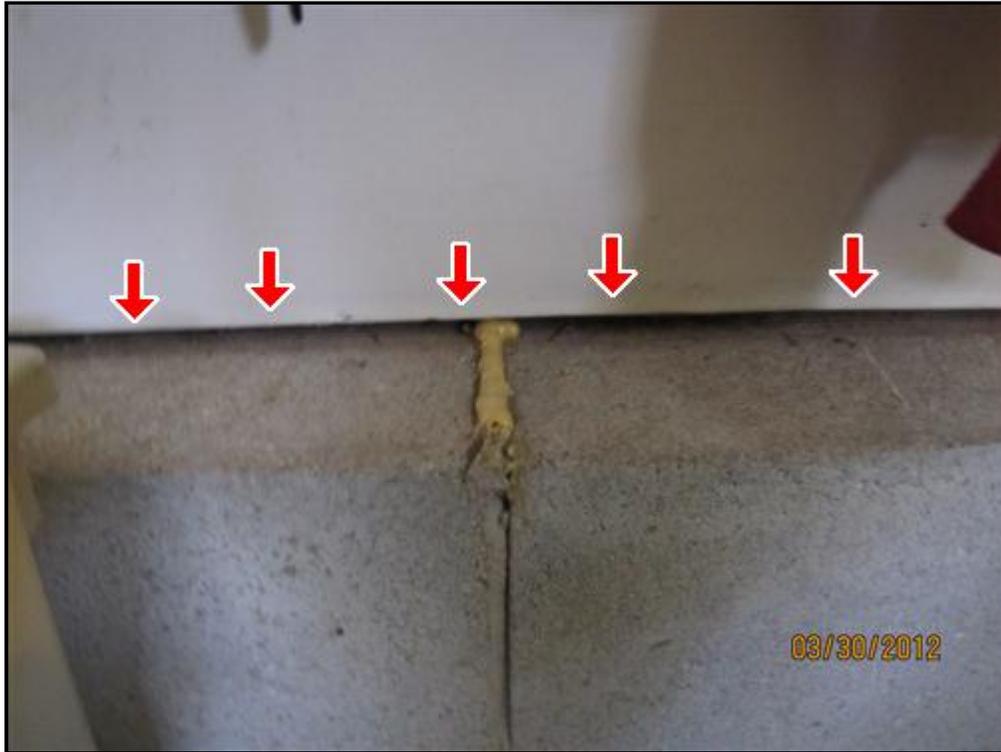
The bottoms of the garage walls were noted as having a gap present which is exposing the bottom plate of the wall framing. This can allow for fire to come in direct contact with combustible materials and easily spread to the living spaces. It is recommended that this gap be filled with fire resistant caulking for fire safety reasons.

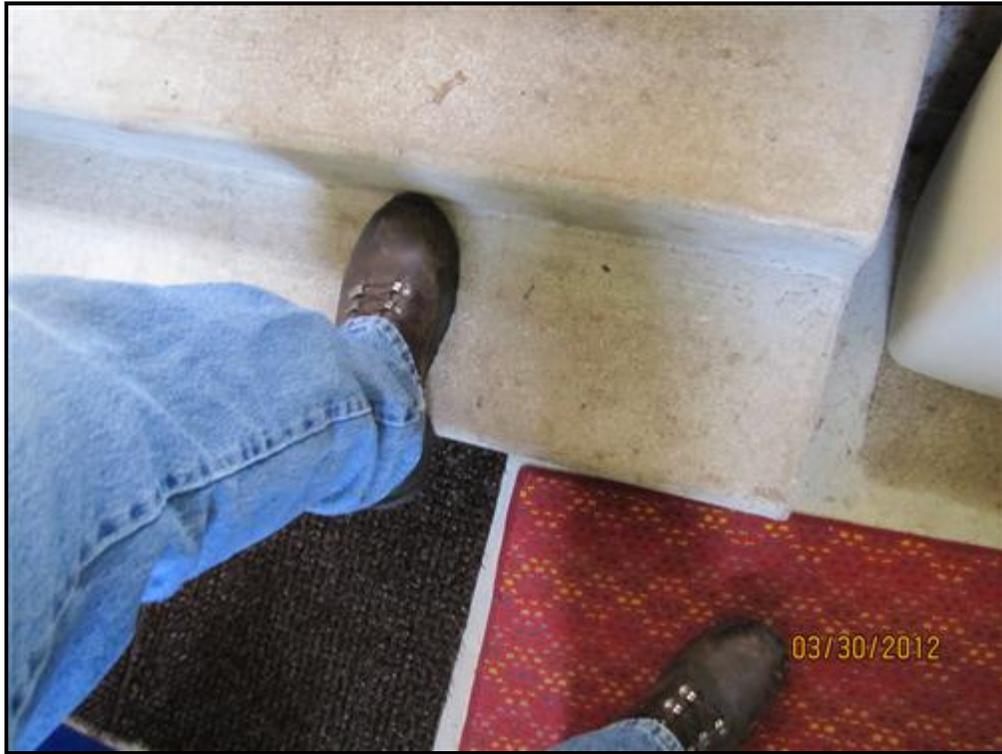
The stair treads in the garage were noted as being undersized according to modern building standards. Stair treads should be a minimum of 10 inches to allow for the entire foot to rest on the tread when climbing stairs. Undersized tread depth can result in potential trip and fall accidents. Recommend replacement of the garage steps by a qualified contractor to conform to modern building safety standards.

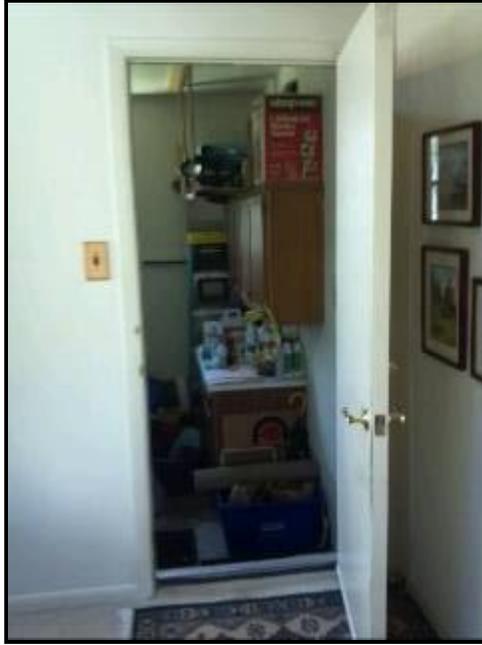
⚠ The occupant door to the living space was noted as not having a self closing device installed. These devices are required to help prevent the spread of fire and dangerous fumes from stored chemicals or combustion engines. It is recommended that a self closing device such as spring loaded hinges be installed on the occupant door by a qualified contractor.

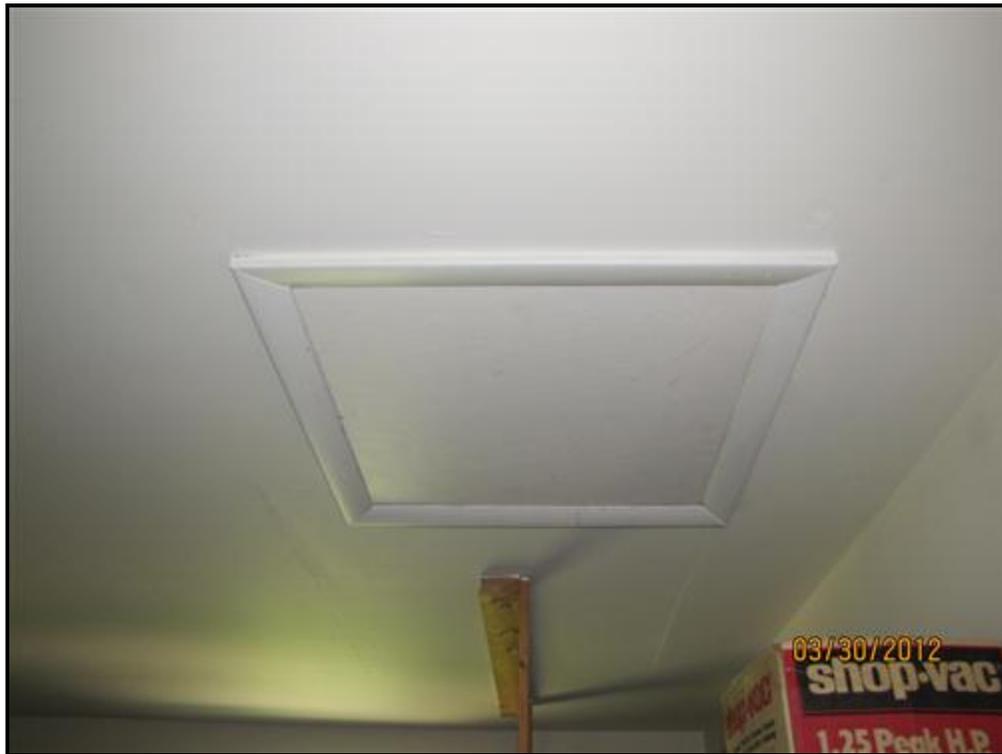
⚠ (1) The access panel for the attic space over the garage was noted as being constructed out of plywood. This does not provide a one hour fire rating on the ceiling surface to prevent the spread of fire to the attached living spaces. It is recommended that this be replaced with 5/8" drywall and the opening be insulated and the perimeter have weather stripping installed for fire safety reasons.

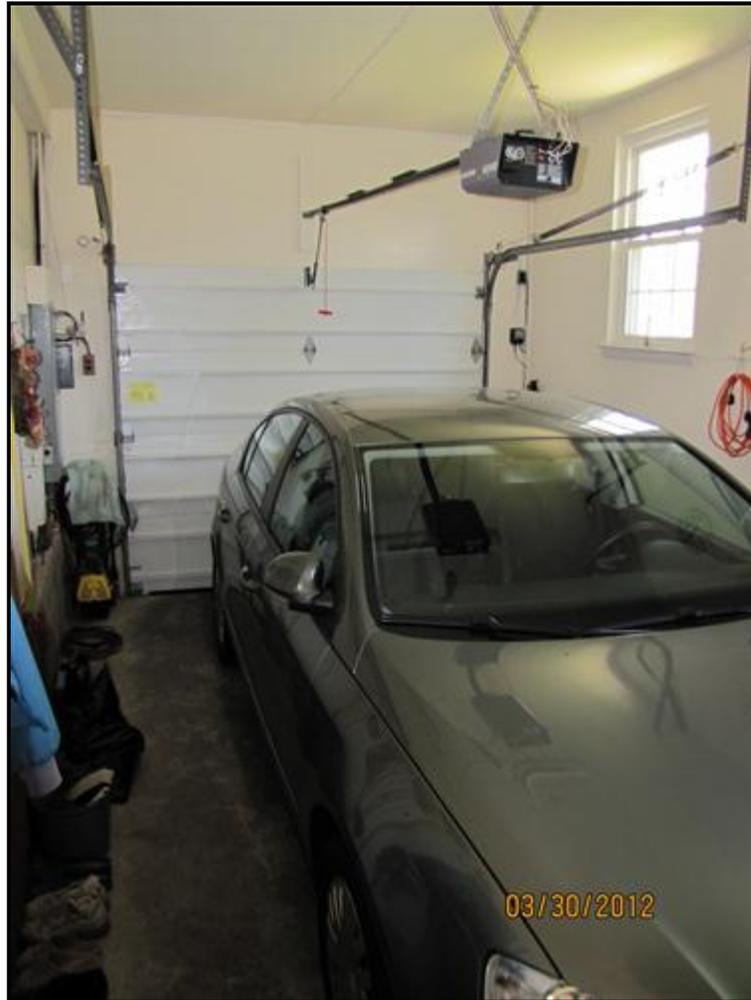
(2) The attic area over the garage could not be inspected due to a car being parked in the garage which perverted access to the panel. Recommend further evaluation once the area has been made accessible for inspection.
