Gas Water Heater For Your Information

PEACH Inspections

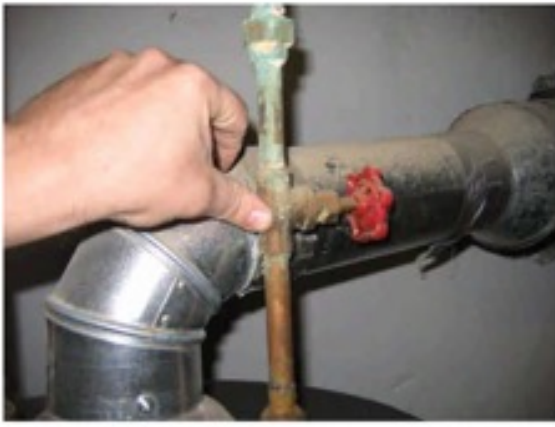
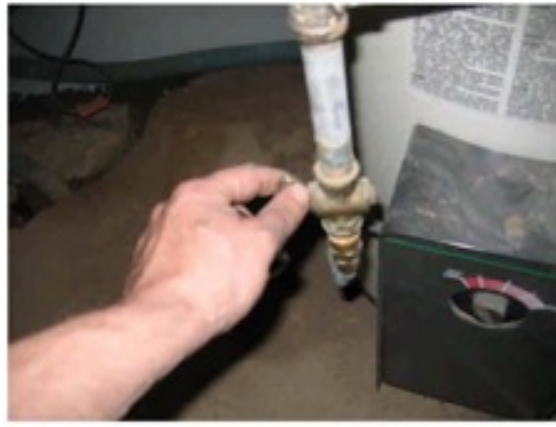
The water shut-off valve to the water heater tank is installed. Not leaking. This valve turns off the cold water supply to the tank. Good.

The gas shut-off valve at the water heater is installed within reach of the tank. This valve turns off the gas supply to the tank. Good.

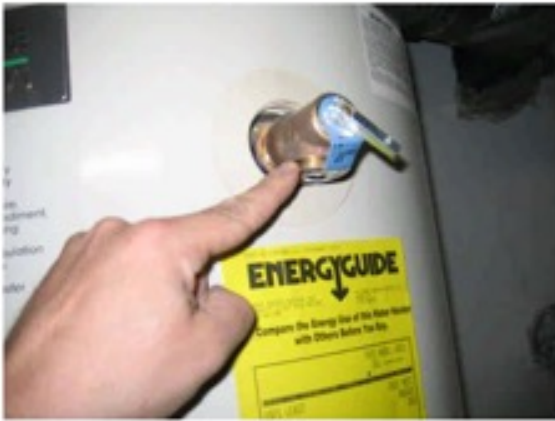
The pressure relief valve on the water heater does not have a discharge pipe. One should be installed that terminates within six inches of the floor. For safety.

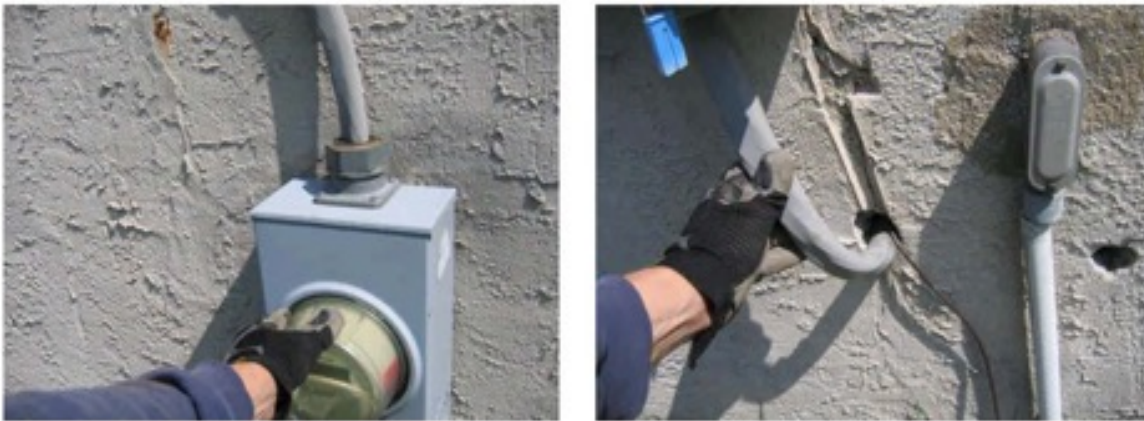
There is one electric meter.

The meter is located at the right-side of the house.

The meter box exterior appears functional. No major rust or damage. Not loose. Good.

There is a grounding wire visible outside. Good.

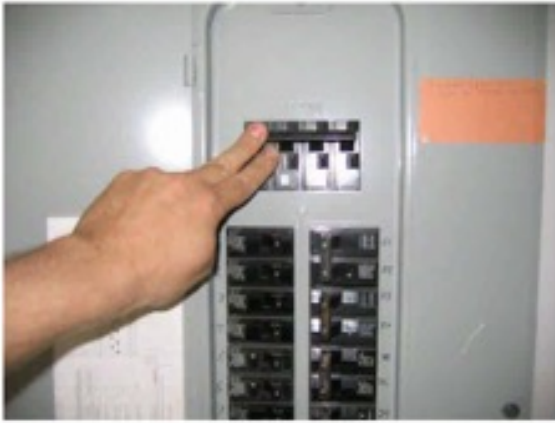
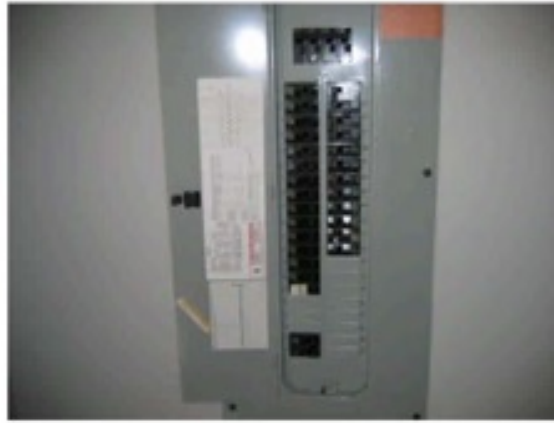
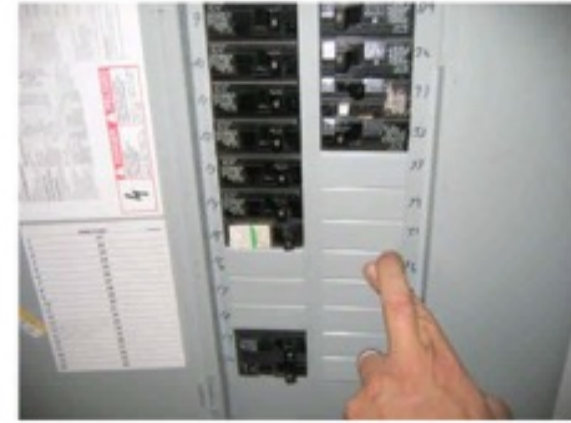
The main panel is located in the basement.

The main disconnect is installed.

The main electrical panel appears to be 200-amps.

Various circuit breakers within the electrical panel are not labeled, but should be.

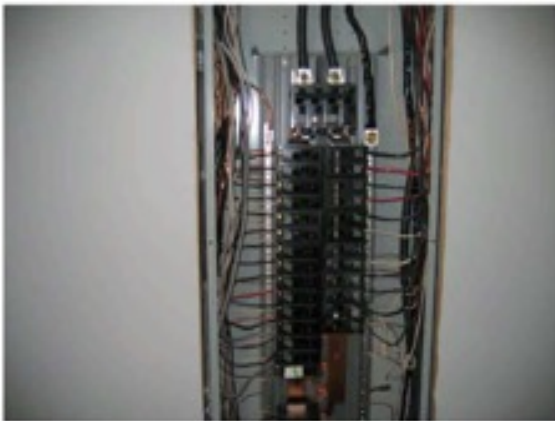
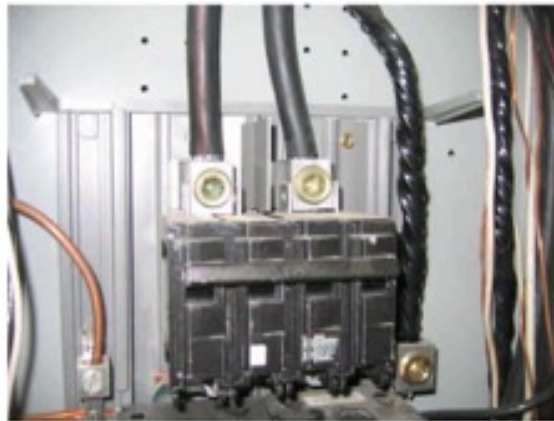
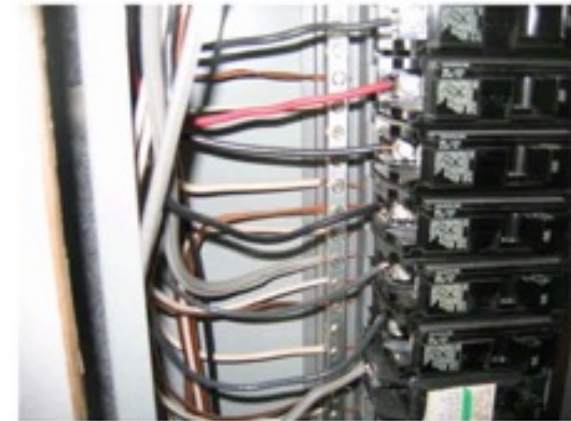
Modern Romex wiring is visible. Good.

There is apparently open room for additional breakers and circuits.

The ground-fault circuit interrupter breaker at the panel were manually tested. Tested functional. Good. Tub.

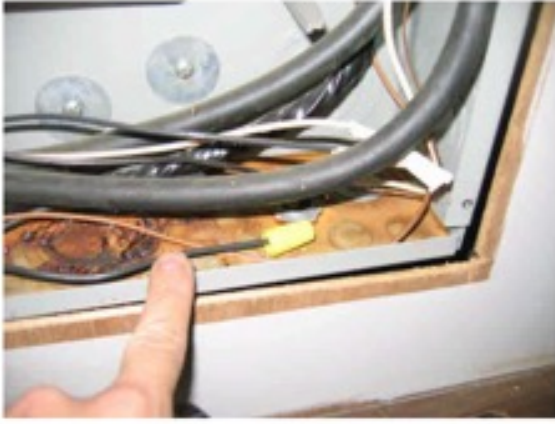
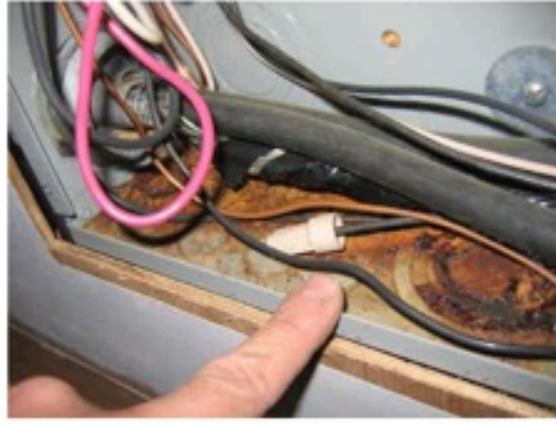
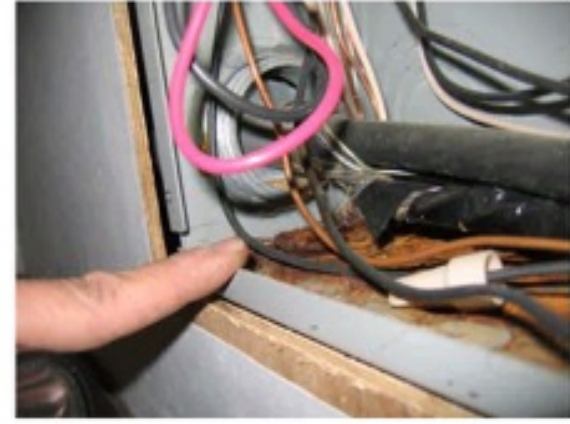
There are water marks on the bottom of the panel box interior. Visible inside the electrical panel. Potentially hazardous. May have affected the performance of the breakers. Further evaluation by an electrician is recommended.

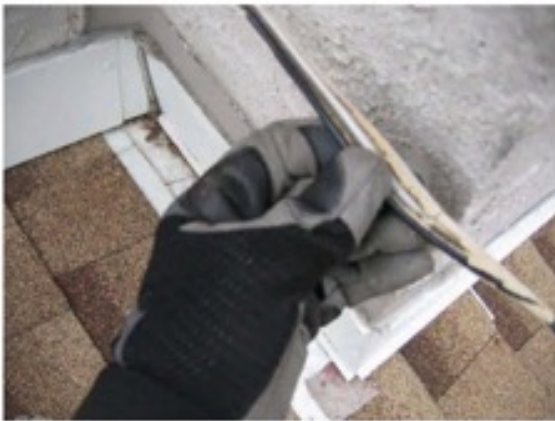
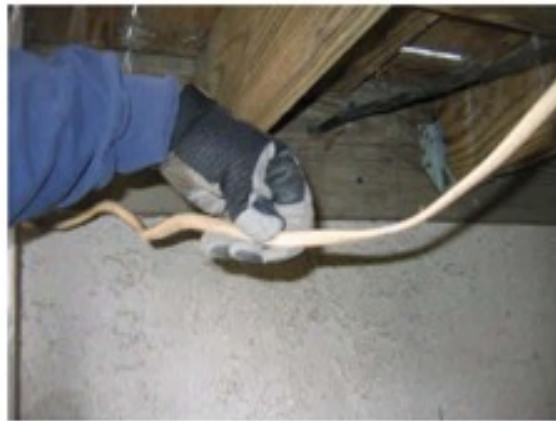
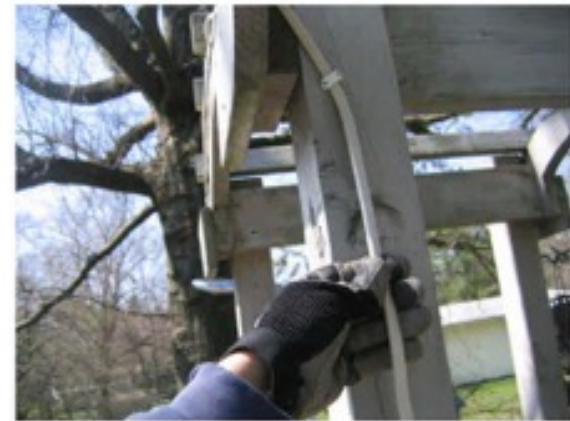
A professional electrician is needed to repair the wire on the roof, wire below the deck, and wires at the fence around the pool. They are type NM-B, for interior-use only. The wire on the roof is completely frayed open. Hazardous.

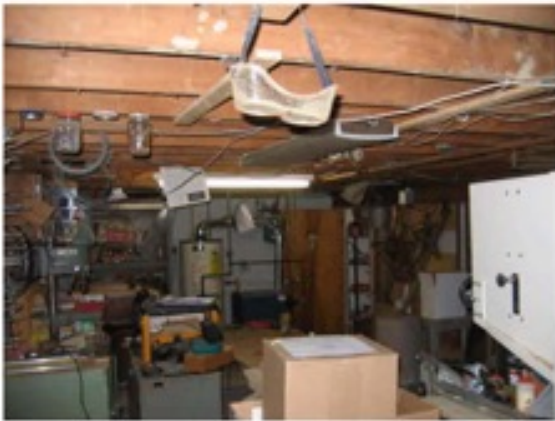
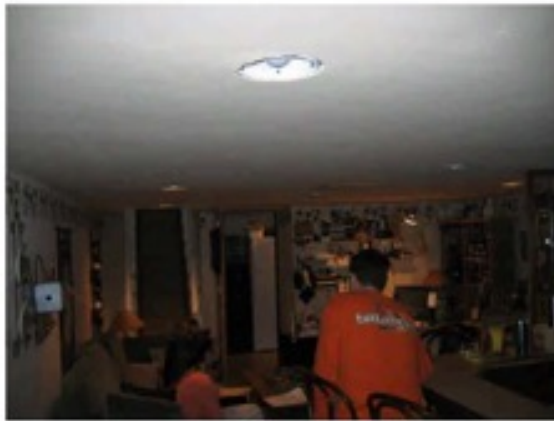
This residence has a basement. We try to enter and inspect all accessible areas, looking for any evidence of structural material defects. We look for cracks, but those that are less than 1/4" and which do not exhibit any vertical or horizontal displacement are generally not regarded as being material structural defects. We look for signs of water penetration too, but please consult the seller's disclosure.

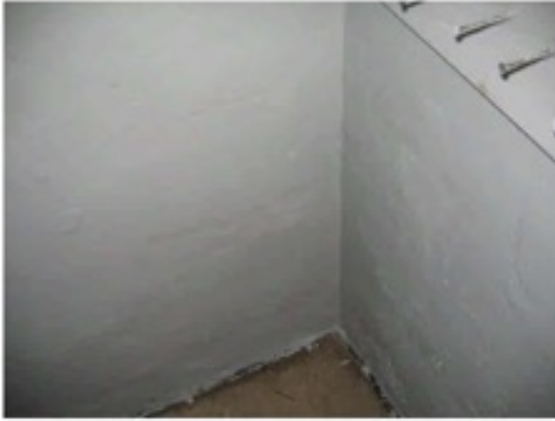
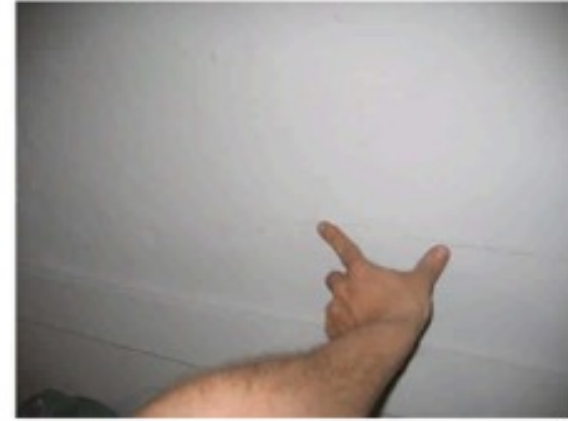
There are some cracks in the mortar joints of the concrete block wall. Located at the front wall. They do not appear to be major material defects. Possibly settlement or movement. Recommend asking the seller about the cracks. Monitoring is recommended.

The concrete block foundation of the structure appears to be functional. Readily accessible areas were inspected. There are no indications of major material defects apparent.

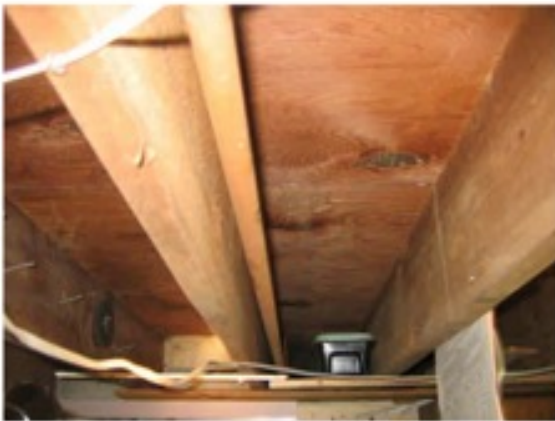
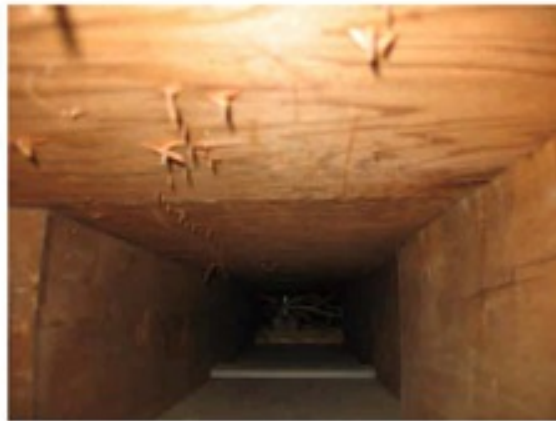
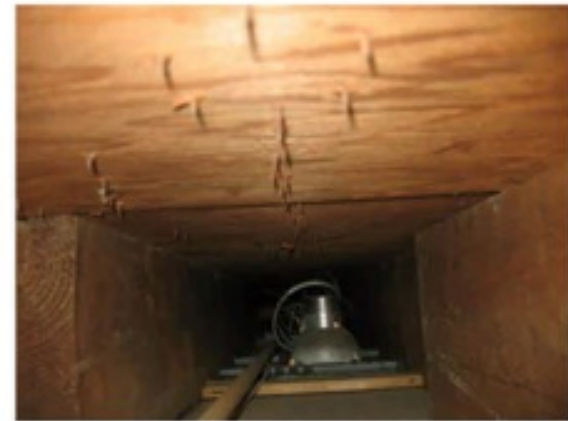
The floor joists are made of dimensional wood lumber - 2x10s.

I walked around, probed, checked the floor as best as I could. No material defects apparent. No major structural defects found. Recommend asking the seller if any repairs have been made to the floor structure in the past.

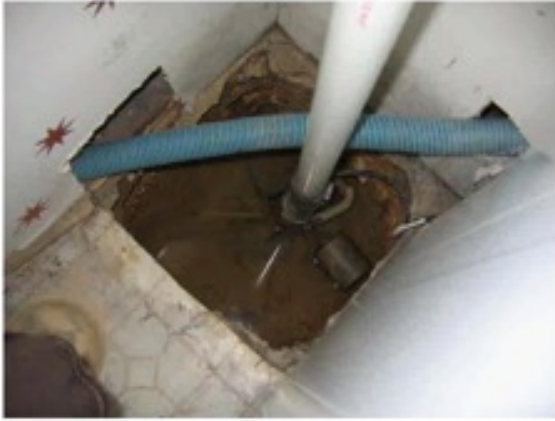
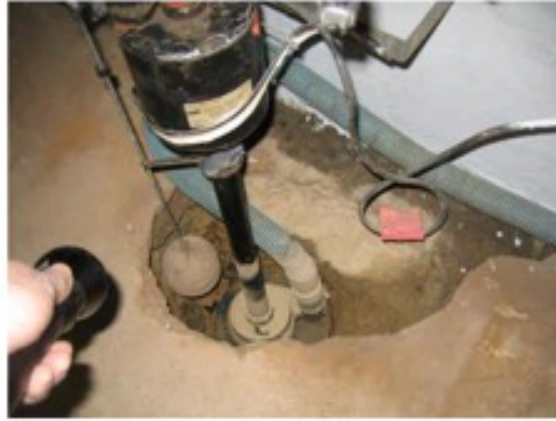
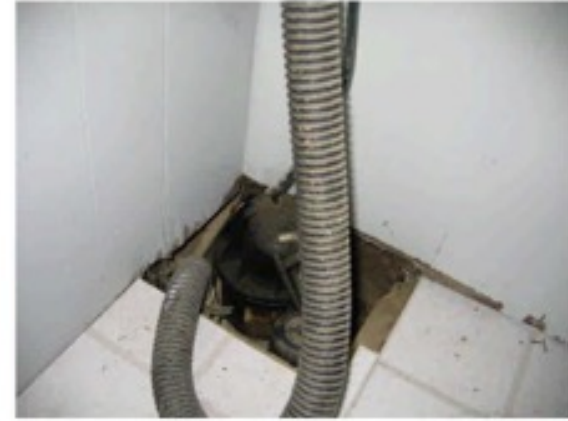
There are three sump pumps being used. Recommend asking the seller why a sump pump has been installed. Has there been water penetration problems that required the pump to be installed?

There is water in the sump pit.

A check valve is needed on the sump pump's discharge pipe.

The flexible discharge hose is not reliable.

The pump is plugged into an extension cord, which is for temporary-use only.

Each sump pump is sitting in a muddy hole. Not installed properly in a sump pump bucket. The mud will erode away. Each pump is prone to excessive wear and clogging. Likely not discharging an adequate amount of water from the hole. Not professionally installed, and therefore not reliable.

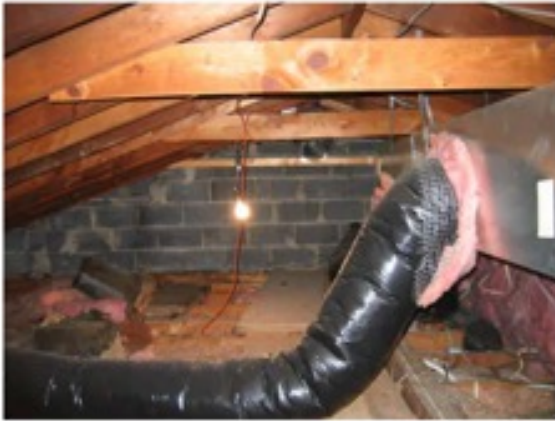
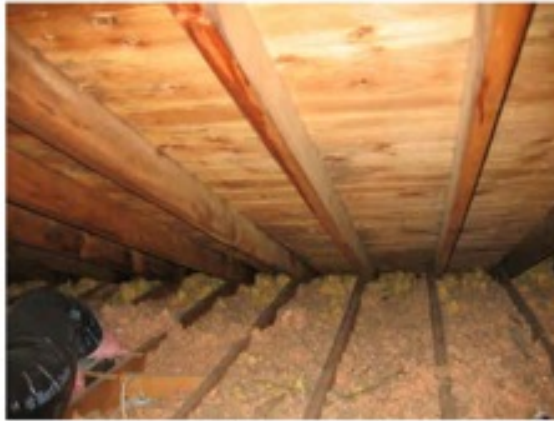
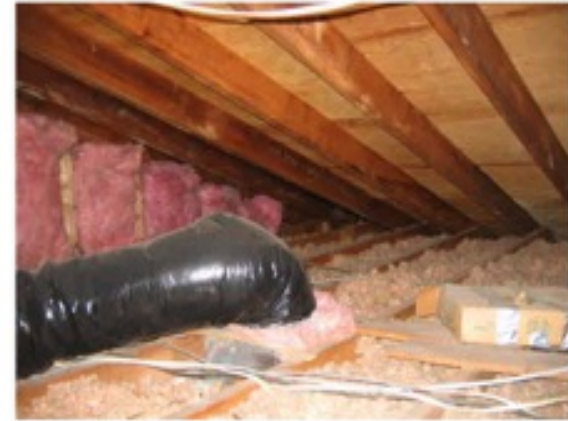
Conventional stick framing methods at the roof system are visible from the attic space.

The house has had roof leaks in the past, indicated by the water marks or stains on the roof decking and components here and there. Visible from the attic space. This is commonly found in older homes. No major structural damage. Ask seller about prior roof leaks. Monitoring recommended.

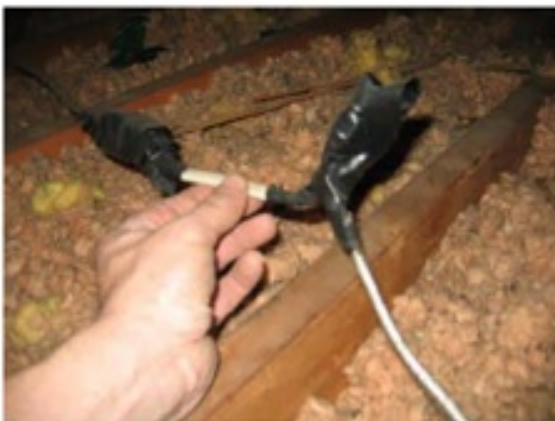
A splice - an electrical connection has been incorrectly made outside of a junction box, which is a potential fire-hazard. All such connections should be made inside a junction box, with clamps on the wires, in order to hold the wires in place securely, and contain any arcing or sparking within the box.

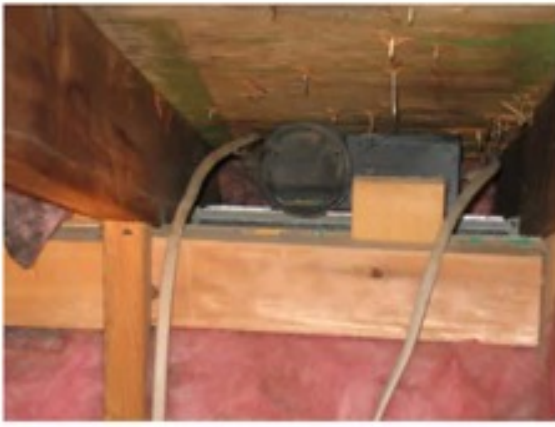
The bathroom fan exhausts into the attic. This has not been properly installed. The fan should be vented to the outside properly. Either through the roof or through an outside wall. Not to the soffit vent at the eaves of the roof. Currently the fan vents moisture into the attic space. This moisture can reduce the R-value of the insulation. The moisture can contribute to mold and mildew growth on the underside of the roof sheathing. Correction of the bath fan which is exhausting into the attic is recommended.

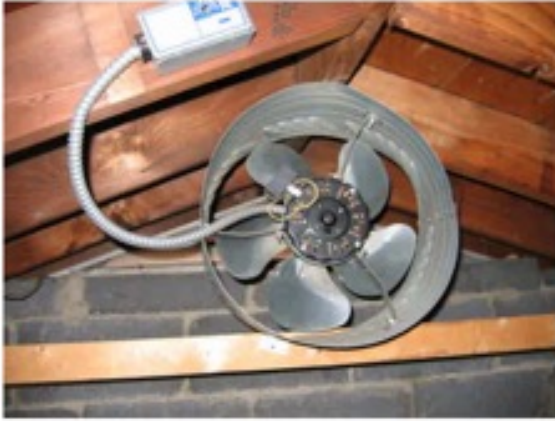
Seems adequate. Gable fan turned on.

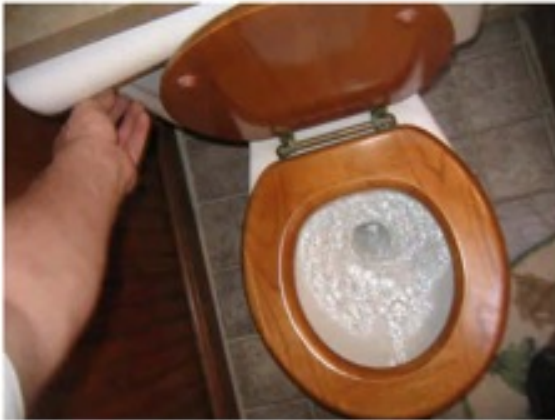
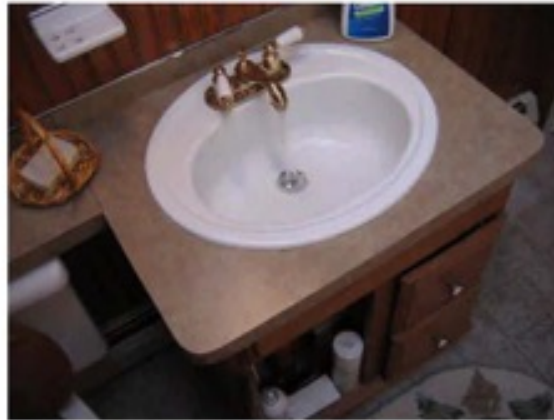
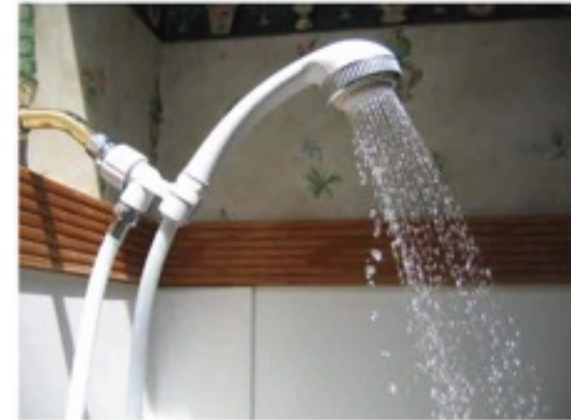
We inspected the bathroom, and found no major defects. Toilet flushed a couple times. Running water at the sink. Sink drained. The tub/shower functional. No active leaks.

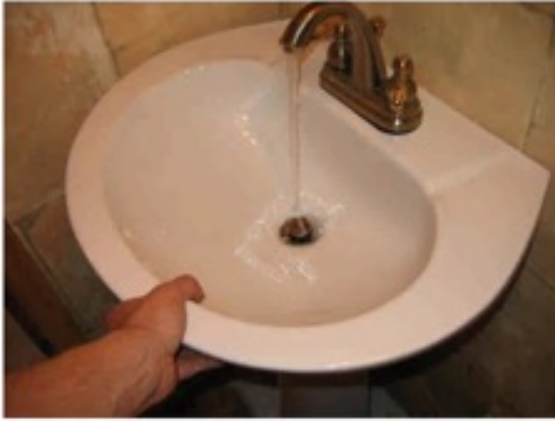
The sink top is not secure. Loose. Basement bath.

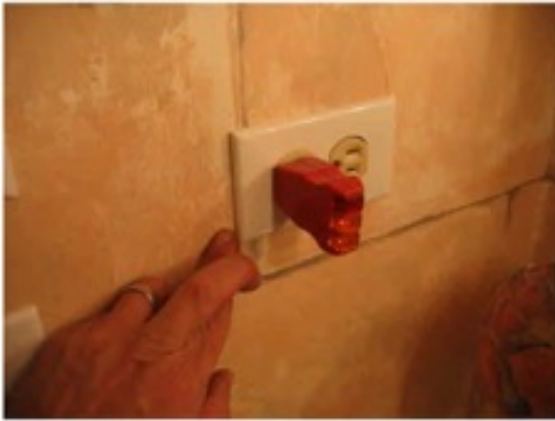
The receptacles in this basement full bath are not protected by a functional GFCI (or ground fault circuit interrupter).

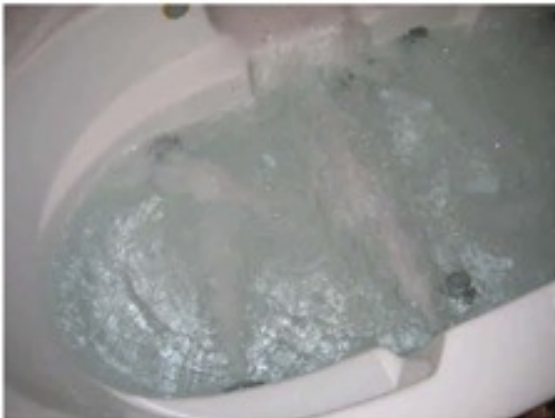
The whirlpool tub is functional but should be flushed with a cleanser if not used frequently.

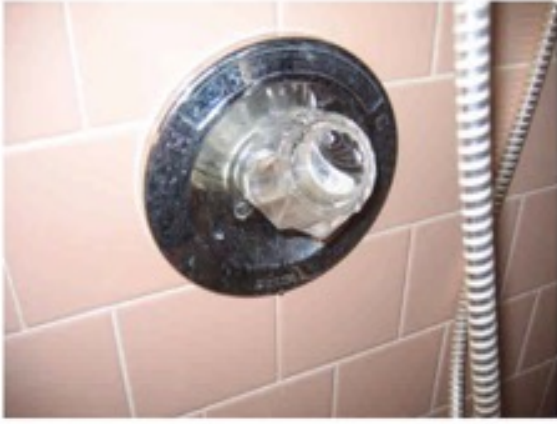
The hot and cold are reversed at the shower handle.

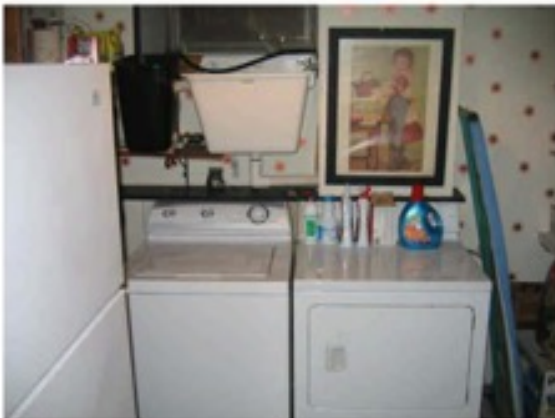
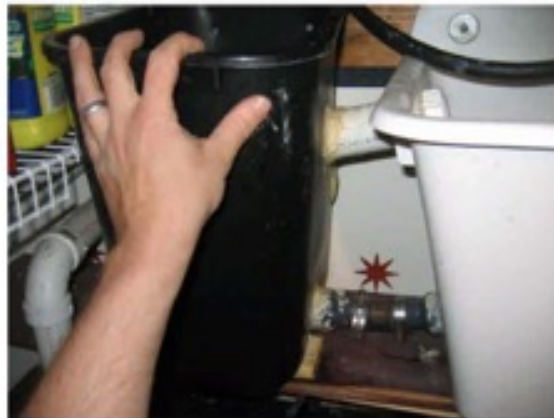
Unconventional method of draining - prone to clogging - not reliable. The washer drains into a tub, but the tub is draining into a waste basket. ? Not professionally installed. Further evaluation by a plumber is needed.

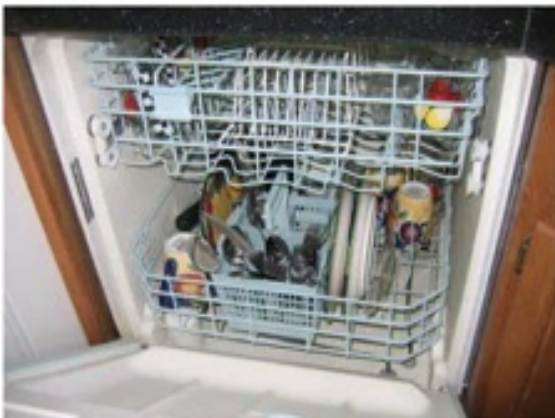
Ran a short cycle with no leaks. (This is no guarantee against future problems.)

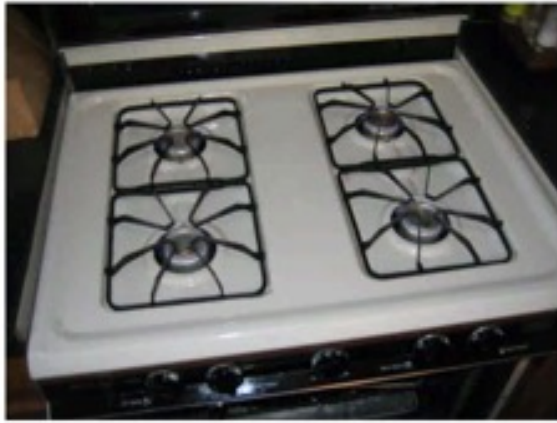
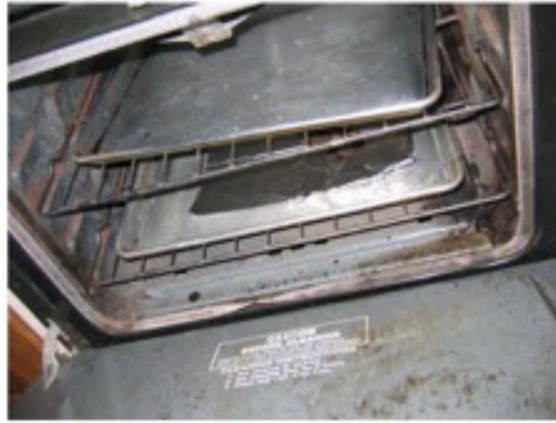
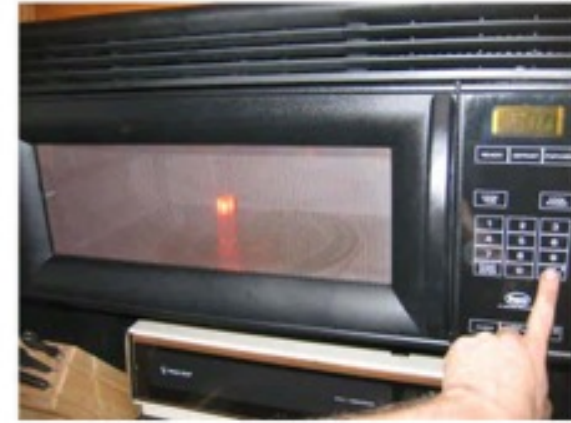
The gas cook top elements turned on.

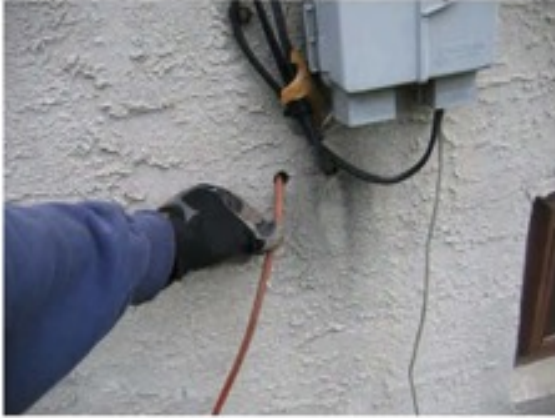
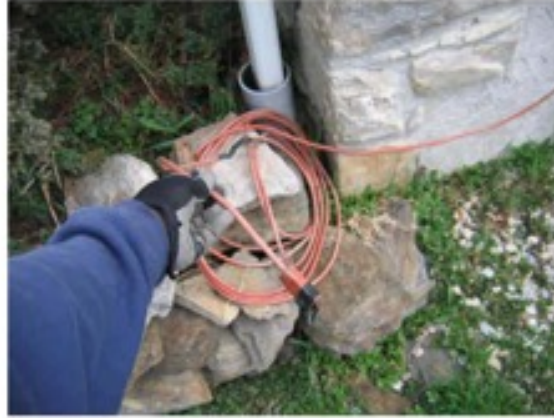
Recommend asking the seller of the property about the extension cord coming out of the wall.

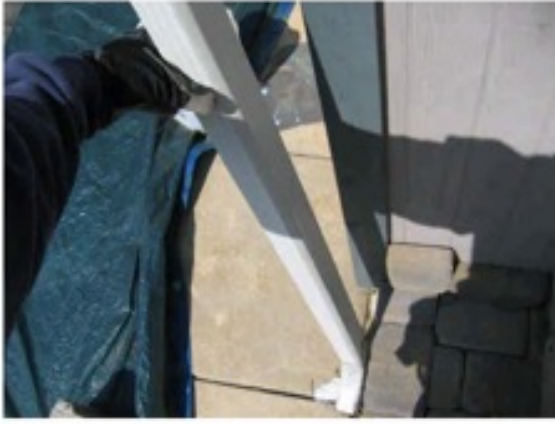
The downspout is loose. No gutter on the back-side.

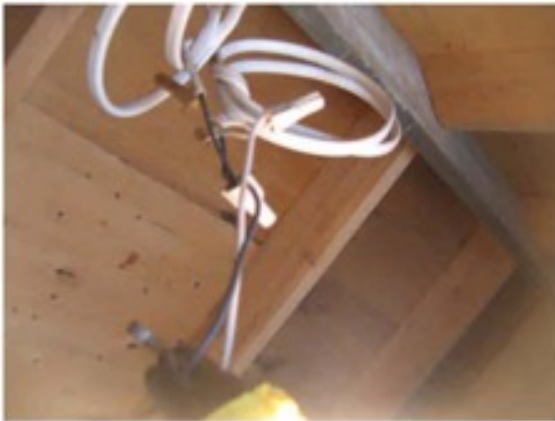
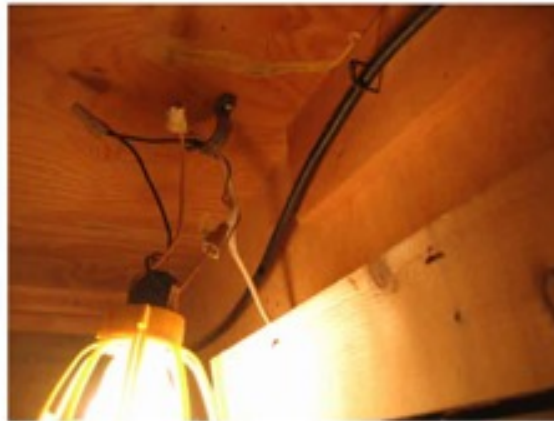
CORRECTION AND FURTHER EVALUATION RECOMMENDED:
Electrical repairs needed at the shed. Open splices at lights.
