Inspection Report

MDV Inspection, Inc.

Date: 4/8/2017	Time: 02:04 PM	Report ID: 1704008-A
Property:	Customer:	Real Estate Professional:

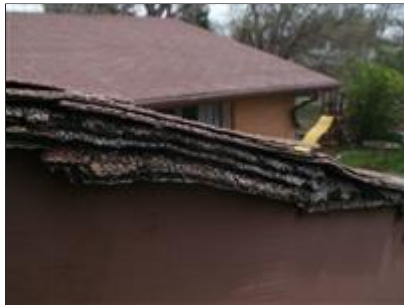
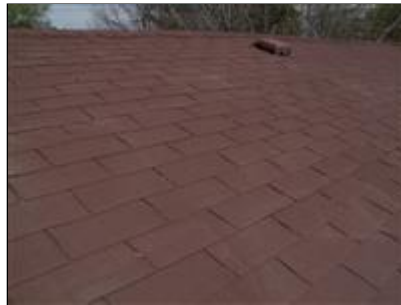
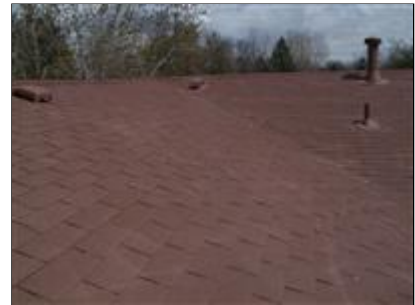
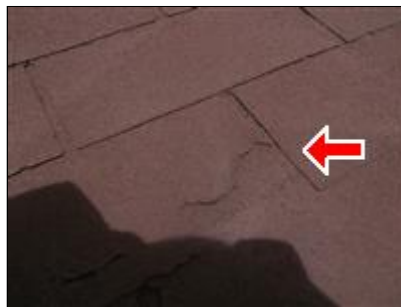
1.0 Picture 1 3 layers

**1.0** Asphalt Shingle roofing at all areas of the home.
 - Estimated age of the Roofing = 25 Years / Design Life of Roofing is 15 - 20 Years.
 - Multiple Layers of Roofing noted (2 or more). Roof surface will need to be stripped at time of next re roofing.
 - Deterioration, surface nailing , missing tabs and cracking noted to all surface areas of the roof. Recommend obtaining estimations for roof replacement.

- Estimated age of the Roofing = 25 Years / Design Life of Roofing is 15 - 20 Years.
- Multiple Layers of Roofing noted (2 or more). Roof surface will need to be stripped at time of next re roofing.
- Deterioration, surface nailing , missing tabs and cracking noted to all surface areas of the roof. Recommend obtaining estimations for roof replacement.

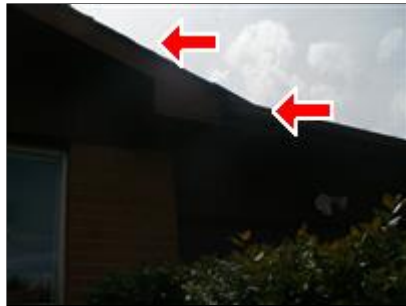
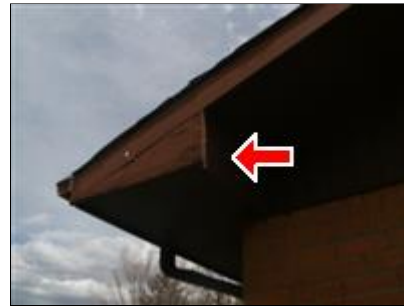
1.4 Picture 1

- Areas of deterioration noted.
- Recommend periodic repair and painting as needed to maintain.

Fascia / Soffit / Trim
 - Areas of deterioration noted.
 - Recommend periodic repair and painting as needed to maintain.

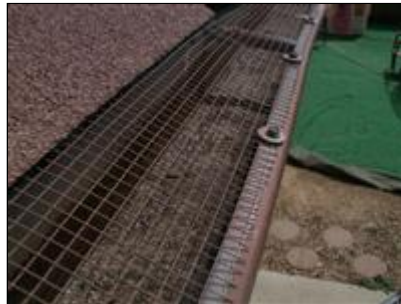
1.5 Picture 1

- Accumulations of leaves and debris noted in the gutters. All gutters should be checked for damage, blockage, or overflow on a regular basis (at least twice annually).
- Gutter guards may help in cases where leaves and other debris routinely accumulate in a short period of time.
- Recommend clearing debris from the gutters

Gutters
 - Accumulations of leaves and debris noted in the gutters. All gutters should be checked for damage, blockage, or overflow on a regular basis (at least twice annually).
 - Gutter guards may help in cases where leaves and other debris routinely accumulate in a short period of time.
 - Recommend clearing debris from the gutters

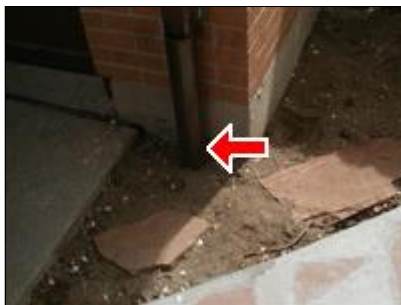
1.6 Picture 1

- Downspouts are routed sub grade at some areas of the home. Verify and maintain clear drainage at all times to divert water away from the sub structure of the home.
- Downspouts terminate at grade adjacent to the foundation wall. Recommend extending downspouts to move water away from the foundation.

Downspouts
 - Downspouts are routed sub grade at some areas of the home. Verify and maintain clear drainage at all times to divert water away from the sub structure of the home.
 - Downspouts terminate at grade adjacent to the foundation wall. Recommend extending downspouts to move water away from the foundation.

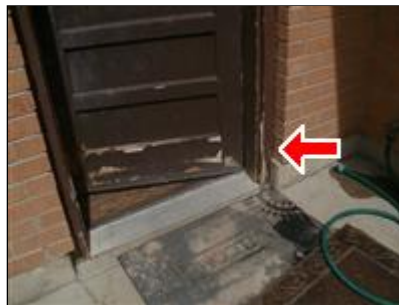
2.2 Picture 1

- Damaged storm door. Recommend replacement.
- Hollow core entry door. Recommend upgrade to steel security door.

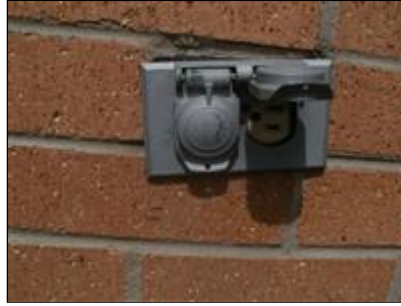
2.5 Picture 1

- Non-GFCI rated receptacles present at the exterior of the home. Recommend repair with replacement made for safety.

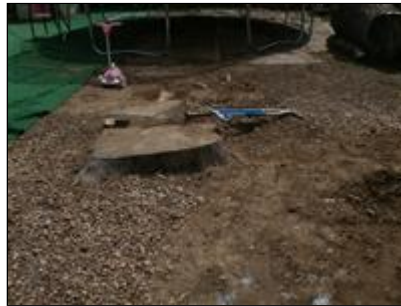
2.7 Picture 1

- Vegetation overgrowth noted at all areas of the property. Recommend landscape repair with pruning and/or removal as needed.
- Decaying tree stump at the rear yard. Recommend removal.

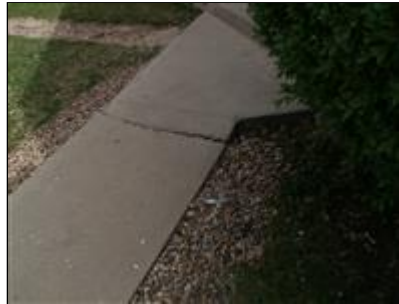
3.0 Picture 1

- Concrete sidewalk and walkways at the front entry with cracking, settlement and trip hazards present. Recommend repair with replacement as needed.

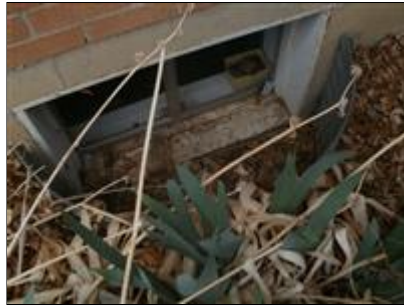
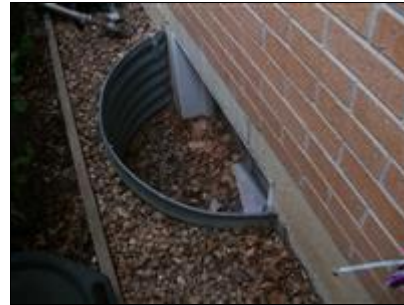
3.3 Picture 1

- Leaves and debris present. Recommend removal of vegetation and cleaning as needed for proper drainage.
- Soil is in contact with the window sills and framing. Condition present is conducive to wet rot and WDI infestation. Recommend repair as needed to correct.
- Recommend the installation of well covers at all areas to maintain and alleviate water intrusion concerns.

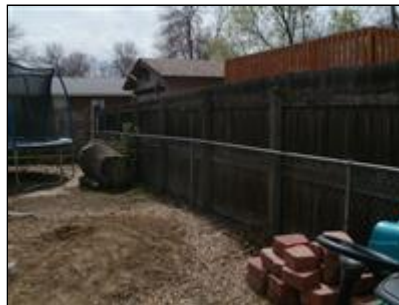
3.7 Picture 1

- Fencing at the perimeter of the rear yard.
- Recommend inquiring of the homeowner to verify the extent of ownership and maintenance responsibility of the fence.

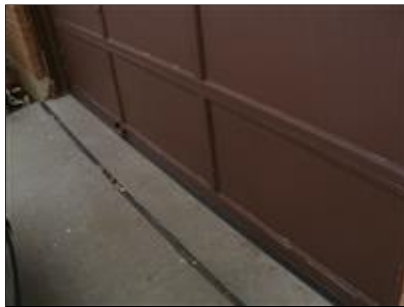
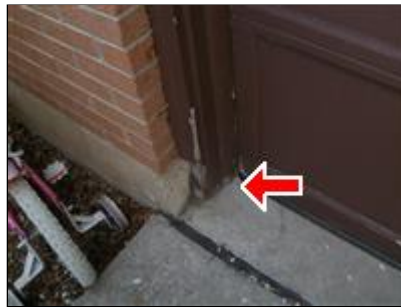
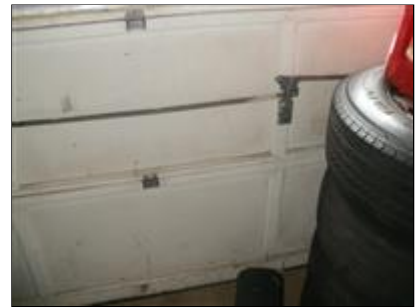
4.5 Picture 1

4.5 Older garage door noted. Anticipate maintenance, repairs and replacement.

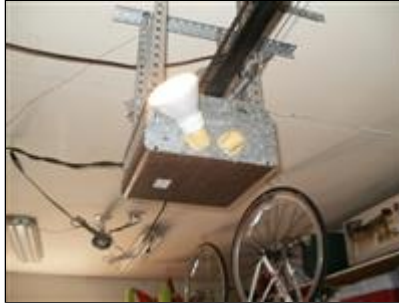
4.6 Picture 1

- Inoperable door operator. Recommend repair / replacement as needed.

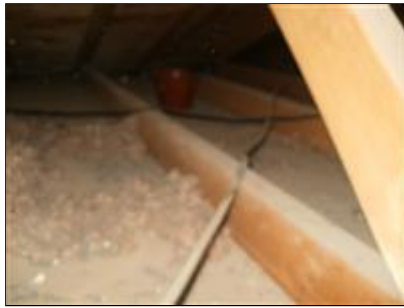
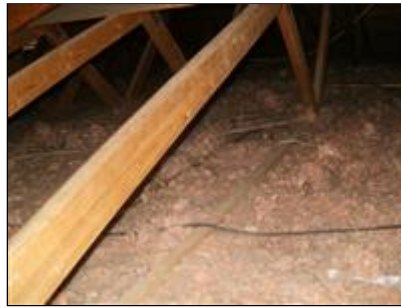
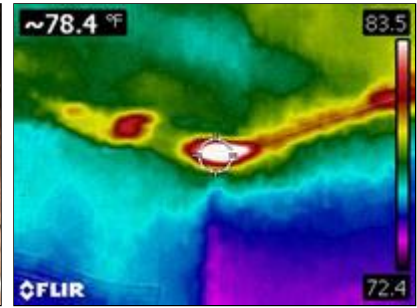
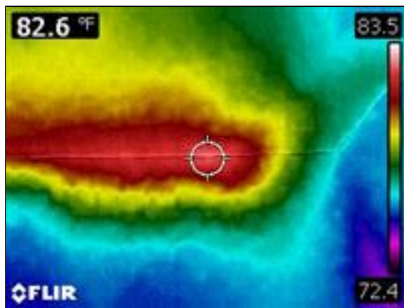
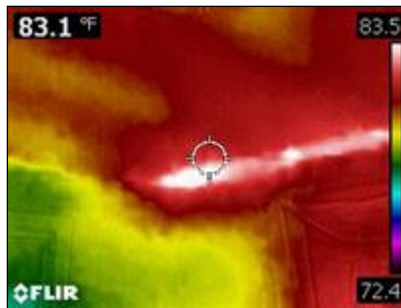
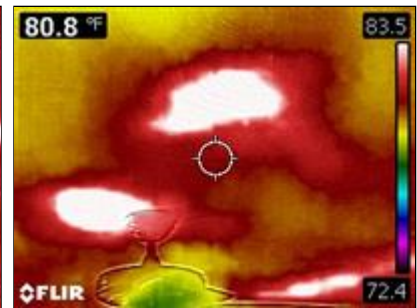
5.2 Picture 1

- Insulation level is inadequate for the current needs of the home. Recommend the installation of additional insulation as needed.

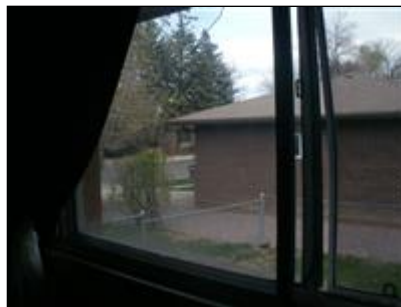
6.3 Picture 1

- Older single glazed windows at all areas of the home with damaged glazing, torn screens and deteriorated exterior surfaces. Recommend carpentry repair and painting.
- Due to age and overall condition, replacement should be estimated at this time.

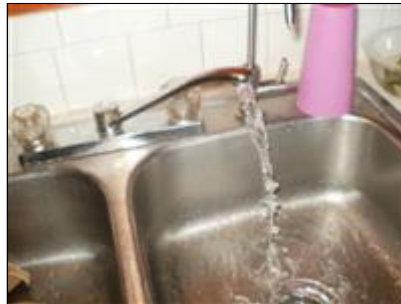
7.0 Picture 1

- Incomplete shutoff at the faucets. Recommend plumbing repair.

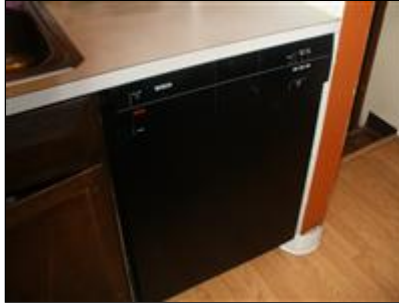
7.3 Picture 1 Inoperable

- Inoperable appliance. Recommend appliance repair / replacement as needed.

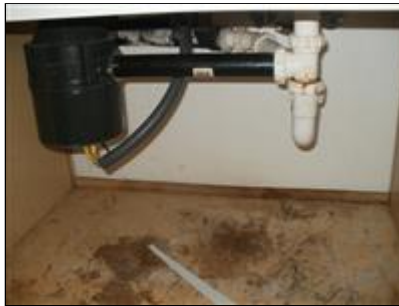
7.5 Picture 1

- Inoperable at time of Inspection. Recommend replacement.

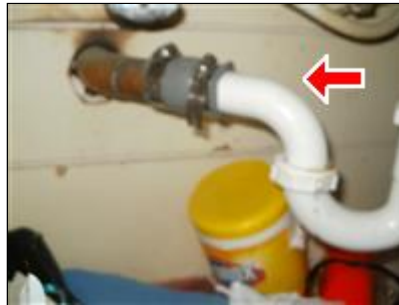
8.0 Picture 1 prior repair

- Defective / missing / poor seal at sink drainage stopper. Recommend plumbing repair.
- Prior repairs noted at the drain trap piping. Recommend repair.

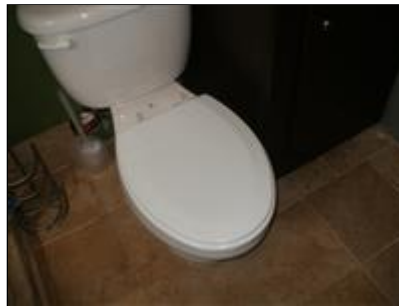
8.1 Picture 1

- Inadequate clearances for use. Recommend plumbing repairs as needed.

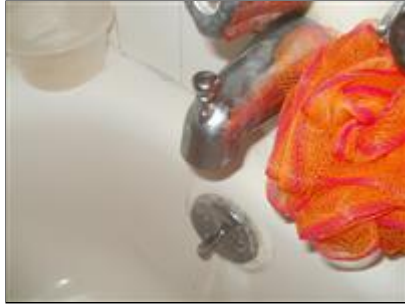
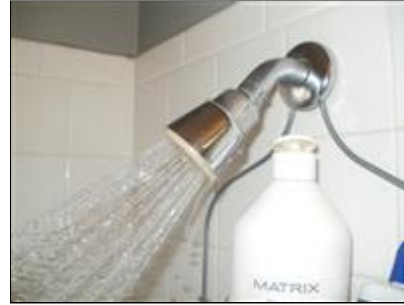
8.2 Picture 1

- Defective shower diverter at the tub spout. Recommend plumbing repair with replacement of the spout.

- Leakage at the shower head. Recommend plumbing repair.

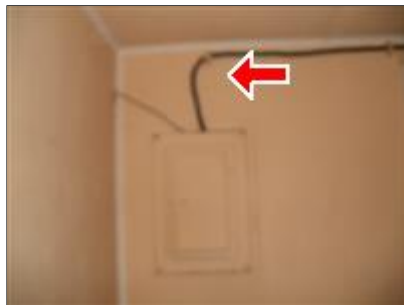
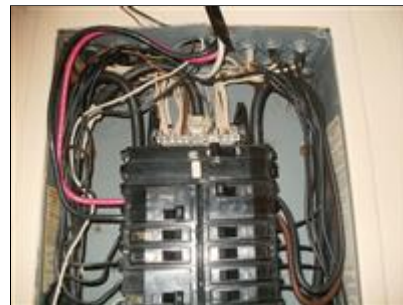
10.3 Picture 1

- The circuits in the distribution panel have not been completely labeled. Recommend identifying and labeling all circuits.
- Improper wiring at the main panel. Recommend electrical review and repair.

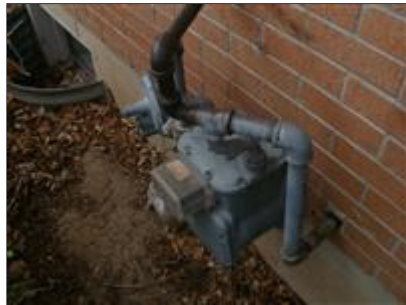
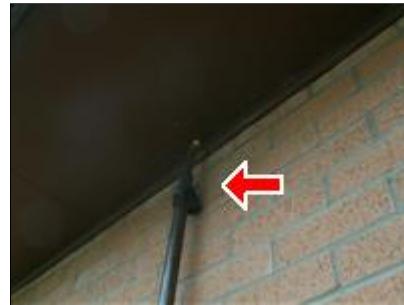
11.3 Picture 1

- Improper piping at the left side routed thru the roof soffit to the Kitchen Range. Recommend plumbing review and repair as needed.

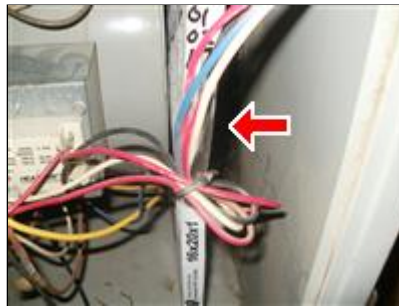
13.5 Picture 1 Damaged Filter

**13.5** Return Air Filter
 - Recommend replacement of the filter at this time and monthly thereafter.

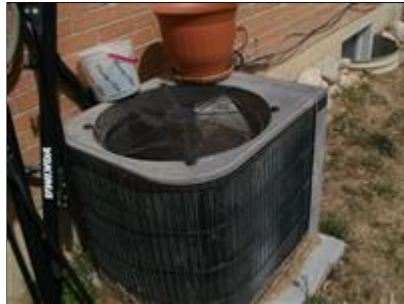
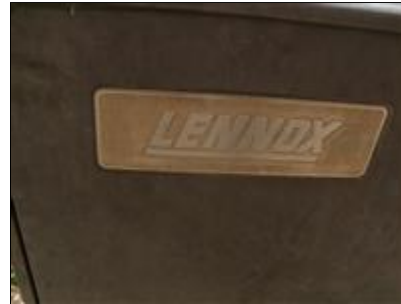
14. Cooling System

IN	RR	NI	NA	Styles & Materials
14.0	COOLING UNIT	X				System Type: Electric Central Air Conditioning
14.1	BLOWER / FAN	X				Estimated Age: 28 Years
14.2	CONDENSER / COMPRESSOR	X				Design Life: 10 to 15 Years
14.3	DUCT WORK	X				System Location: Exterior
14.4	CONDENSATE PROVISIONS	X				Basement
14.5	THERMOSTAT	X				General Distribution: Ducted W/ Registers Shared W/ Heating System
						Special limitations: Temperature Constraints
