# Inspection Report

**Property Address:**  
30-89 00 Street  
Anyplace NY 10000

INSPECT THIS, HOME INSPECTIONS LLC

<b>Date:</b> 7/16/2014	<b>Time:</b> 05:30 PM	<b>Report ID:</b> 234
<b>Property:</b> 30-89 00 Street Anyplace NY 10000	<b>Customer:</b> Mr. John Doe	<b>Real Estate Professional:</b> Mario Tsikis Citi Zone

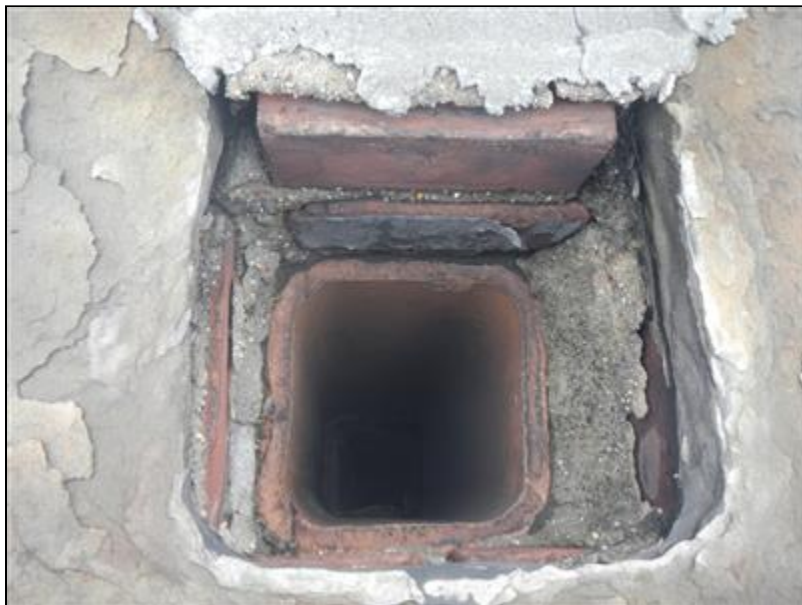
1.2 Picture 1 Ceramic Flue pipe for water heater is 6" too short.

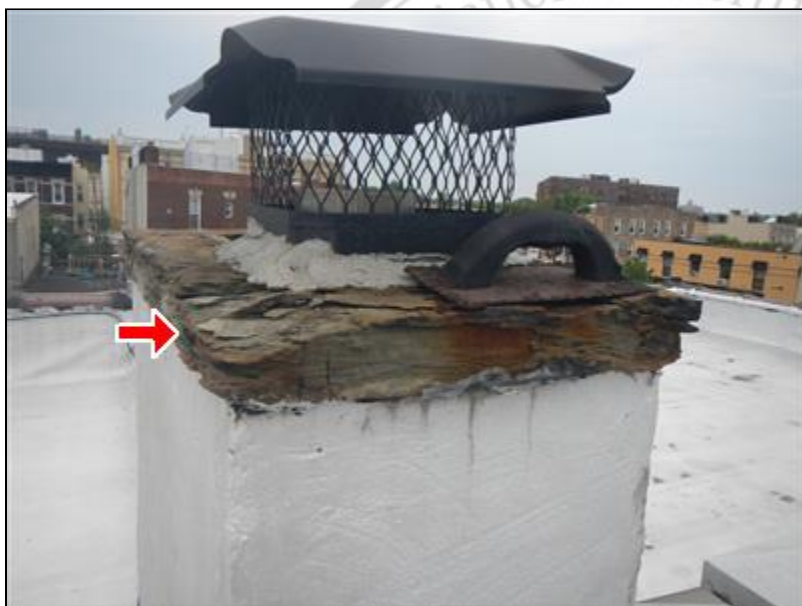
**Chimney blue stone cap is badly deteriorated.**

1.2 Picture 2 Chimney blue stone cap is badly deteriorated

**Recommend evaluation and repair by a licensed mason contractor.**

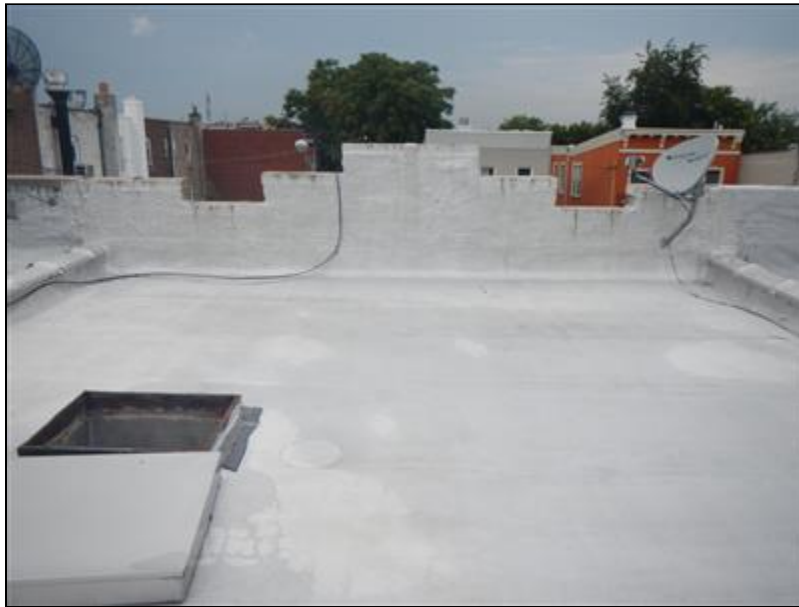
**This roof is not ventilated, Recommend installation of vents to eliminate humidity and keep attic cool by a licensed roofing contractor.**

1.3 Picture 1 Roof View toward front, no vents visible

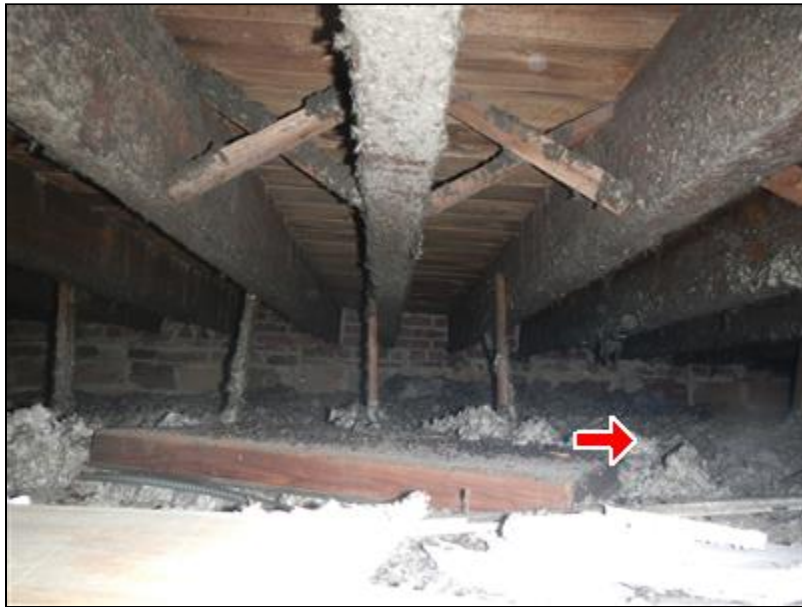
1.7 Picture 1 blown in insulation

**Attic has blown in insulation**

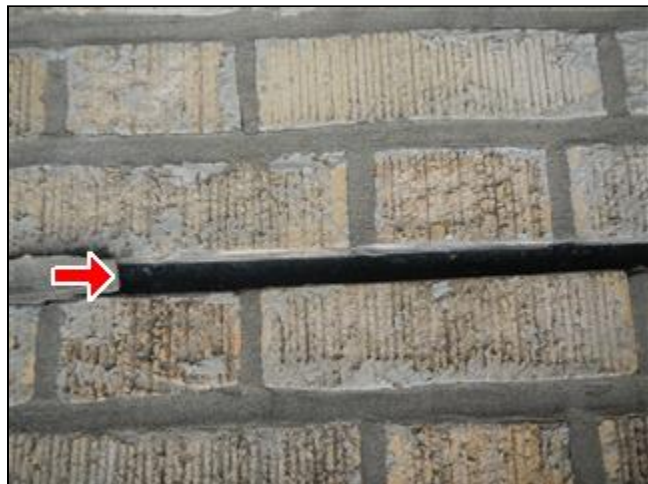
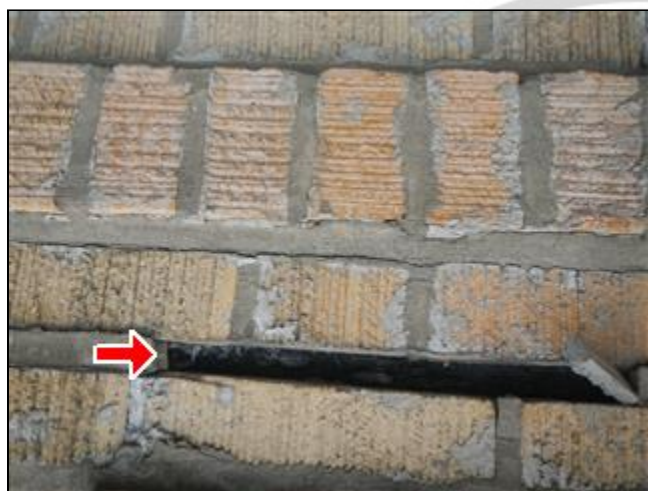
**Front Parapet Wall mortar joints loose and falling out. Recommend evaluation and repair by a licensed mason contractor.**

2.0 Picture 1 Front Parapet Wall mortar joints loose and falling out

2.0 Picture 2 Front Parapet Wall mortar joints loose and falling out

2.0 Picture 3 Front Parapet Wall mortar joints loose and falling out

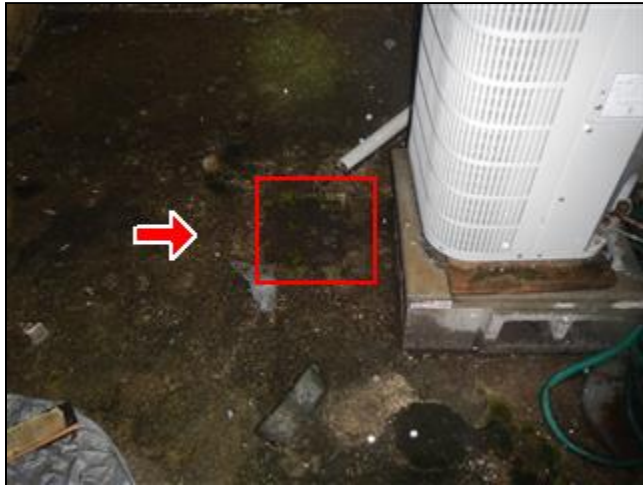
**Drain clogged in mini court yard. 4" of water built up during rain. Recommend evaluation and repair by a licensed plumbing contractor.**

2.3 Picture 1 Drain clogged in mini court yard

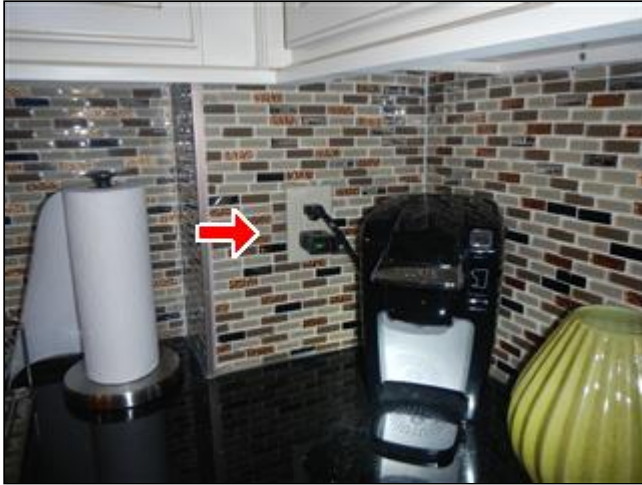
**Outlet to right of sink open ground. Recommend evaluation and repair by a licensed electrical contractor.**

3.8.A Picture 1 Outlet to right of sink open ground

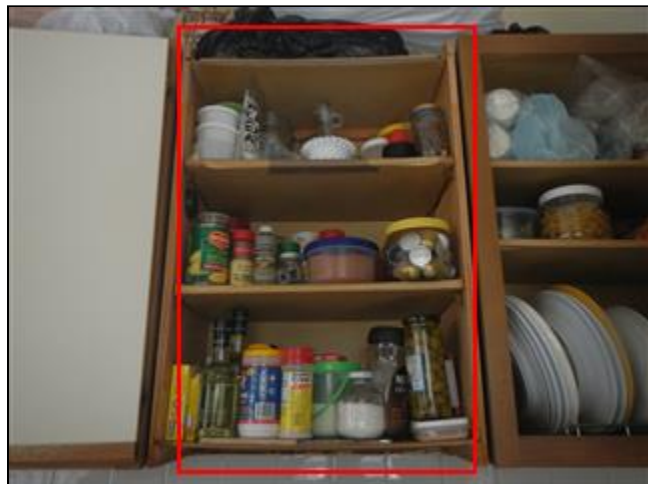
**Base cabinet left side of sink missing draw and door.**

3.4.B Picture 1 Wall cabinet over sink style and door not attached

**Recommend evaluation and repair by a licensed finish carpenter contractor.**

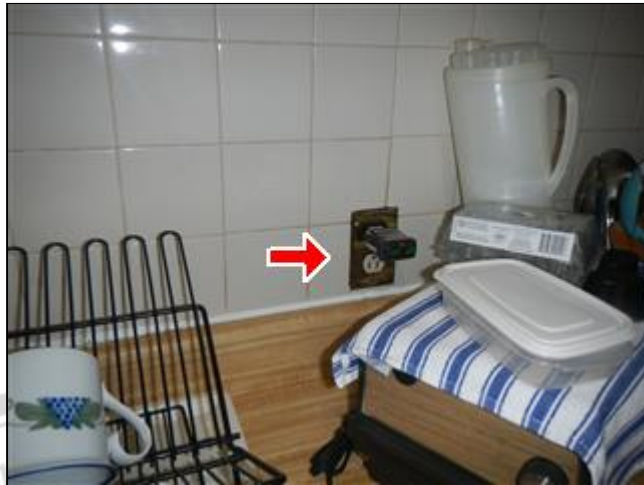
**Outlet to right of sink open ground and not GFCI protected. Recommend evaluation and repair by a licensed electrical contractor.**

3.7.B Picture 1 Outlet to right of sink open ground and not GFCI protected

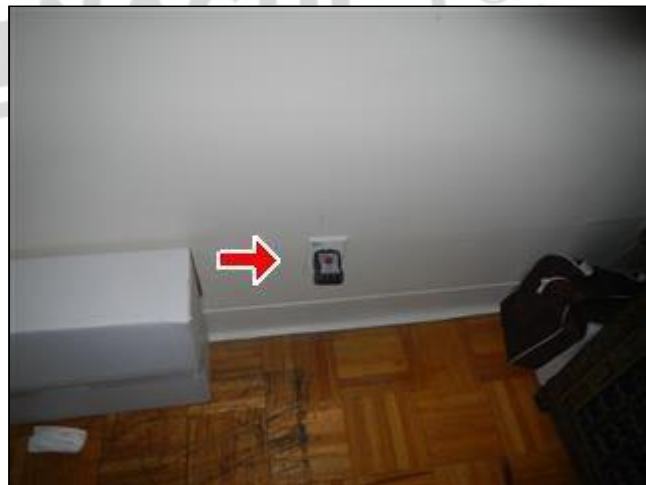
**Outlet open ground on right side. Recommend evaluation and repair by a licensed electrical contractor.**

4.6.A Picture 1 Outlet open ground on right side

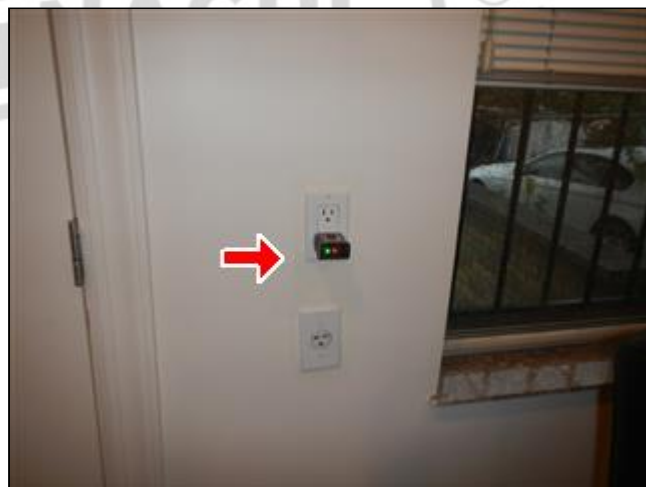
**Outlet on rear wall first floor dining room has open ground. Recommend evaluation and repair by a licensed electrical contractor.**

4.6.C Picture 1 Outlet on rear wall first floor dining room has open ground

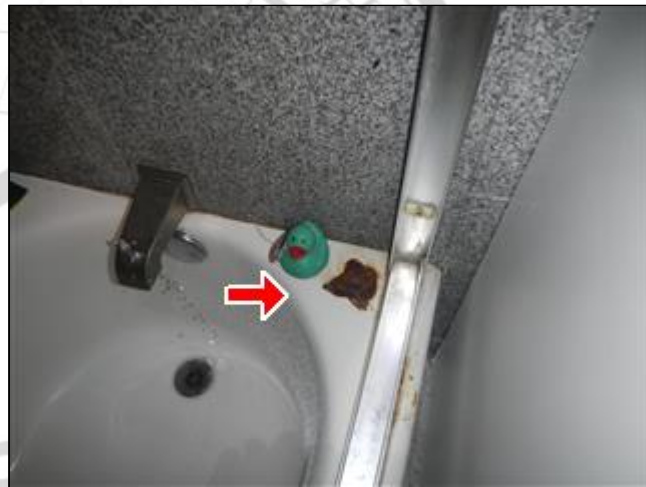
**Large rusted porcelain chip on bathtub flange. Recommend evaluation and repair by a licensed tub refinishing contractor.**

5.4.A Picture 1 Large rusted porcelain chip on bathtub flange

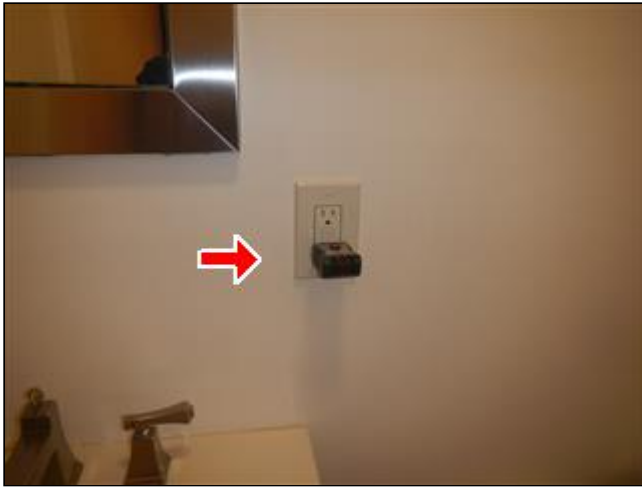
**Outlet is mis-wired, no current. Recommend evaluation and repair by a licensed electrical contractor.**

5.5.B Picture 1 Outlet has no current

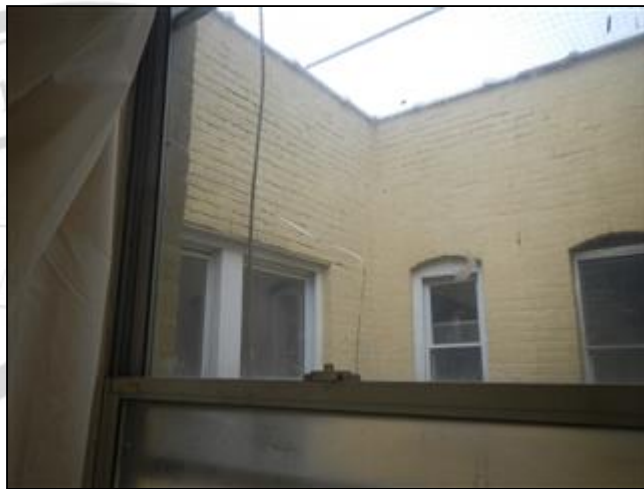
**Window won't stay up or lock.  
Recommend evaluation and repair  
by a licensed window contractor.**

5.2.C Picture 1 Window won't stay up or lock

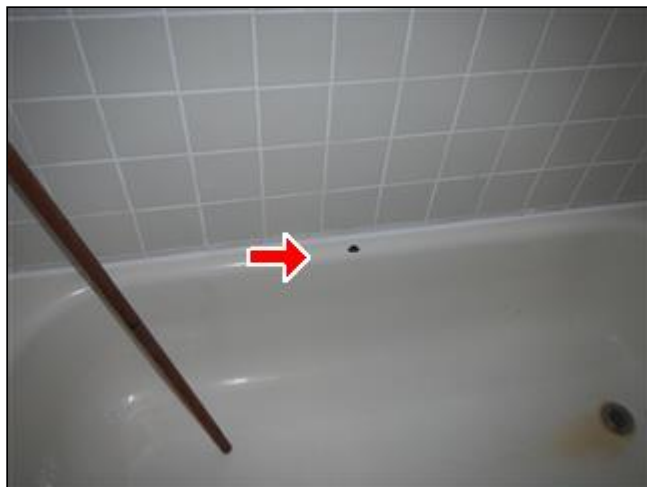
5.4.C Picture 1 Bathtub chipped

**Recommend evaluation and repair  
by a licensed plumbing contractor**

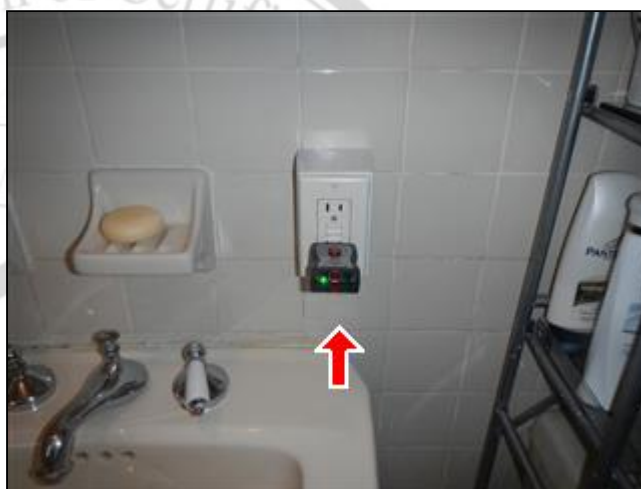
**GFCI outlet inoperable, open ground. Recommend evaluation and repair by a licensed electrical contractor**

5.5.C Picture 1 GFCI outlet inoperable, open ground

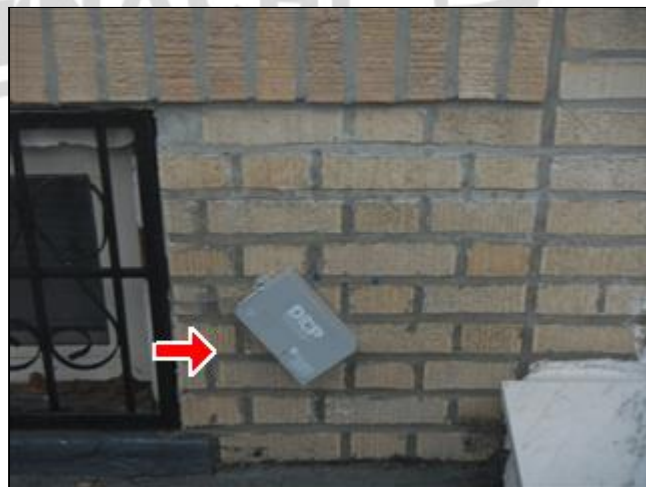
**Remote water meter hanging off front wall. Recommend evaluation and repair by a licensed electrical contractor..**

7.1 Picture 1 Remote water meter hanging off front wall

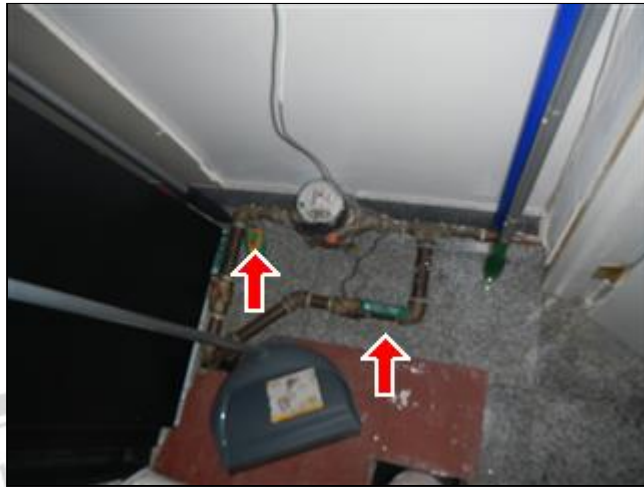
In basement left side front wall closet.

7.3 Picture 1 Main water shut off valve

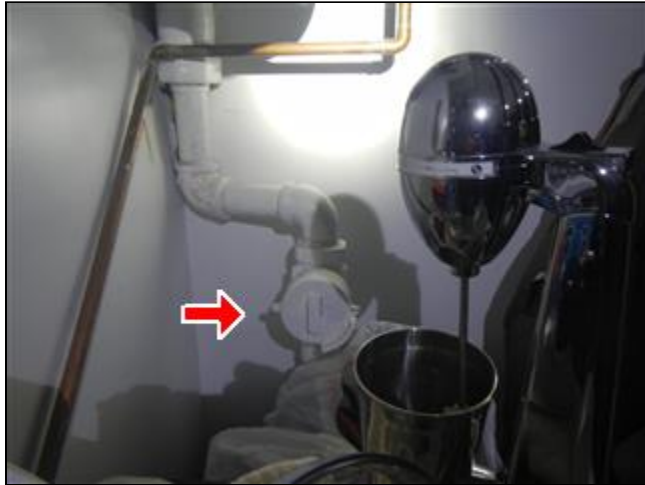
7.5 Picture 1 Main Gas Shut Off Valve

In basement front wall in center closet

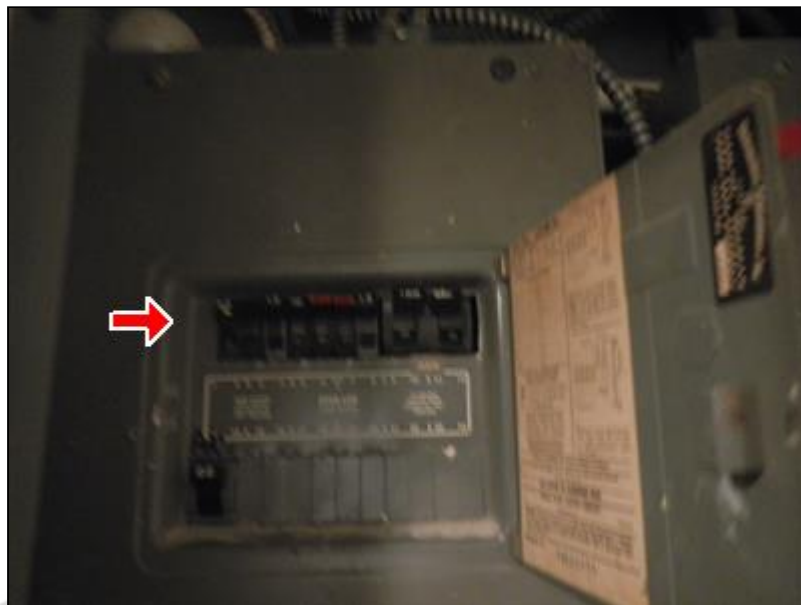
Federal Pacific Electric "Stab-Lok®" service panels and breakers are a latent hazard and FPE circuit breakers can fail to trip in response to overcurrent, leading to electrical fires. The breakers may also fail to shut off internally even if the toggle is switched to "off." Some double-pole (240-Volt) FPE circuit breakers and single-pole FPE Stab-Lok® circuit breakers simply do not work safely.

8.1 Picture 1 Federal Pacific Sub Panel

There are other FPE panel-defects independent of the breaker problems, panel and panel-bus fires and arcing failures in some equipment. The failure rates for these circuit breakers were and still are significant. In some cases failure to trip occurs 60% of the time - a serious fire and electrical shock hazard. Failures are documented in the CPSC study and by independent research. Additional independent testing and research are on-going and are reported here. FPE Stab-Lok® electrical panels should be replaced. Do not simply swap in some replacement breakers. (Details are at FPE REPLACEMENT BREAKERS).

Recommend remove and replace by a licensed electrical contractor.

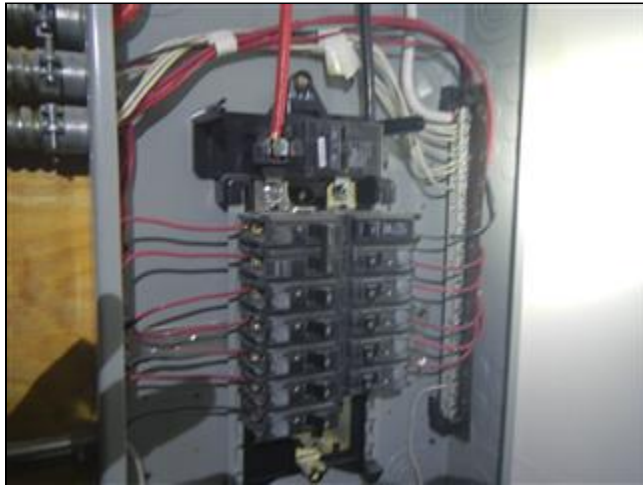
8.6 Picture 1 First Floor Sub Panel

In basement, left front corner

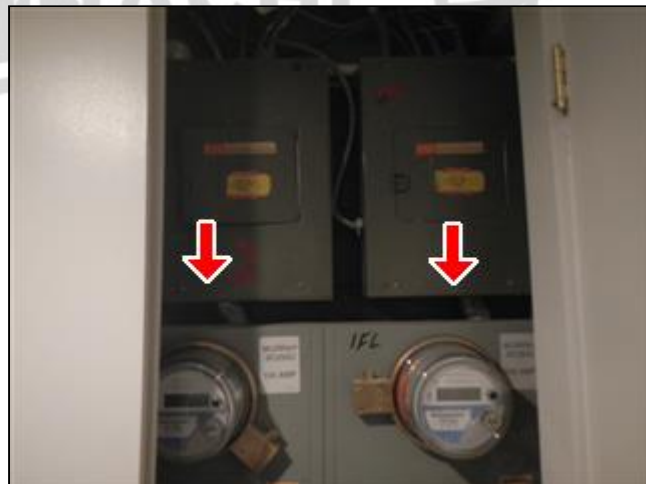
8.7 Picture 1 Electric meters

In basement, left front corner

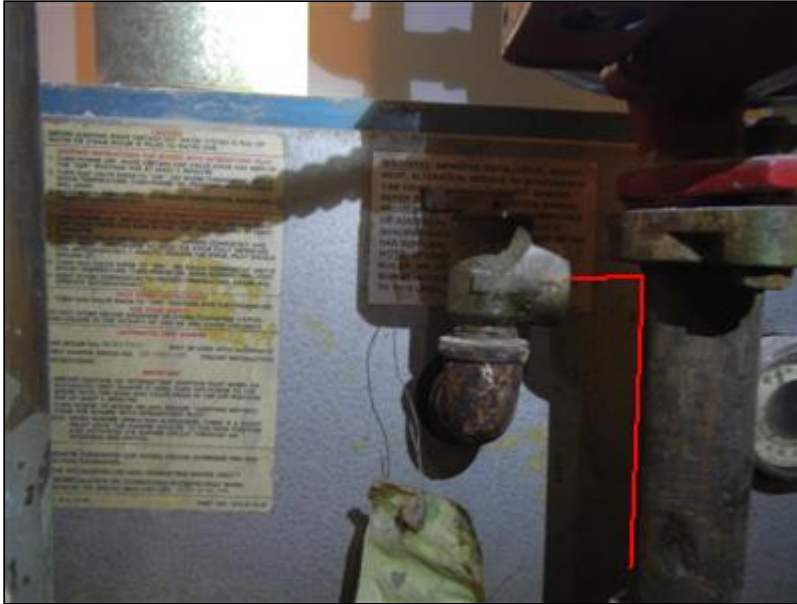
**TPR pipe extension and elbow not installed. Recommend evaluation and repair by a licensed plumbing contractor.**

9.2 Picture 1 TPR pipe extension and elbow not installed

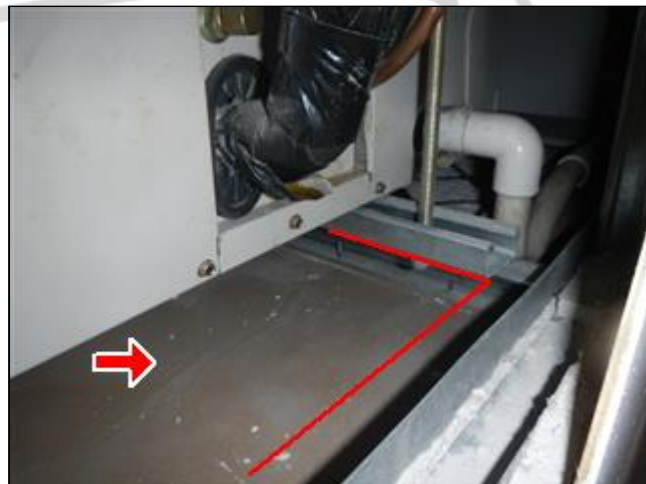
9.8 Picture 1 No condensate drip pan present under air handler

**Recommend installation of drip pan with automatic shut off switch. Evaluation and repair by a licensed HAVAC contractor**

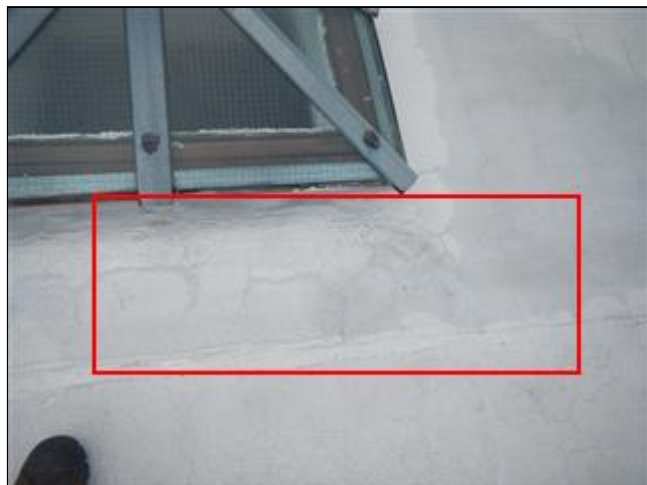
1.0 Picture 1 Water bubble under roof covering at rear corner of sky light

**Water bubble under roof covering at rear corner of sky light and at left rear corner of roof. Recommend evaluation and repair by a licensed roofing contractor.**

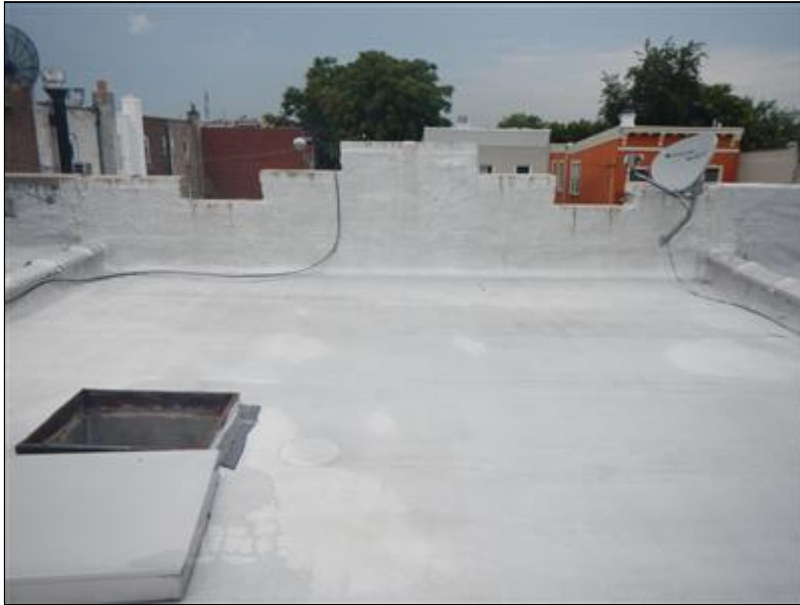
1.3 Picture 1 Roof View toward front, no vents visible

**This roof is not ventilated, Recommend installation of vents to eliminate humidity and keep attic cool by a licensed roofing contractor.**

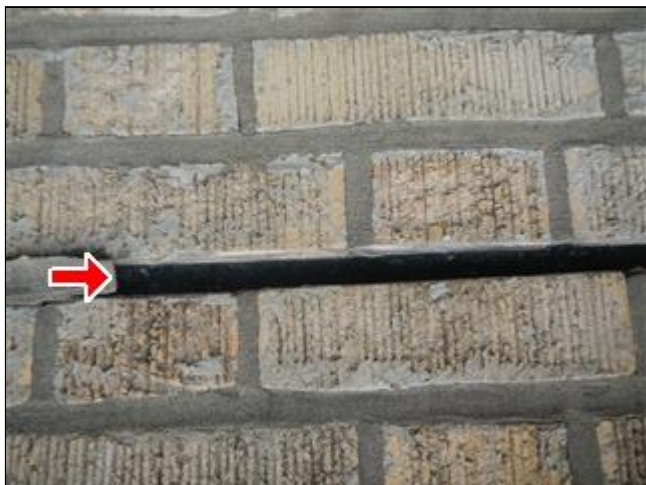
2.0 Picture 1 Front Parapet Wall mortar joints loose and falling out

**Front Parapet Wall mortar joints loose and falling out. Recommend evaluation and repair by a licensed mason contractor.**

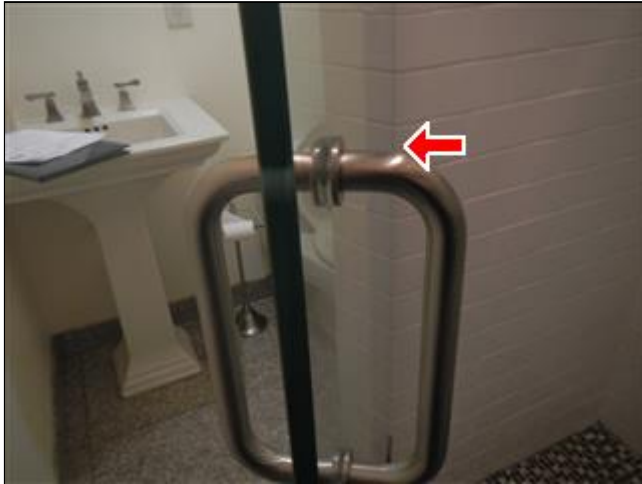
**Door handle loose to glass shower door. Recommend evaluation and repair by a qualified handy-man**

5.4.B Picture 1 Door handle loose to glass shower door

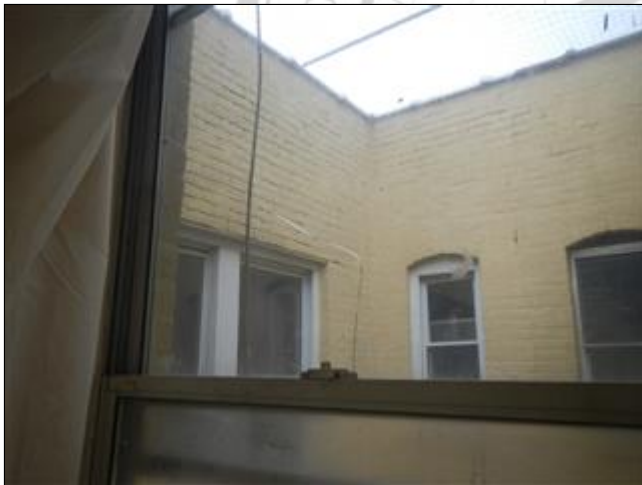
**Window won't stay up or lock. Recommend evaluation and repair by a licensed window contractor.**

5.2.C Picture 1 Window won't stay up or lock

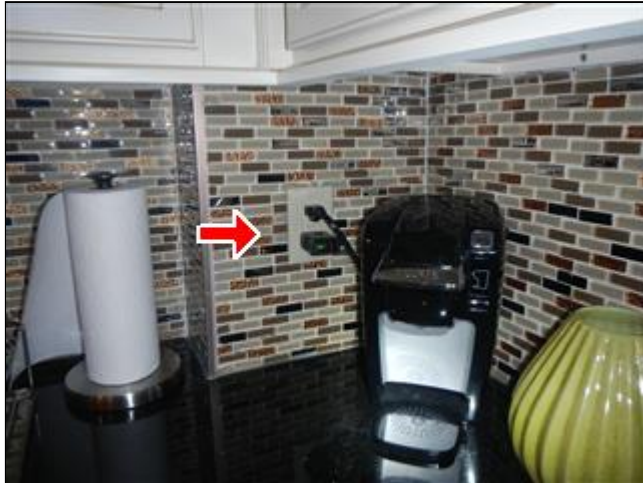
**Outlet to right of sink open ground. Recommend evaluation and repair by a licensed electrical contractor.**

3.8.A Picture 1 Outlet to right of sink open ground

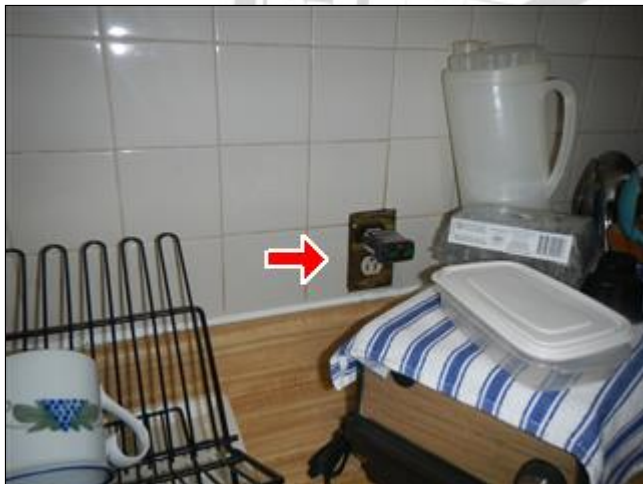
**Outlet to right of sink open ground and not GFCI protected. Recommend evaluation and repair by a licensed electrical contractor.**

3.7.B Picture 1 Outlet to right of sink open ground and not GFCI protected

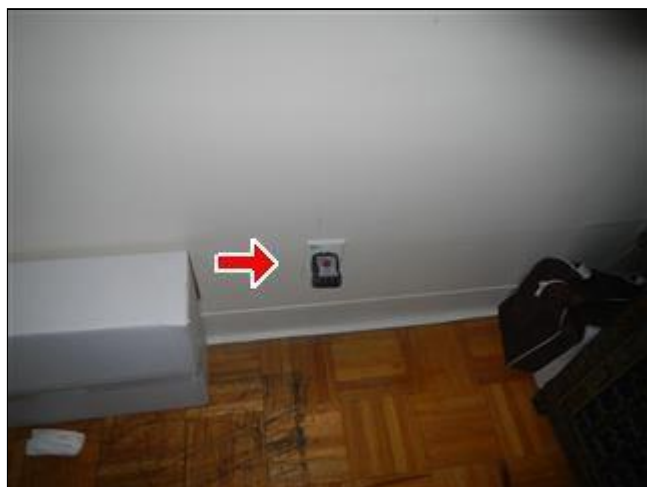
**Outlet open ground on right side. Recommend evaluation and repair by a licensed electrical contractor.**

4.6.A Picture 1 Outlet open ground on right side

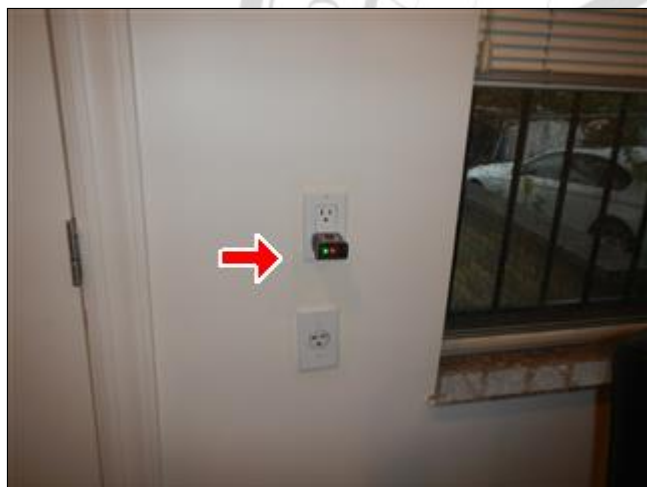
**Outlet on rear wall first floor dining room has open ground. Recommend evaluation and repair by a licensed electrical contractor.**

4.6.C Picture 1 Outlet on rear wall first floor dining room has open ground

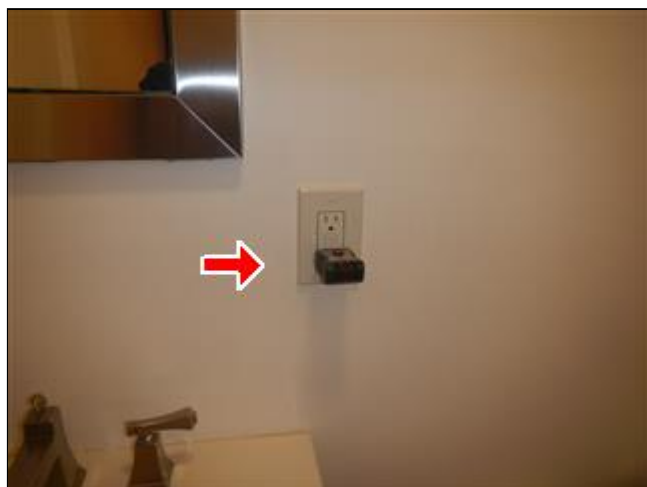
**Outlet is mis-wired, no current. Recommend evaluation and repair by a licensed electrical contractor.**

5.5.B Picture 1 Outlet has no current

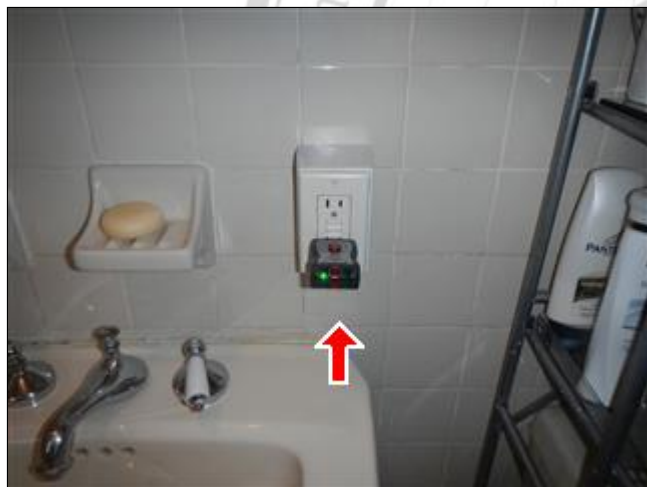
**GFCI outlet inoperable, open ground. Recommend evaluation and repair by a licensed electrical contractor**

5.5.C Picture 1 GFCI outlet inoperable, open ground

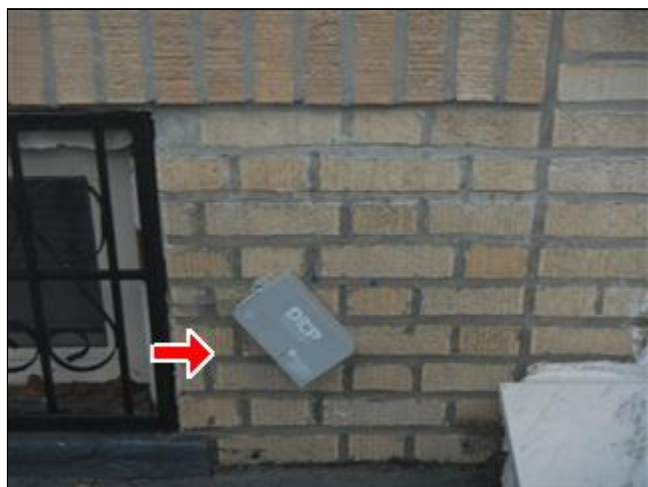
**Remote water meter hanging off front wall. Recommend evaluation and repair by a licensed electrical contractor..**

7.1 Picture 1 Remote water meter hanging off front wall

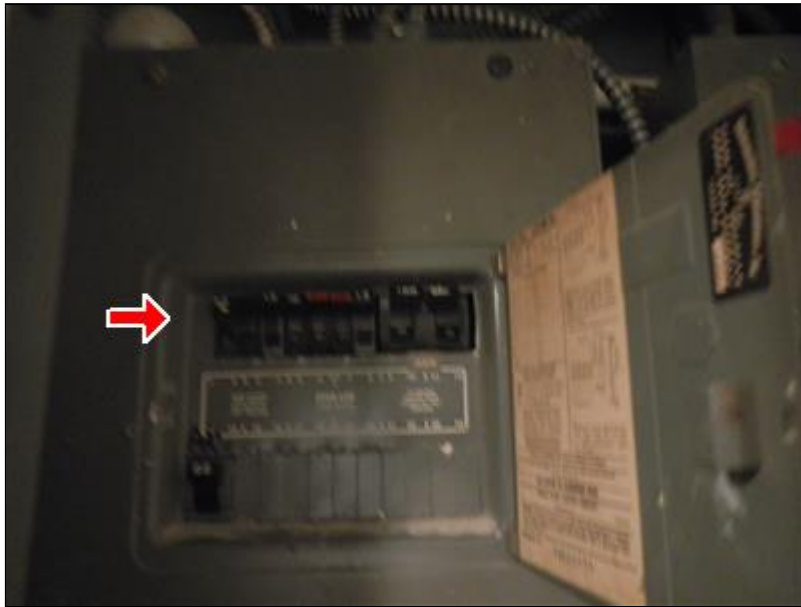
Federal Pacific Electric "Stab-Lok®" service panels and breakers are a latent hazard and FPE circuit breakers can fail to trip in response to overcurrent, leading to electrical fires. The breakers may also fail to shut off internally even if the toggle is switched to "off." Some double-pole (240-Volt) FPE circuit breakers and single-pole FPE Stab-Lok® circuit breakers simply do not work safely.

There are other FPE panel-defects independent of the breaker problems, panel and panel-bus fires and arcing failures in some equipment. The failure rates for these circuit breakers were and still are significant. In some cases failure to trip occurs 60% of the time - a serious fire and electrical shock hazard. Failures are documented in the CPSC study and by independent research. Additional independent testing and research are on-going and are reported here. FPE Stab-Lok® electrical panels should be replaced. Do not simply swap in some replacement breakers. (Details are at FPE REPLACEMENT BREAKERS).

8.1 Picture 1 Federal Pacific Sub Panel

**Recommend remove and replace by a licensed electrical contractor.**

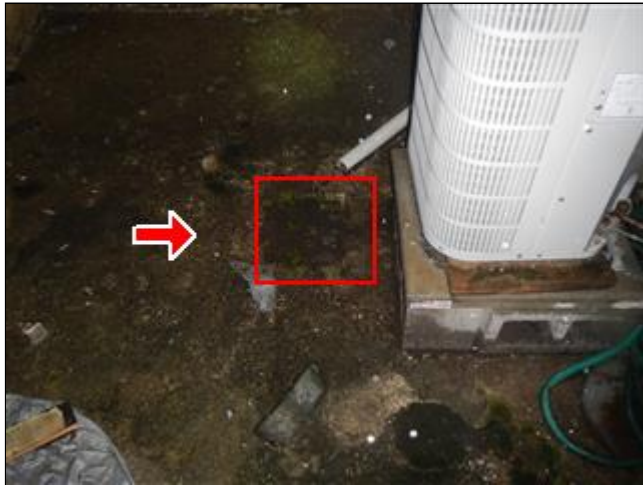
**Drain clogged in mini court yard. 4" of water built up during rain. Recommend evaluation and repair by a licensed plumbing contractor.**

2.3 Picture 1 Drain clogged in mini court yard

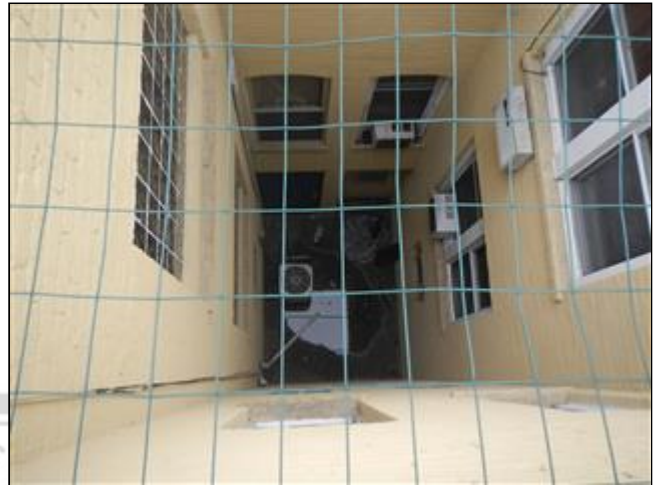
2.3 Picture 2 View of Mini Courtyard from roof.

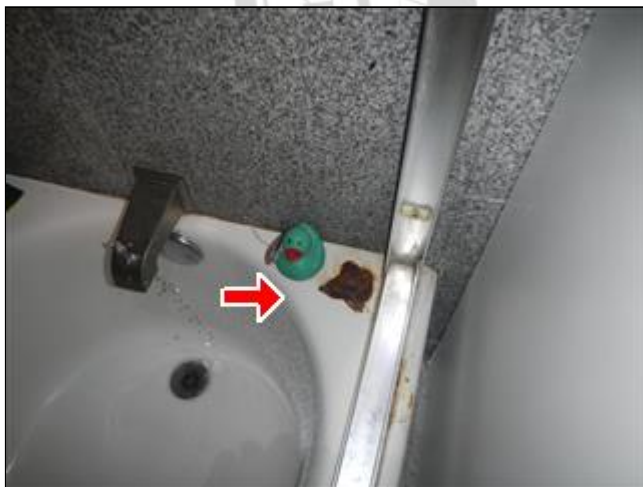
**Large rusted porcelain chip on bathtub flange. Recommend evaluation and repair by a licensed tub refinishing contractor.**

5.4.A Picture 1 Large rusted porcelain chip on bathtub flange

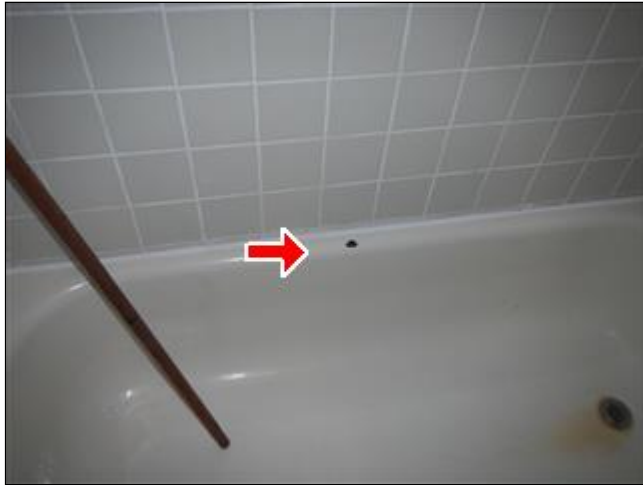
**Bathtub chipped and stopper inoperable.**

5.4.C Picture 1 Bathtub chipped

**Recommend evaluation and repair by a licensed plumbing contractor**

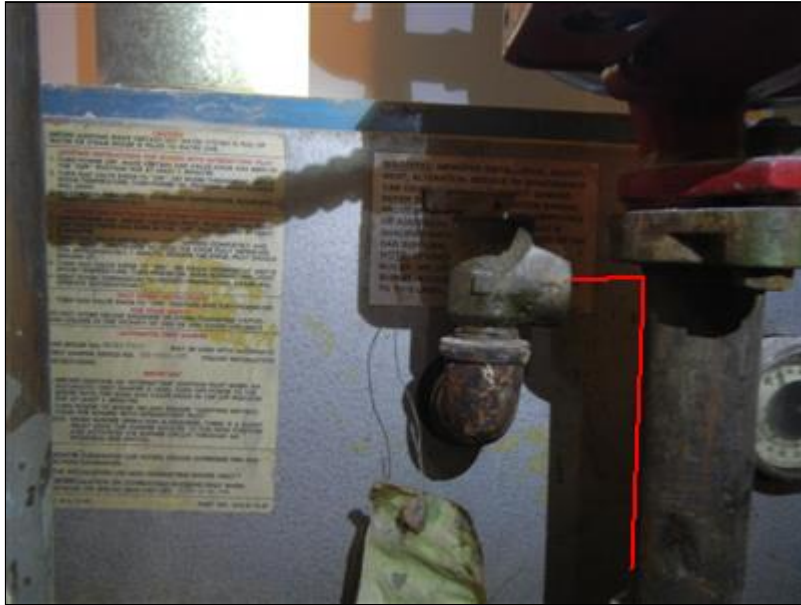
**TPR pipe extension and elbow not installed. Recommend evaluation and repair by a licensed plumbing contractor.**

9.2 Picture 1 TPR pipe extension and elbow not installed

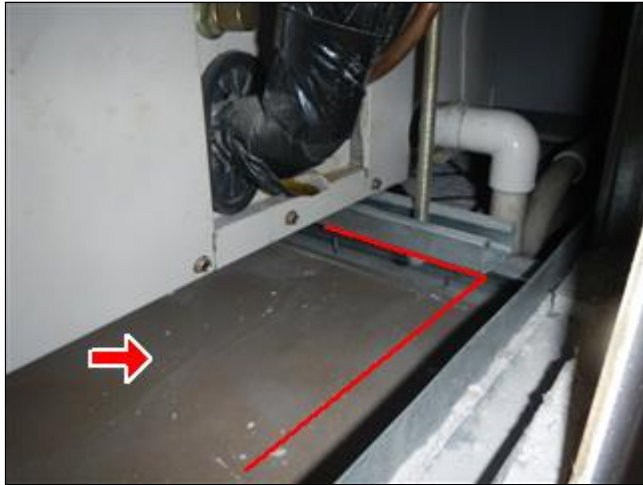
No condensate drip pan present under air handler.

9.8 Picture 1 No condensate drip pan present under air handler

Recommend installation of drip pan with automatic shut off switch. Evaluation and repair by a licensed HAVAC contractor
