A Accredited Inspection Service, Inc.
6742 Forest Hill Blvd # 271, West Palm Beach,, FL 33413
561-966-8868
Copyright 2004 2005
All Rights Reserved

Client: Anna Morph
Property Address: Ascospore # 8, Mycology FL 01010
Date: 6-16-06

INSPECTORS FINAL CONCLUSIONS

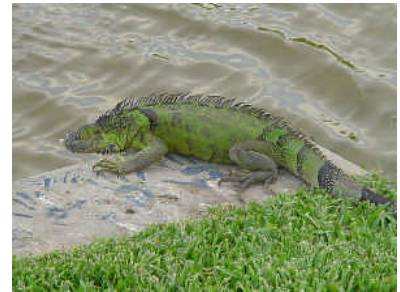
PHOTO

Serious mold problems should come as no surprise in a climate where escaped 3 foot long iguana lizards reside in the rear yard.
