Property Inspection Report

10812 Collington Dr, Midlothian, Va, 23112

April 9, 2019

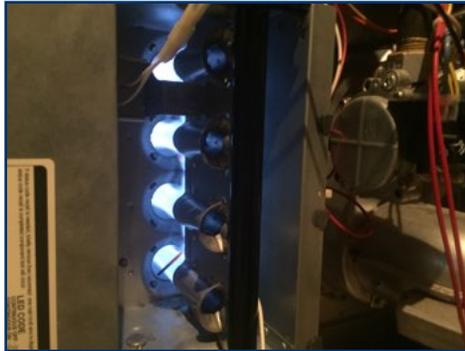
1.1. The heating system was operational at the time of inspection. General maintenance and service will prolong the life of the unit.

1.2. The heating system is old and regular cleaning and maintenance will prolong the life of the unit. It is approaching the average life expectancy and repairs or replacement may be needed in the near future.

Steady blue flame observed at furnace

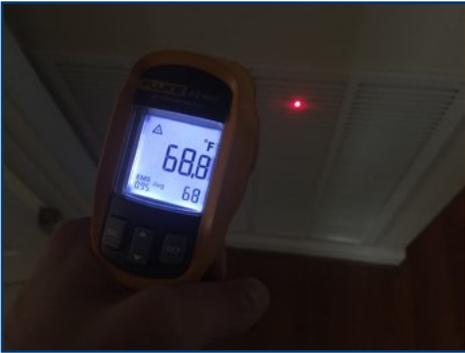
Return air temperature (68.8)

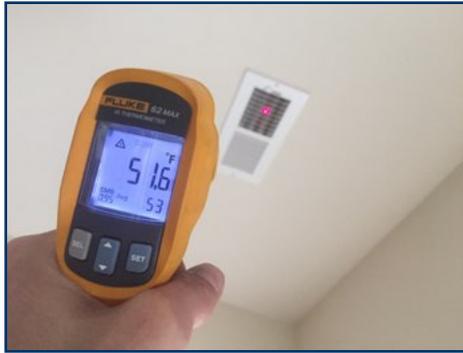
Supply air temperature (51.6)

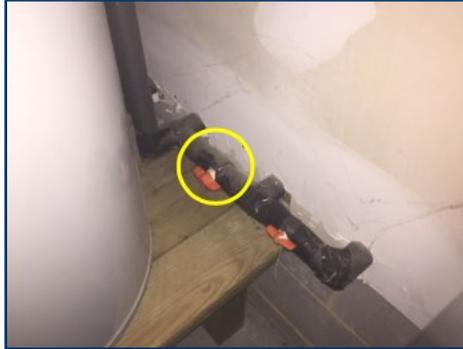
This is the main water shut off valve in the garage

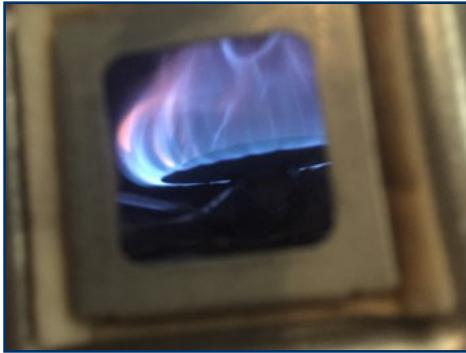
3.1. The typical life span of a water heater is 7-12 years. Given the age of your water heater, repairs, or replacement may be needed in the near future. I recommend planning and budgeting for the replacement of the water heater.

3.2. Knocking sounds were heard when the water heater was operating. This is often the result of sediment build up at the bottom of the tank. I recommend having a qualified plumber service the water heater as needed.

Steady blue flame observed at water heater

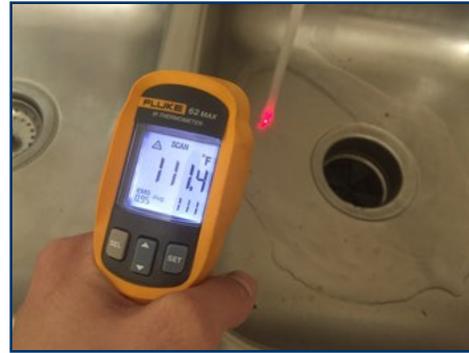
Hot water temperature (111.4)

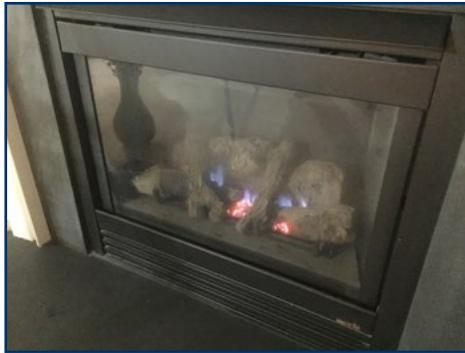
7.1. The gas fireplace functioned at the time of inspection.

7.2. A noticeable fogginess was observed at the glass at the fireplace. You may wish to have this corrected.

Fireplace Functioning

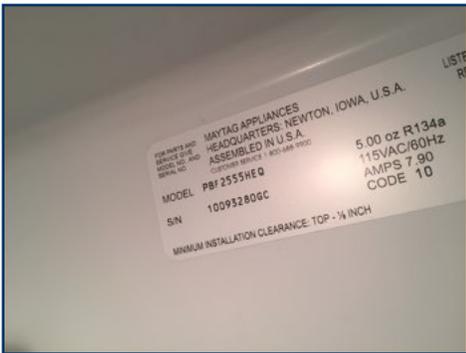
Refrigerator

8.3. The refrigerator door seal was not sealing tightly and condensation was observed in the refrigerator. You may wish to have this repaired.

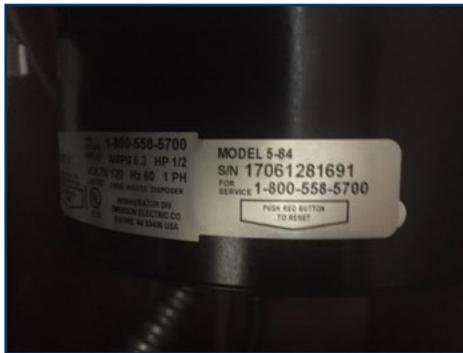
Disposal

8.4. When the disposal was in operation, water backed up into the adjacent sink. I recommend repair by a qualified plumber. (\$150+)
