PEACH Inspections

THE HOME INSPECTION REPORT

07040304B - Mr. & Mrs. Client

Lafayette Hill, PA 19444 .

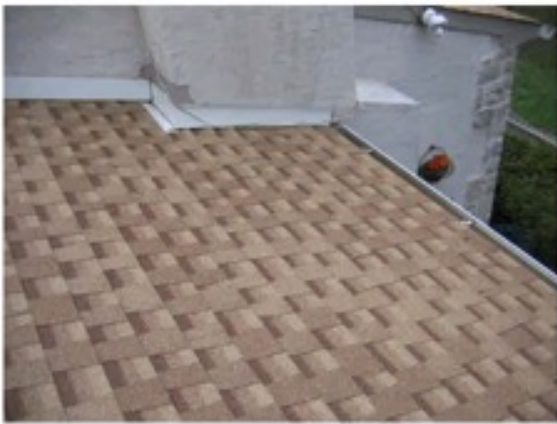
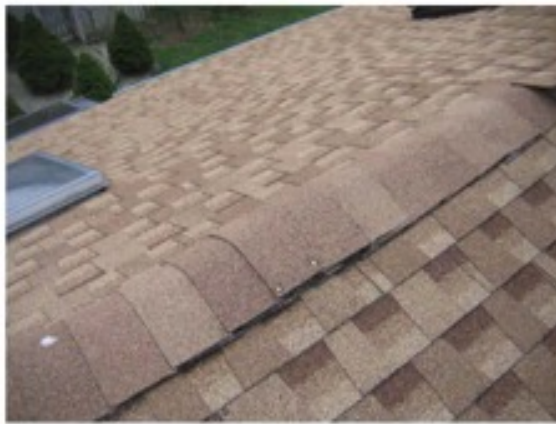
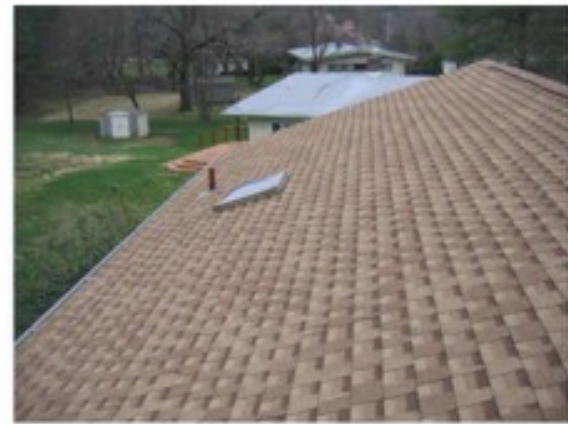
The asphalt shingle roof covering appears to be in good, functional condition. No major material defects. No major cracked, damaged, or missing shingles. Good. But this is not a guarantee against leaks in the future.

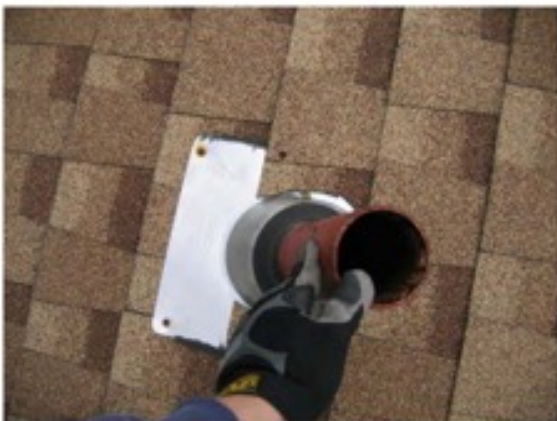
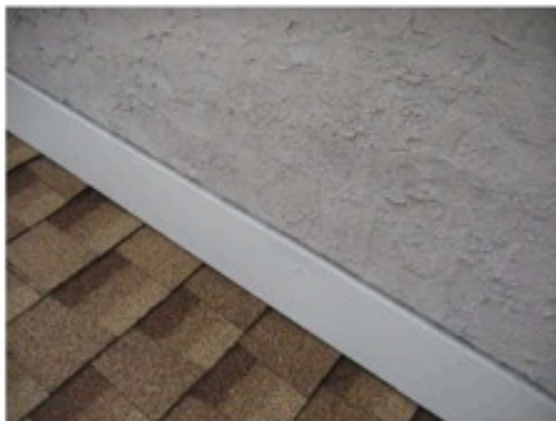
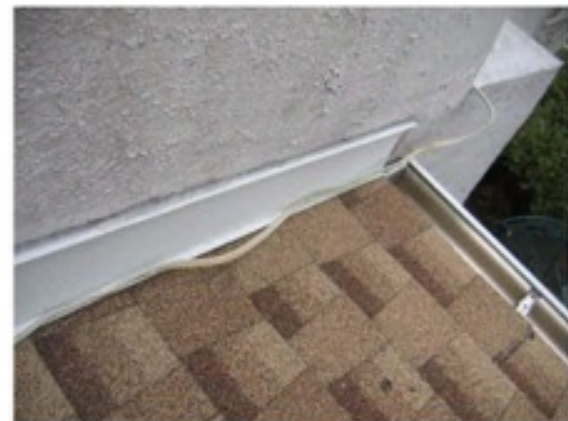
The flashing around the vent stacks coming through the roof appear to be in good condition. Good.

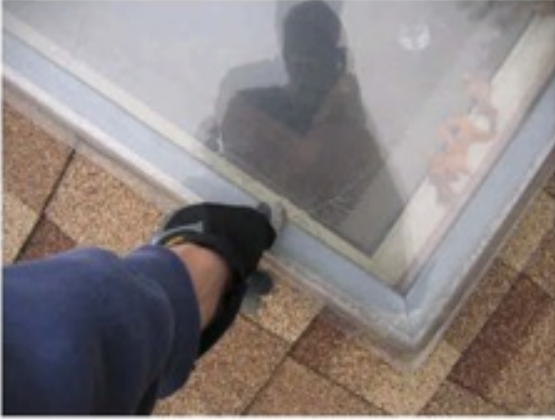
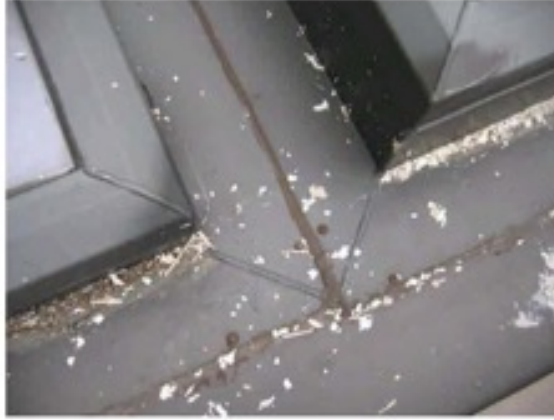
The roof has six skylights. Skylights are notoriously problematic and a common point of leaks. The skylights appear to be in good shape. However, it will be important to keep the area around them clean and to monitor them for evidence of leaks during heavy rains and winter snow melts.

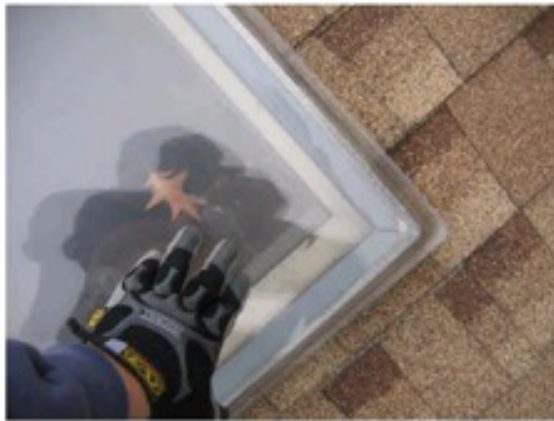
Each of the two skylight windowpanes appears to have numerous cracks in the inner window pane. The outer plastic bubble pane seems intact.

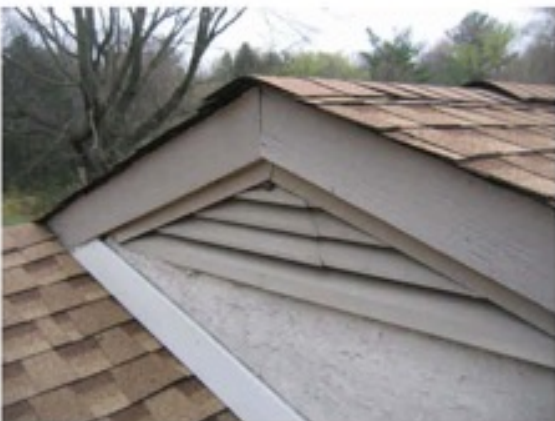
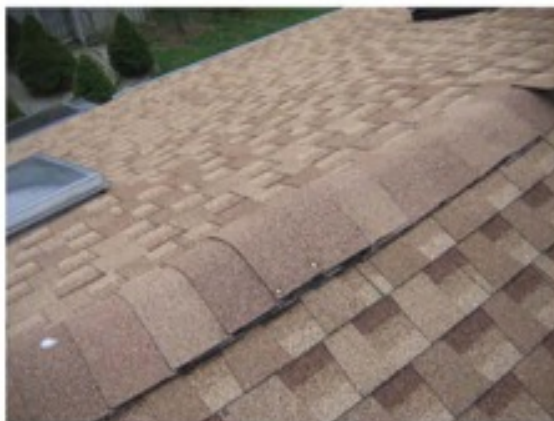
There is a ridge vent installed on the top of the roof.

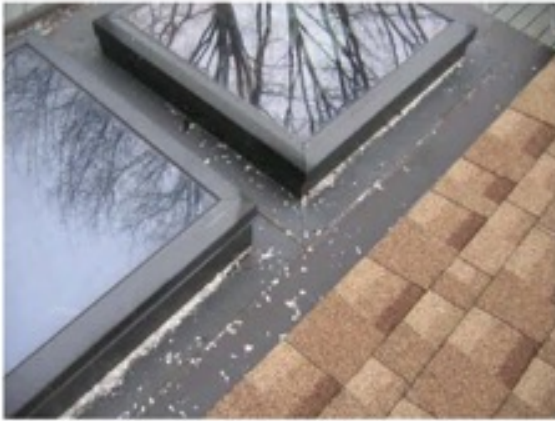
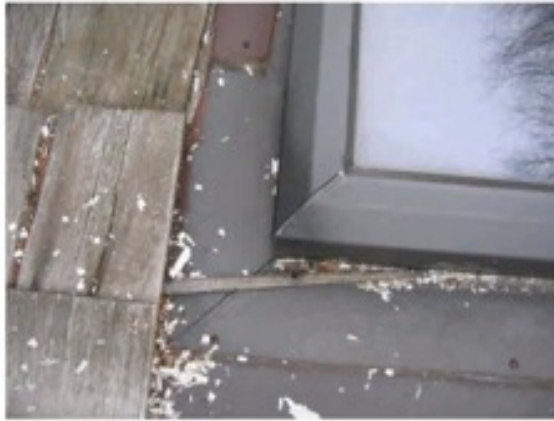
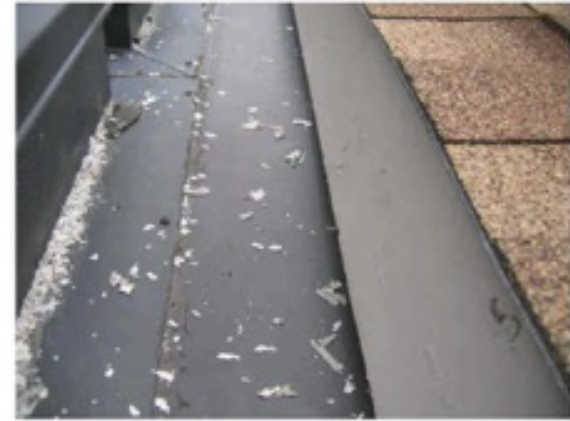
The small metal roof in the rear appears functional, but this is not a guarantee against leaks.

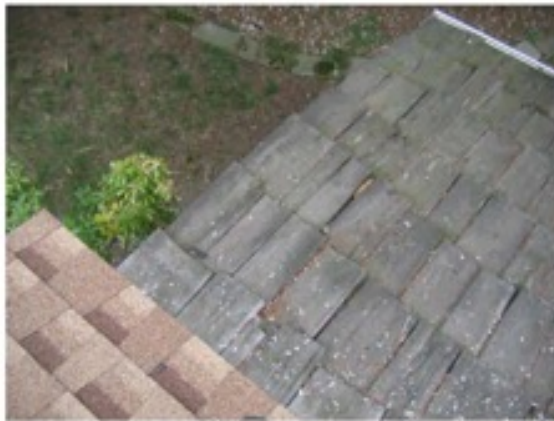
The wooden cedar shingle material on the rear small roof appears to be in old, poor condition. The shingles appear weathered. This is not a guarantee against future leaks.

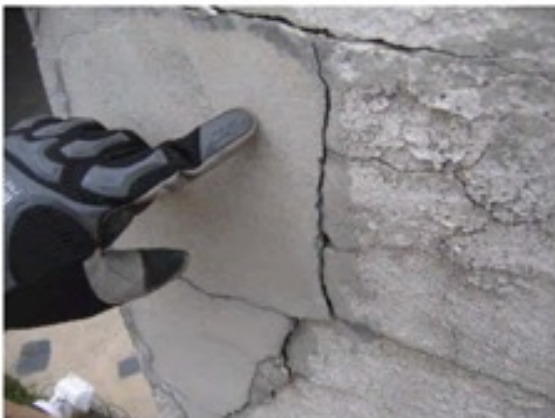
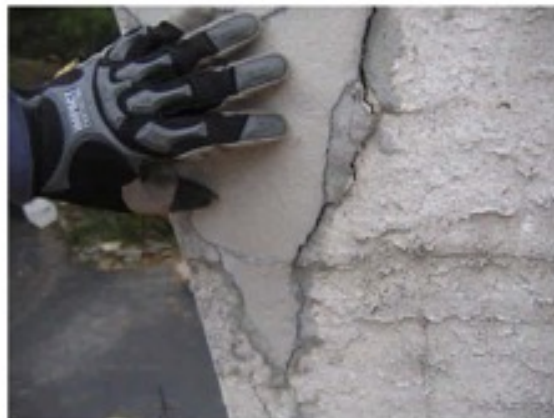
The chimney cement exterior is cracked. Loose sections. Open cracks.

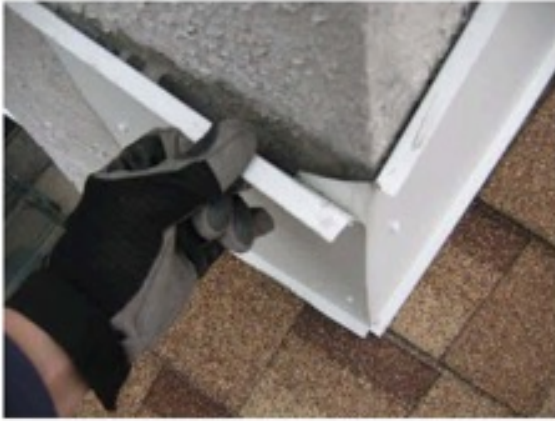
An open gap at the flashing - prone to water penetration. Missing sealant.

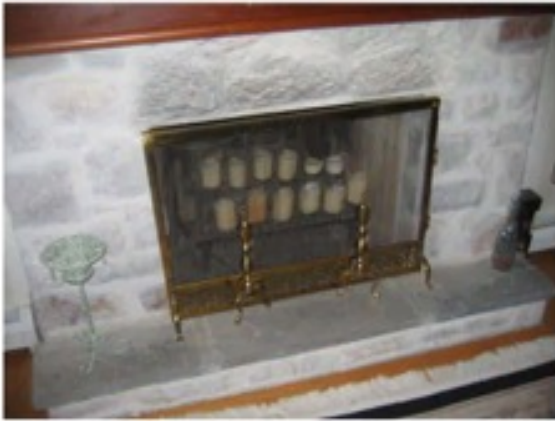
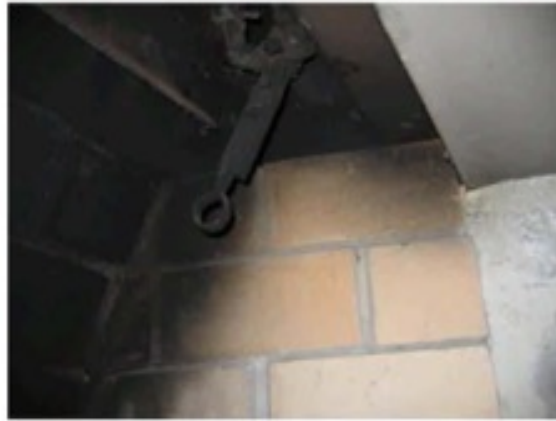
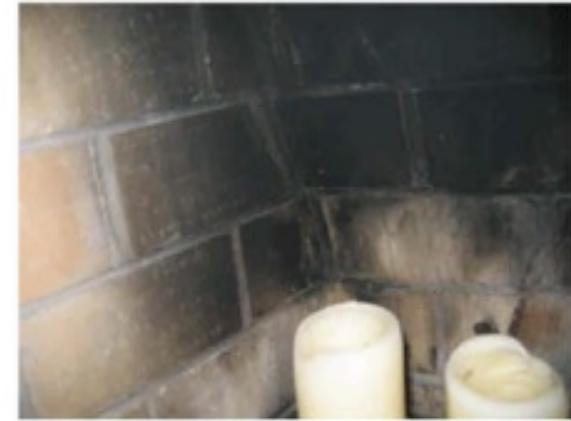
The fireplace interior appears to be in functional condition. Major material defects are not apparent to me. But I'm not a certified chimney sweep. Consider having the chimney inspected by a professional.

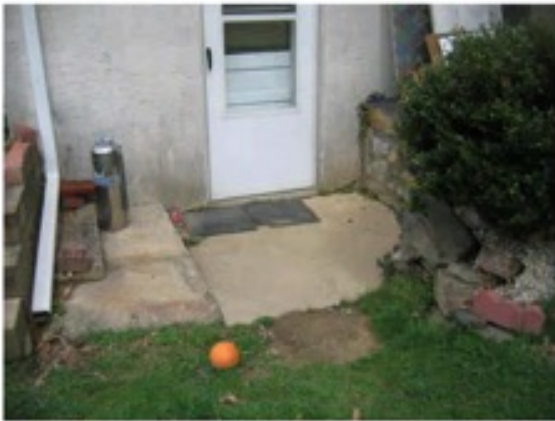
There is a low spot in the ground surface near the rear basement door. A low lying area could allow water to collect near the house foundation during a heavy rain storm. Prone to water penetration.

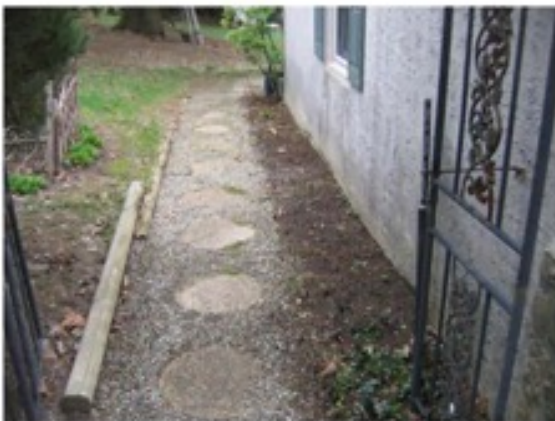
Grading and drainage is either negative or neutral adjacent to the structure's foundation, and may cause moisture or water penetration. Ideally the grading and hard surfaces should slope about 6 inches over the first 10 feet away from the house foundation. Left-side of house, and around attached shed.

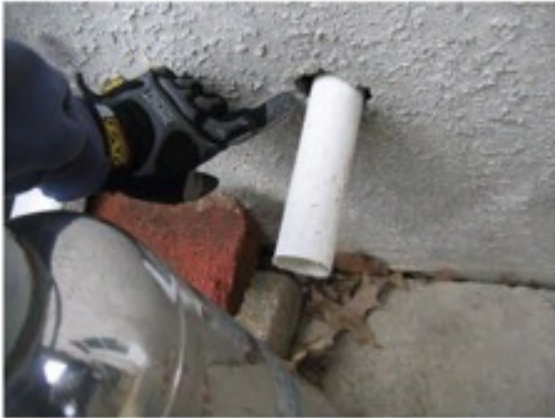
Sealant needed around the sump pipe as it passes through the siding - minor.

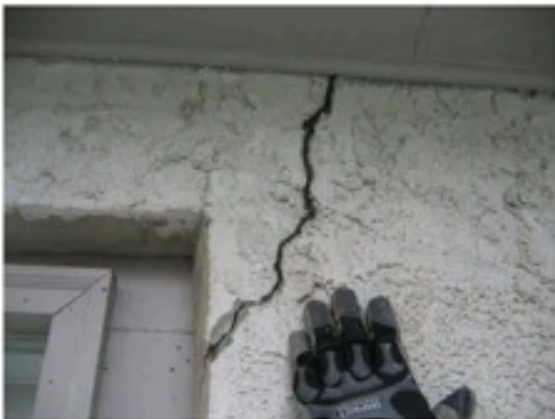
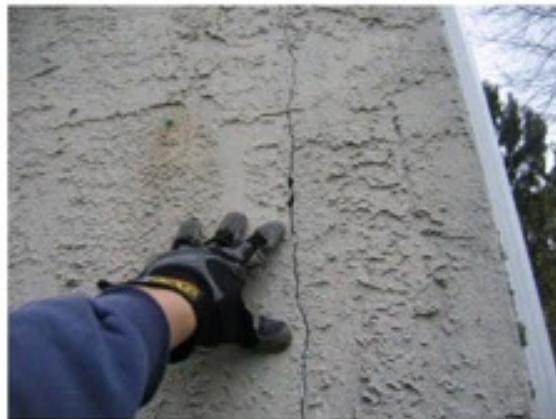
There are cracks in the stucco that need correction and further evaluation by a stucco professional. The cracks could indicate settlement or movement of the house structure. Most of the cracks are open, and not sealed or patched well. Located on the right-side wall, rear right corner, and rear wall.

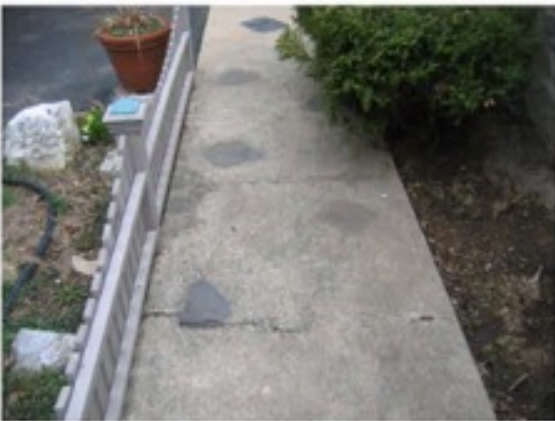
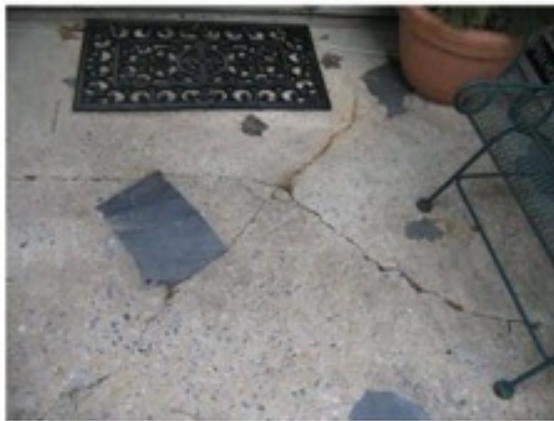
There's a crack in the walk, but it does not seem to be a trip hazard.

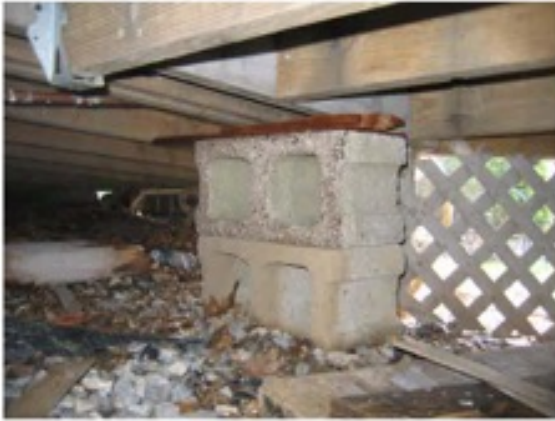
Concrete blocks being used for load-bearing support are turned on their side. Not installed properly. A block on its side is weak, and could collapse under weight.

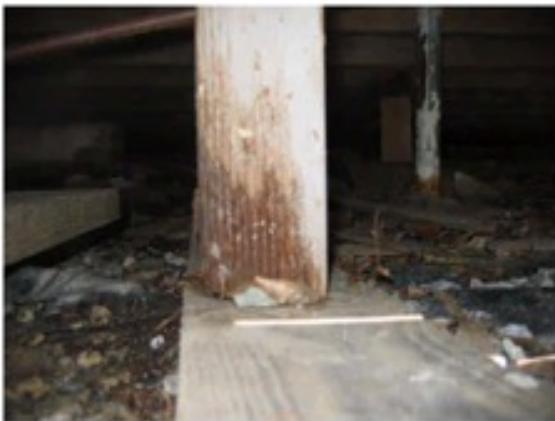
Wood rot at the deck support post. Underneath, center area.

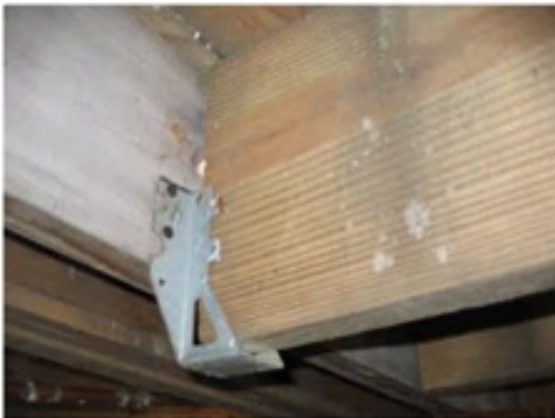
Improperly installed joist hanger on a joist end and beam. Underneath and center area.

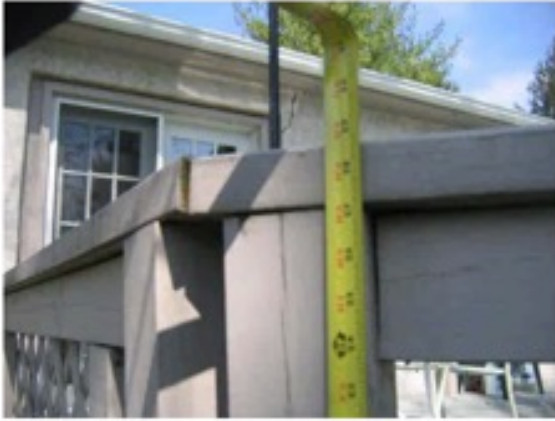
The deck spindles or boards have open spaces that are too far apart. No more than 4 inches of space is allowed by common standards. Safety hazard for small children. A protective barrier should be installed or correction to the spindle spacing. Lattice is not strong enough. Railing height is too low at 29 inches. Missing railing section at tub area.

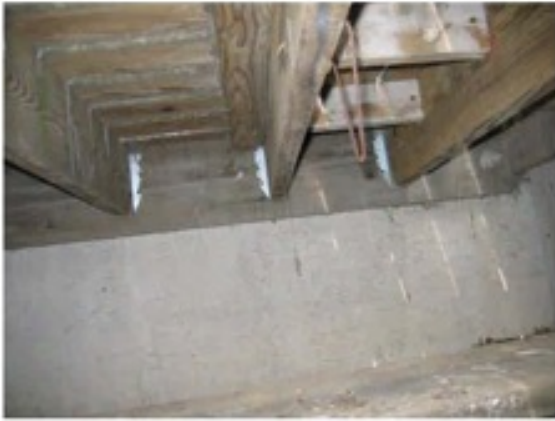
The deck ledger board is attached to the structure with some masonry screws. May be subject to withdrawal. Appears inadequate. The ledger board of the deck should be secured with large-diameter through-bolts or lag screws, every 16 inches or so. Further evaluation by a deck contractor is recommended.

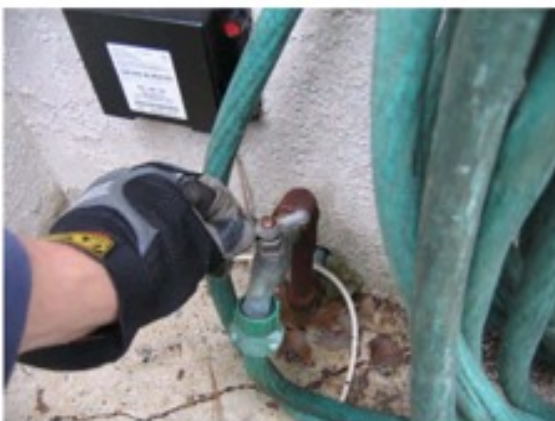
The faucet is not frost-free. Consider replacing the faucet with frost-free hose bibs. To prevent freeze-burst problems in the winter. Or be sure remove the hoses and drain the faucets before winter, to prevent freezing and bursting problems.

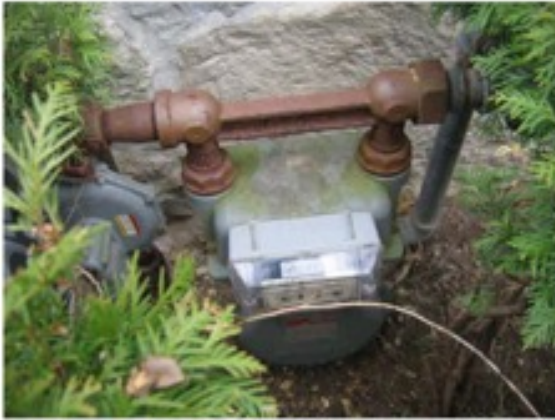
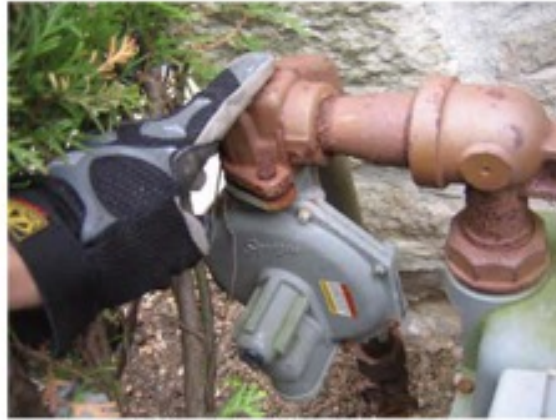
The gas meter has some surface rust on it.

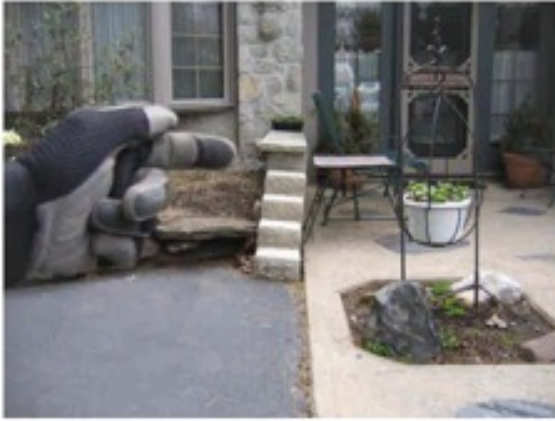
The small retaining wall in the front is leaning. Does not appear to be a major defect - like an imminent collapse. But monitoring is needed.

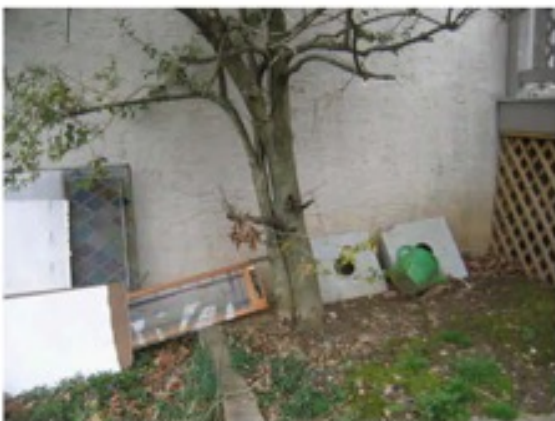
There is a tree next to the house and foundation. Rear of house. The roots of mature trees could have an adverse effect on the foundation and structure. You may wish to consult with an arborist who could inform you about the root system.

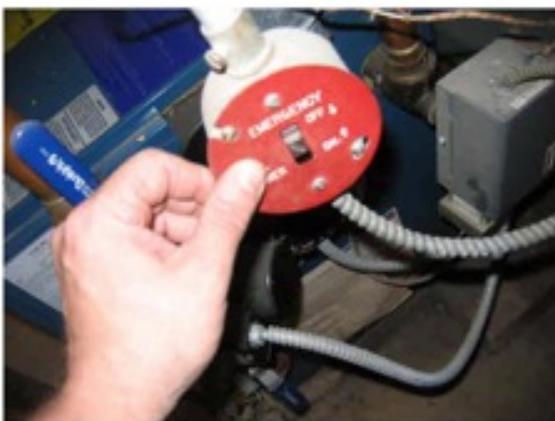
The electric shut-off switch for the heating system is loose.

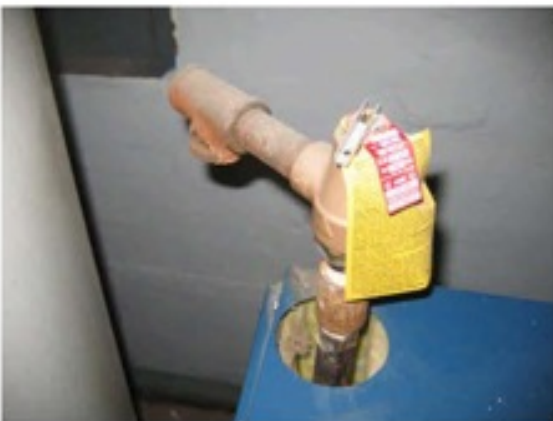
The relief valve on the boiler has no extension pipe installed for safety.

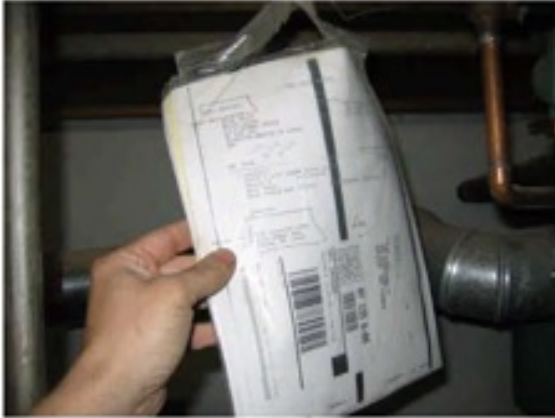
There is no visible record of recent service of the heating system (within the past year). Possibly indicating delayed maintenance. The heating system needs serviced every year.

Recommend having the heating system inspected, cleaned, and serviced by an HVAC professional.

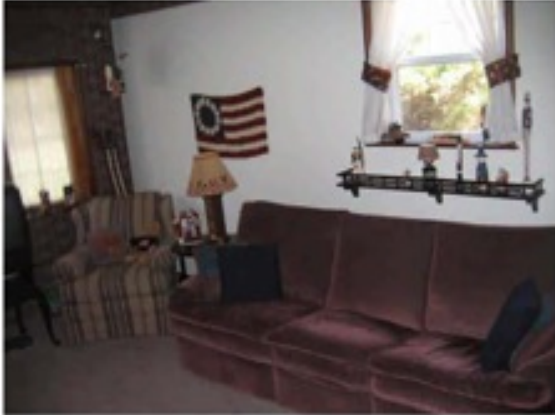
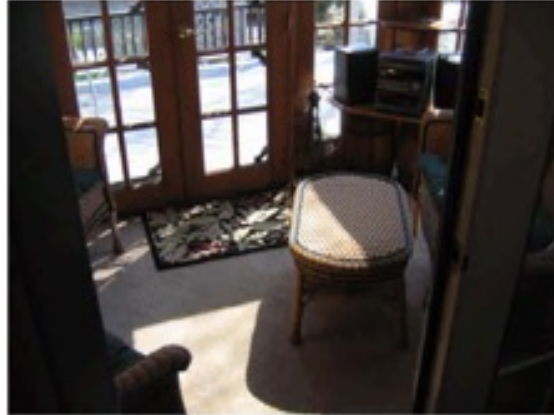
Not every room has a boiler heat source. Far left room included. And rear sun room.

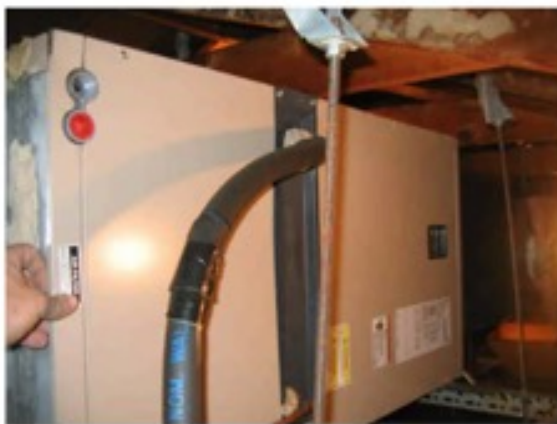
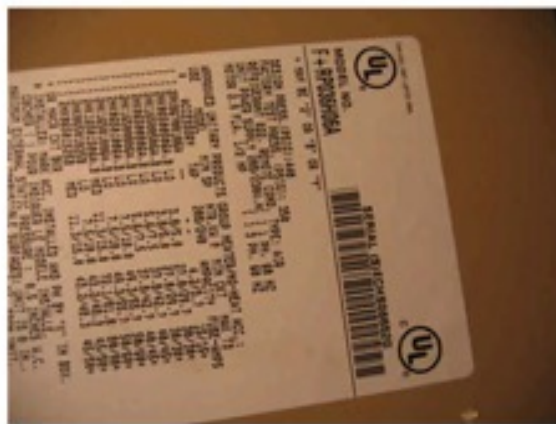
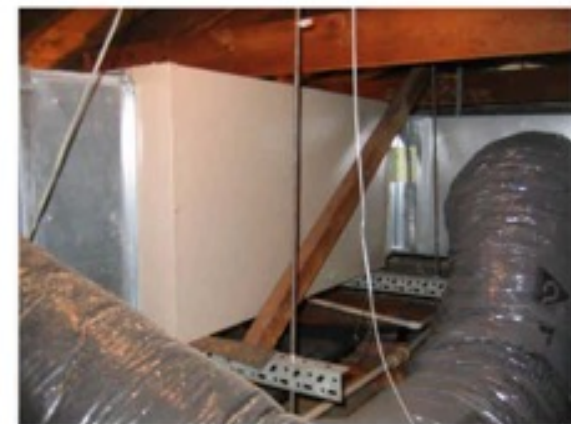
Location of Interior Evaporator

There is an interior evaporator unit located in the attic.

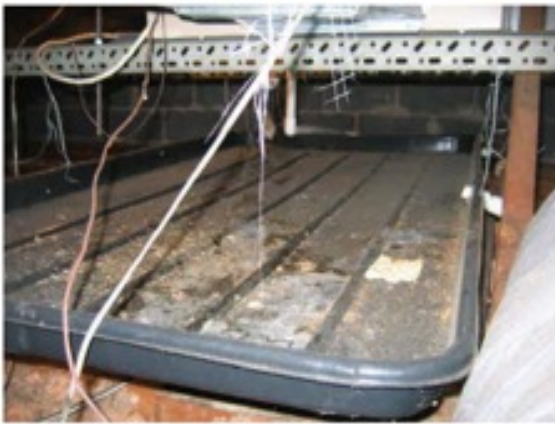
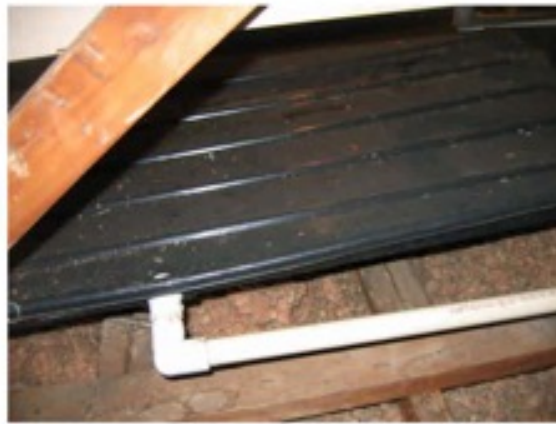
Estimated Age

The estimated age of the interior air handler is 10 to 15 years old, with 5 years of service life expected.

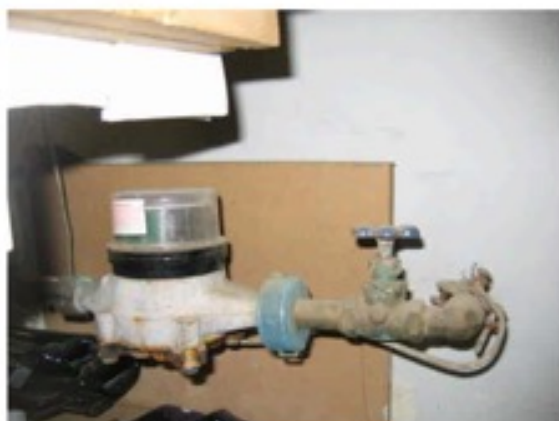
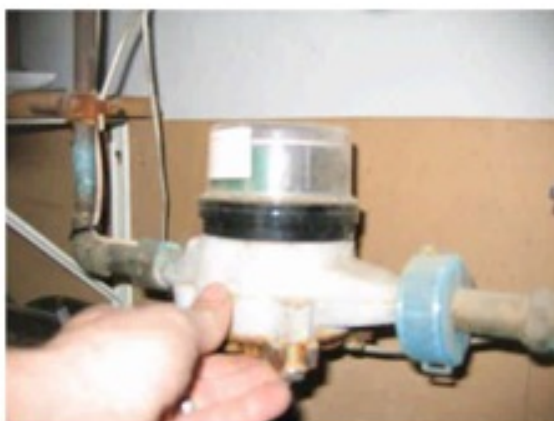
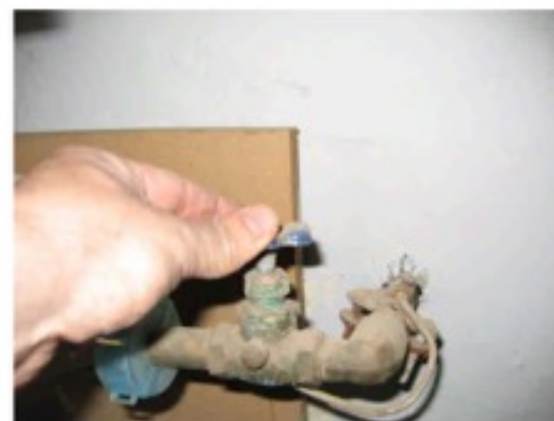
Water Meter

The water meter is located near the main water shut-off valve.

There are no active water leaks at meter. Good.

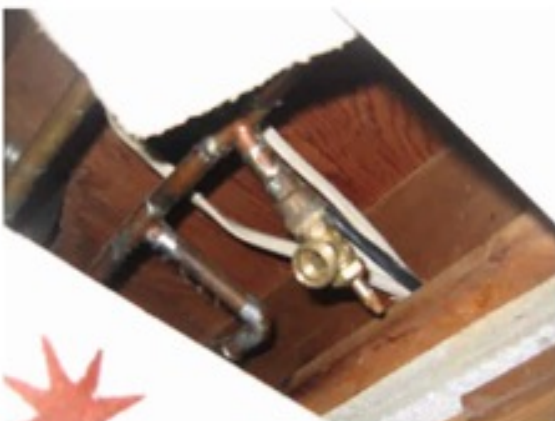
There is a missing handle at a water shut-off valve. Above laundry.

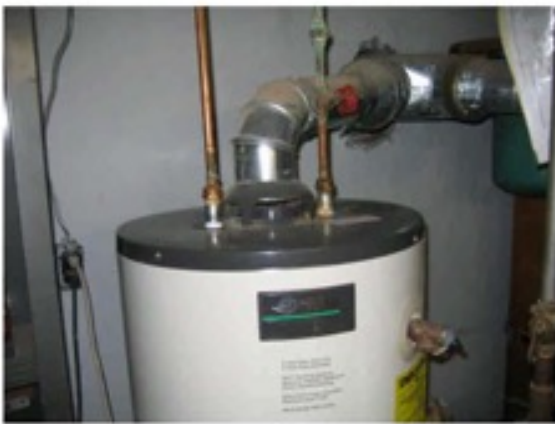
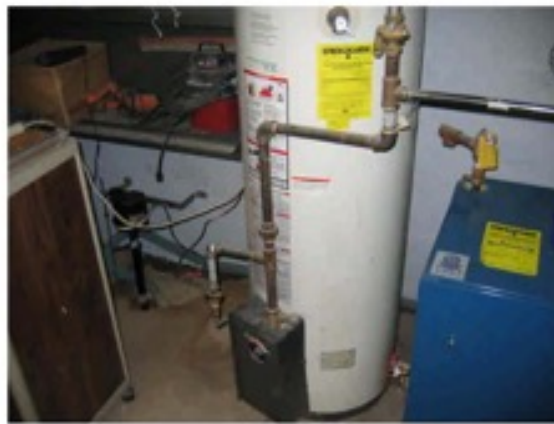
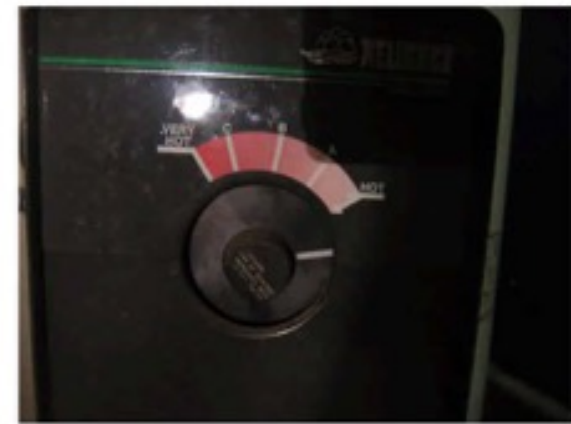
Size

The water heater is 50 gallons in size.
