## Majeske Home Inspection Services

## Certified Home Inspection Report

**601 E Sherwood Rd.**

Inspected on Mon, Jan 22 2018 at 9:00 AM

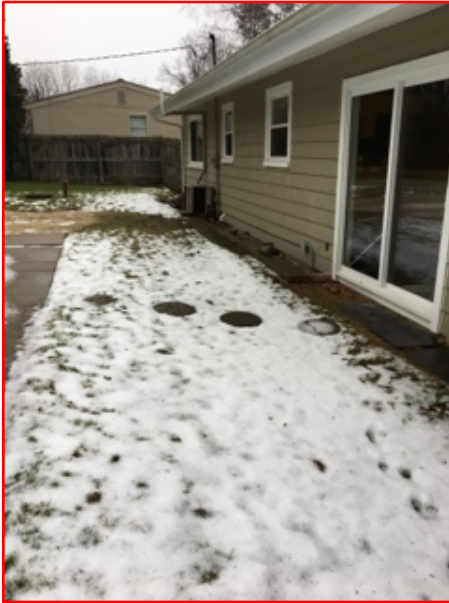
Figure 2-1

The external grading currently allows rain and surface water to flow towards the structure in several locations. This can contribute to potential water penetration into the structure. I recommend building up the grade with heavy fill dirt so that the ground slopes away from the structure for several feet with a grade of at least 1 inch/foot.

1) Comment 2: The external grading currently allows rain and surface water to flow towards the structure in several locations. This can contribute to potential water penetration into the structure. I recommend building up the grade with heavy fill dirt so that the ground slopes away from the structure for several feet with a grade of at least 1 inch/foot.

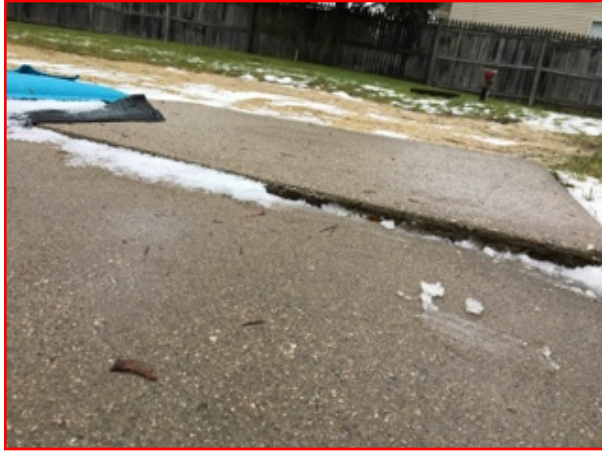
Figure 3-1

The concrete pool patio has settling and/or heaving that can pose a trip hazard. Recommend consulting with a concrete company to consider mud jacking the concrete to bring it back up to level or to consider replacement of the concrete.

2) Comment 3: The concrete pool patio has settling and/or heaving that can pose a trip hazard. Recommend consulting with a concrete company to consider mud jacking the concrete to bring it back up to level or to consider replacement of the concrete.

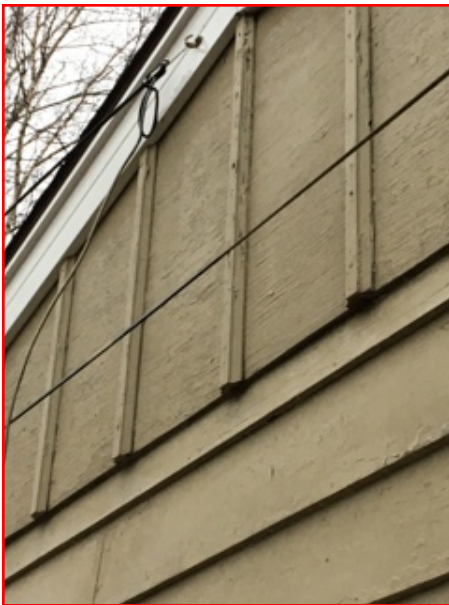
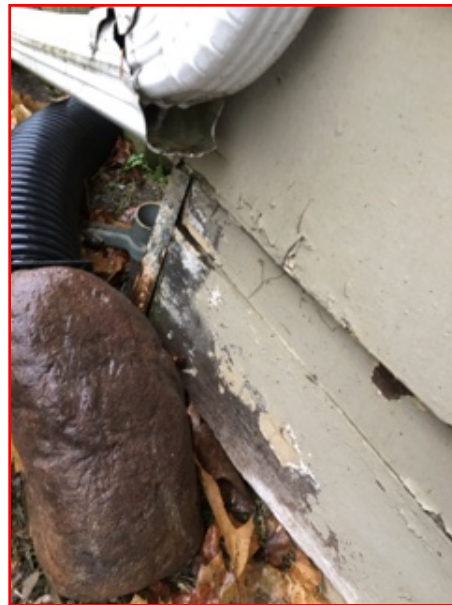
The wood siding has areas of exposed, unprotected wood surfaces. Recommend scraping and painting the wood to seal and prevent future water penetration.

3) Comment 4: The wood siding has areas of exposed, unprotected wood surfaces. Recommend scraping and painting the wood to seal and prevent future water penetration.

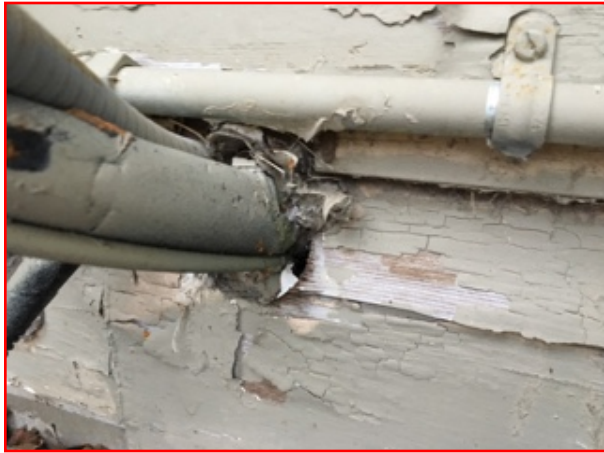
Figure 5-1

The hole(s) where the A/C line enters the house is not sealed properly. This can allow insects and rodents to enter wall. Recommend sealing the hole with steel wool and caulk or petroleum based plumbers putty.

4) Comment 5: The hole(s) where the A/C line enters the house is not sealed properly. This can allow insects and rodents to enter wall. Recommend sealing the hole with steel wool and caulk or petroleum based plumbers putty.

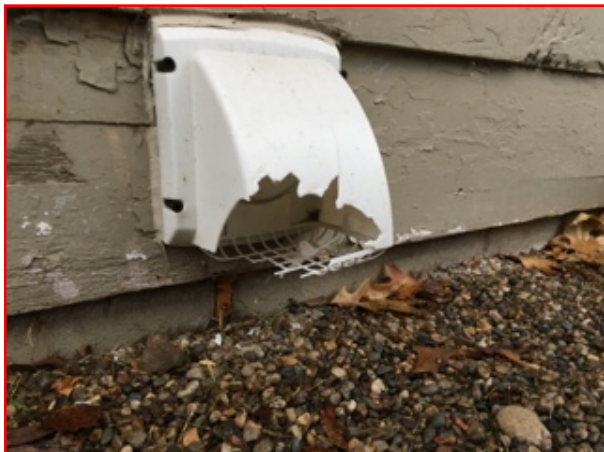
Figure 6-1

The dryer vent is damaged on the northeast corner of the house. This could allow animals and insects to enter the duct. Recommend repair or replacement.

5) Comment 6: The dryer vent is damaged on the northeast corner of the house. This could allow animals and insects to enter the duct. Recommend repair or replacement.

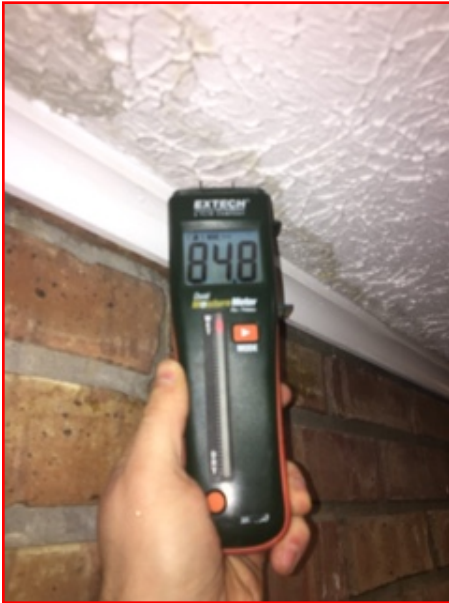
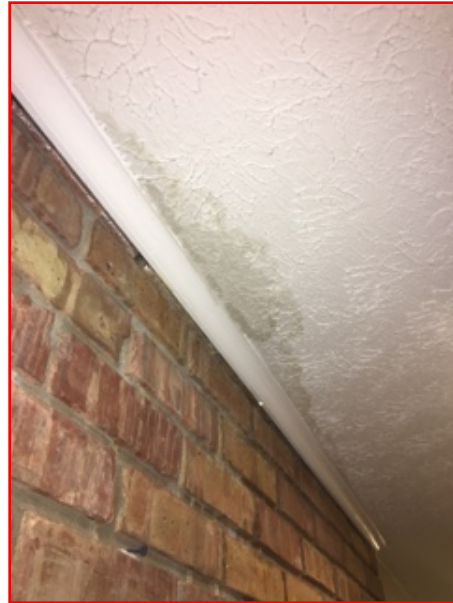
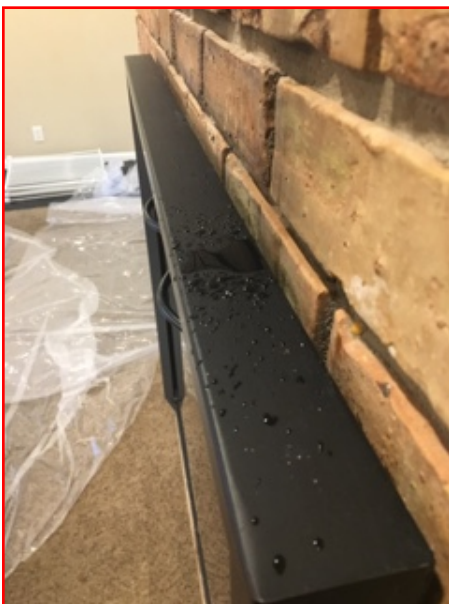
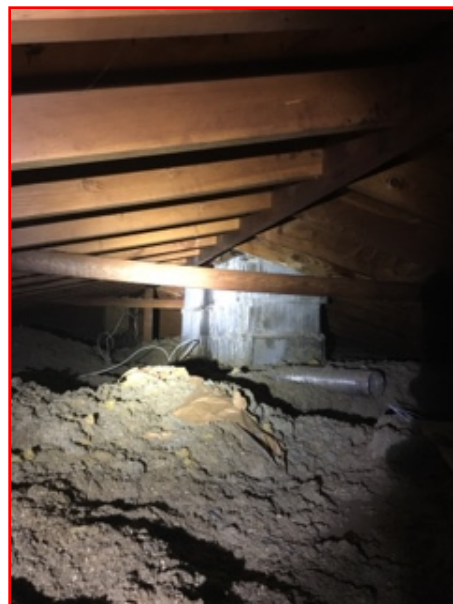
There is moisture and staining present on the drywall in the ceiling over the fireplace. This could indicate a roof leak or flashing issue. Recommend evaluation and repair by a roofer.

6) Comment 7: There is moisture and staining present on the drywall in the ceiling over the fireplace. This could indicate a roof leak or flashing issue. Recommend evaluation and repair by a roofer.

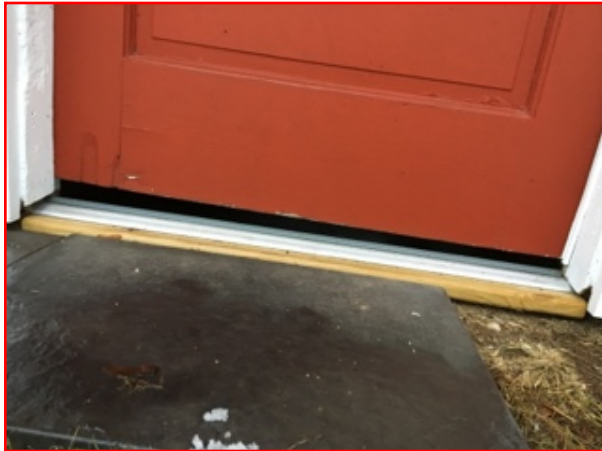
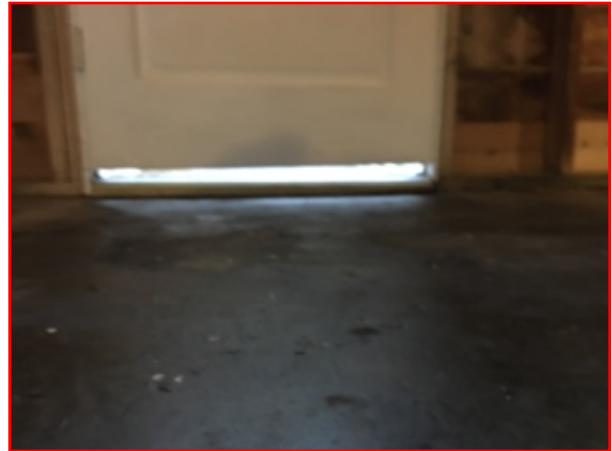
There is visible daylight below the service door to the garage. This could allow insects and animals into the garage. Recommend consulting with a door specialist to consider installing a weatherstrip or threshold around the perimeter of the door to more properly seal it.

7) Comment 8: There is visible daylight below the service door to the garage. This could allow insects and animals into the garage. Recommend consulting with a door specialist to consider installing a weatherstrip or threshold around the perimeter of the door to more properly seal it.

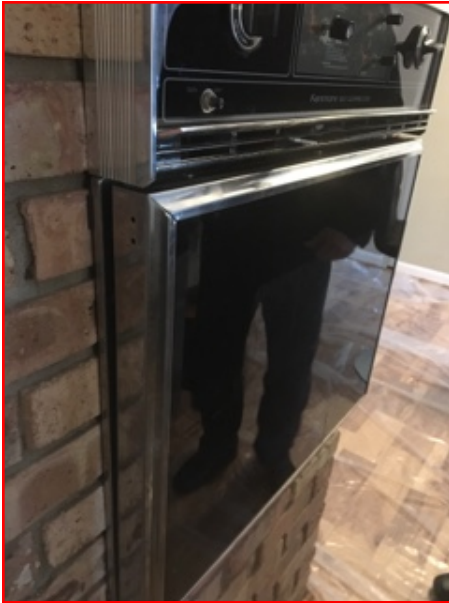
Figure 9-1

The handle is missing from the wall oven. Recommend repair.

8) Comment 9: The handle is missing from the wall oven. Recommend repair.

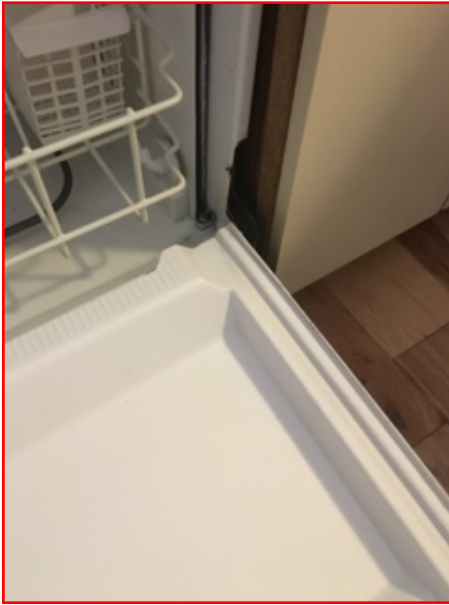
Figure 10-1

The dishwasher door hinges are damaged. Recommend evaluation and repair by an appliance specialist.

9) Comment 10: The dishwasher door hinges are damaged. Recommend evaluation and repair by an appliance specialist.

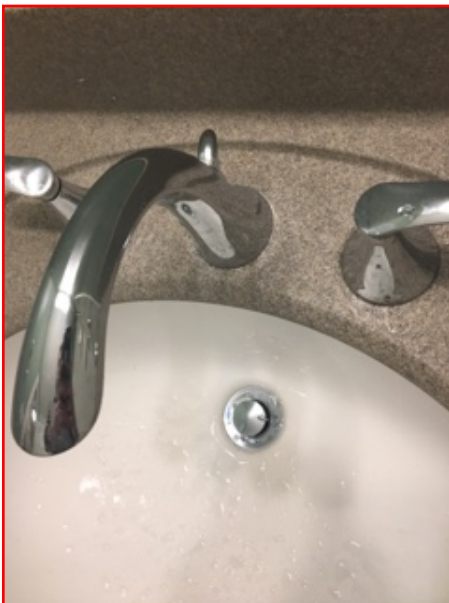
Figure 11-1

Main floor hallway sink drain stop does not operate. Requires repair for proper operation.

10) Comment 11: Main floor hallway sink drain stop does not operate. Requires repair for proper operation.

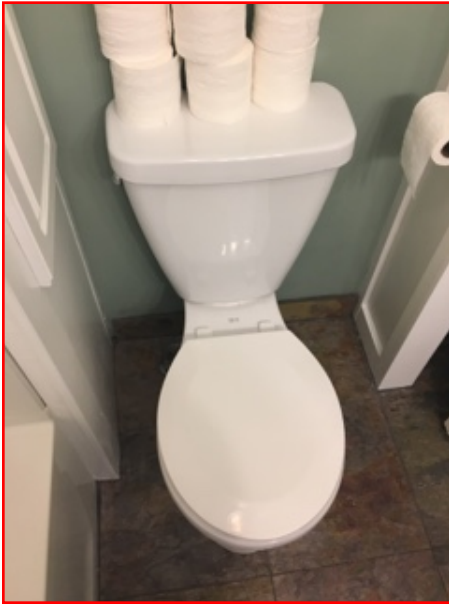
Figure 12-1

The main level hallway-bath toilet is loose on floor. Recommend properly securing the toilet to the toilet flange.

11) Comment 12: The main level hallway-bath toilet is loose on floor. Recommend properly securing the toilet to the toilet flange.

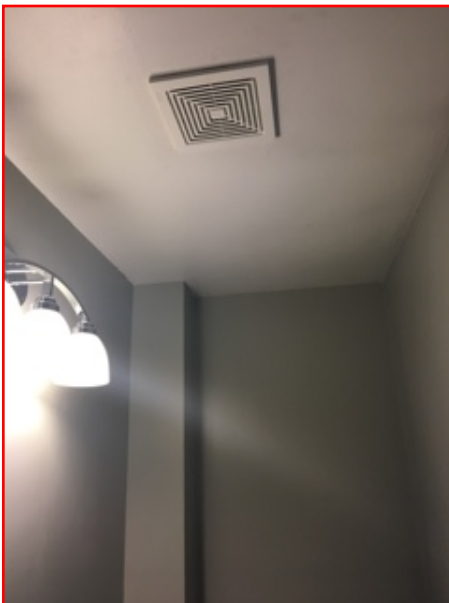
Figure 13-1

The ceiling fan does not operate in the master bathroom. Recommend evaluation and repair as necessary by an electrician.

12) Comment 13: The ceiling fan does not operate in the master bathroom. Recommend evaluation and repair as necessary by an electrician.

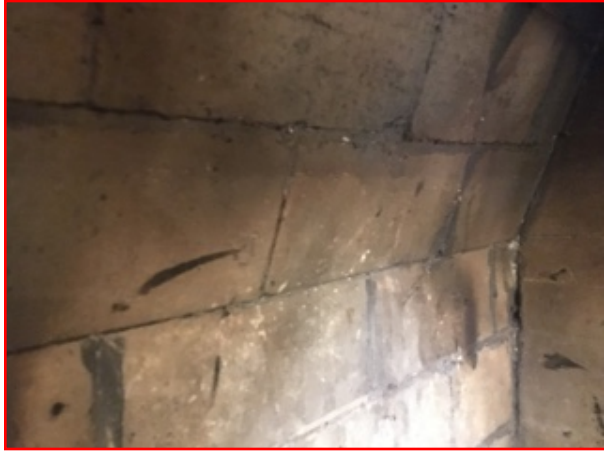
Figure 14-1

13) Comment 14: The brick firebox has loose mortar joints. This could allow for heat loss and damage to the rest of the chimney. Recommend evaluation and repair by a mason or chimney sweep.

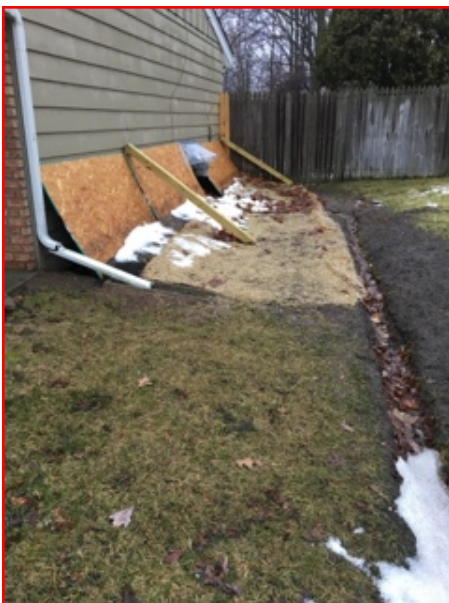
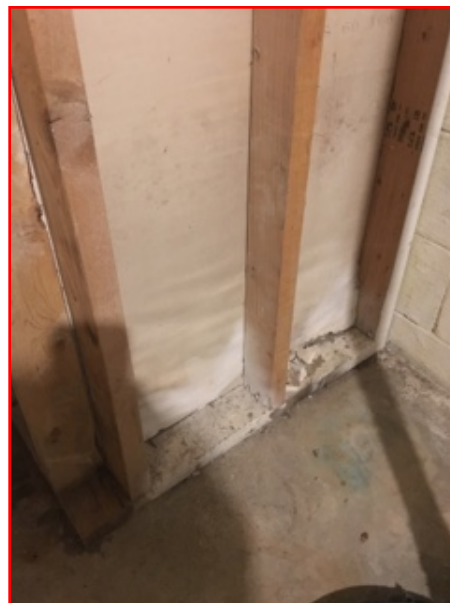
14) Comment 15: There are signs of prior water penetration into the basement. I recommend building up the grade around the house, keeping the gutters clean for proper operation and maintaining downspout extensions so as to direct the surface water away from the foundation. Further evaluation by a water containment company should be considered.

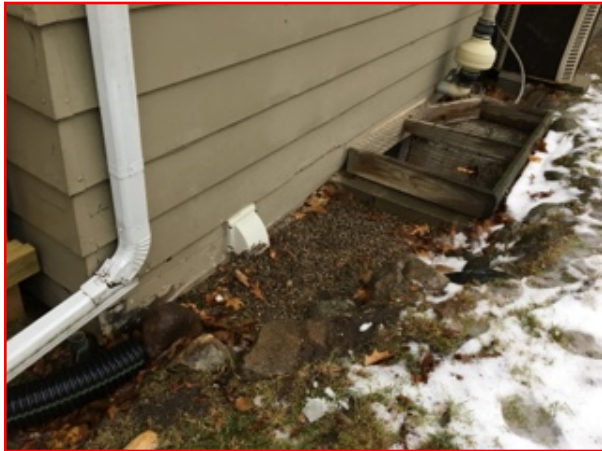
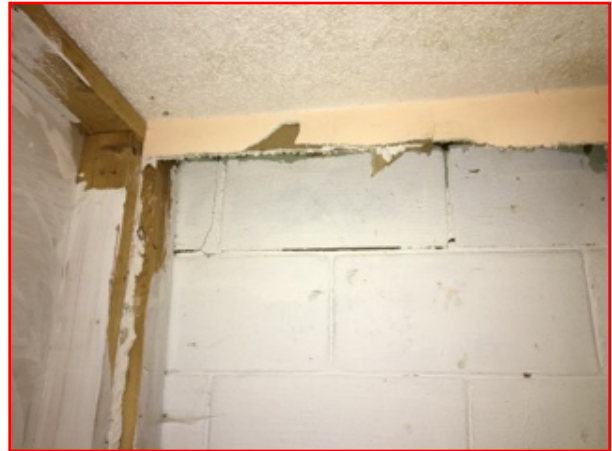
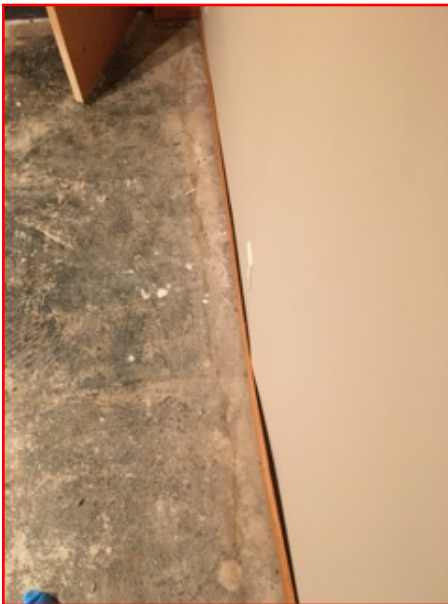
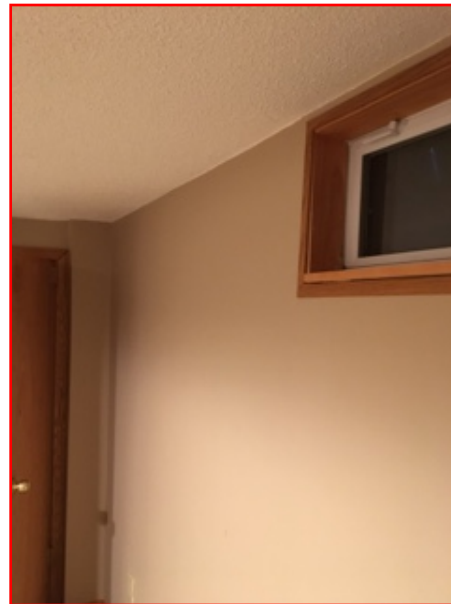
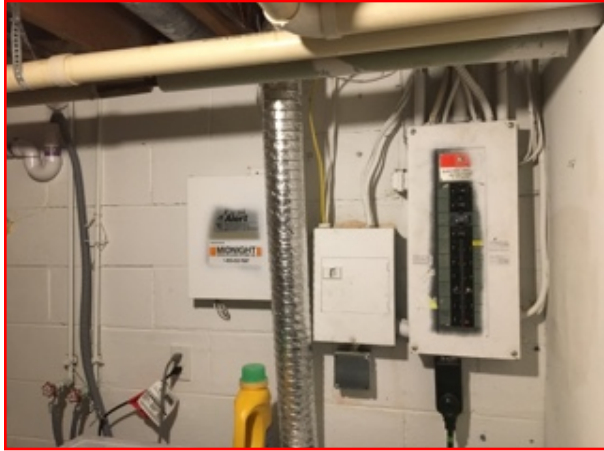
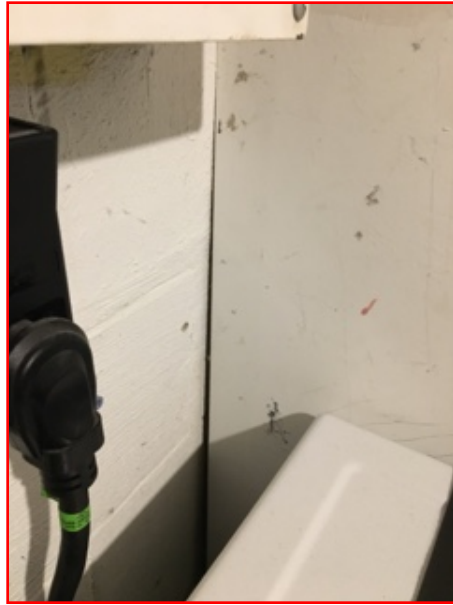
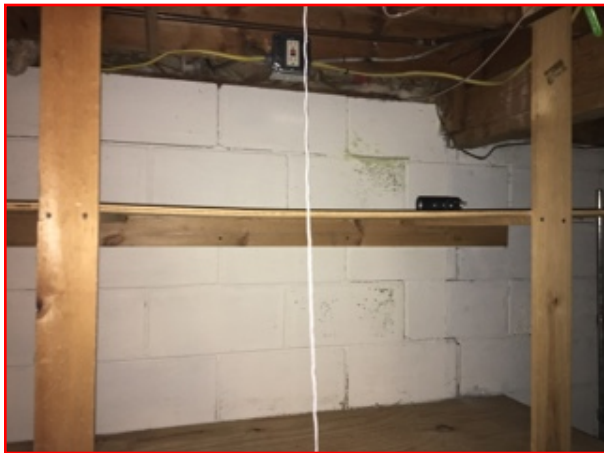
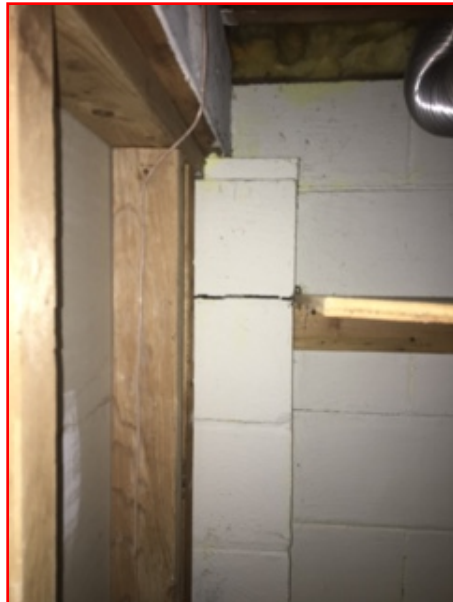
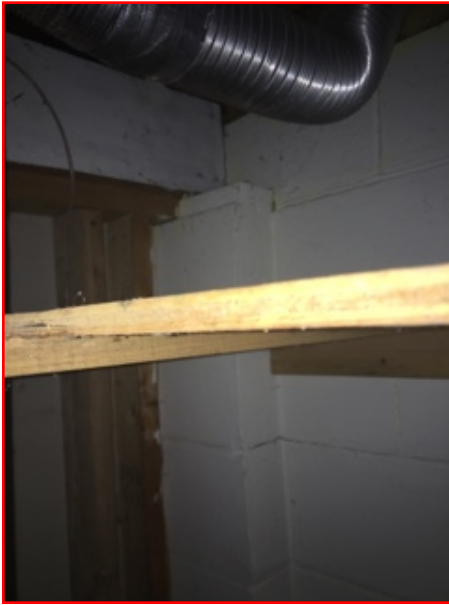
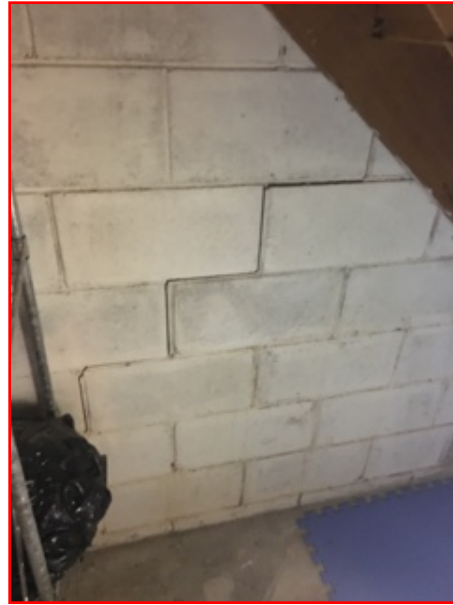
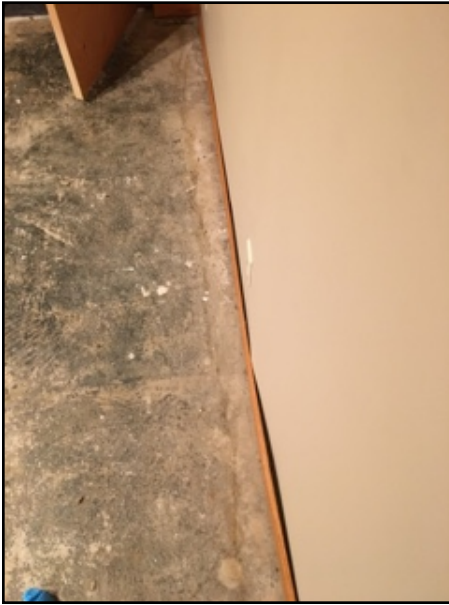
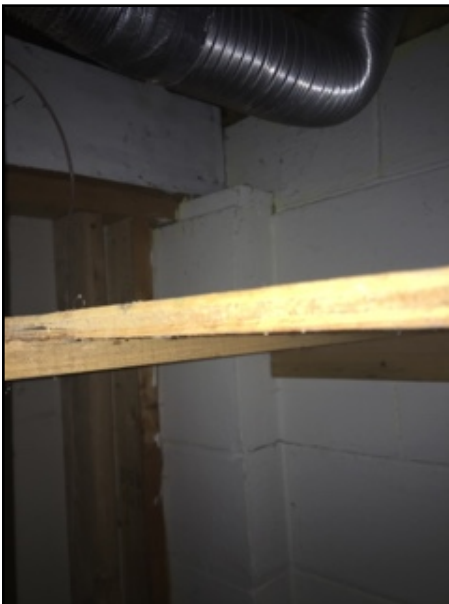
15) Comment 16: Although the north and east foundation walls are finished, there are signs that these walls may be bowed. The West foundation wall is visibly bowed and the north foundation wall below the stairs is also visibly bowed with gaps between blocks present greater than 1/4 inch wide. This could indicate foundation movement. Recommend evaluation and repair as necessary by a foundation specialist.

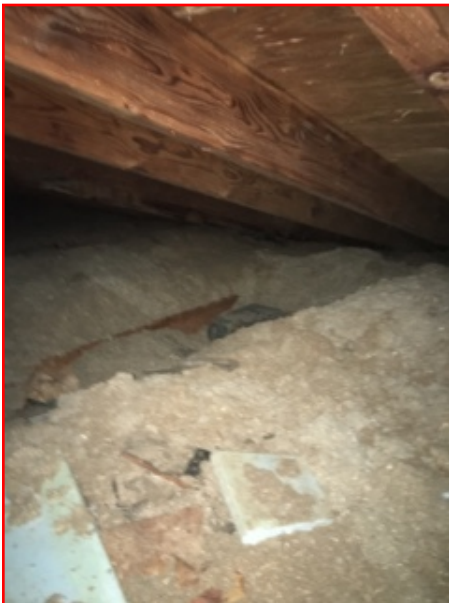
Figure 17-1

16) Comment 17: The bathroom exhaust fans vent to the attic. This can put moisture into the attic that can lead to mold growth. This also puts heat into the attic that could cause snow and ice to melt down to the soffits on the roof causing an ice dam. Recommend venting the exhaust fans through an insulated exhaust duct to the exterior of the attic.

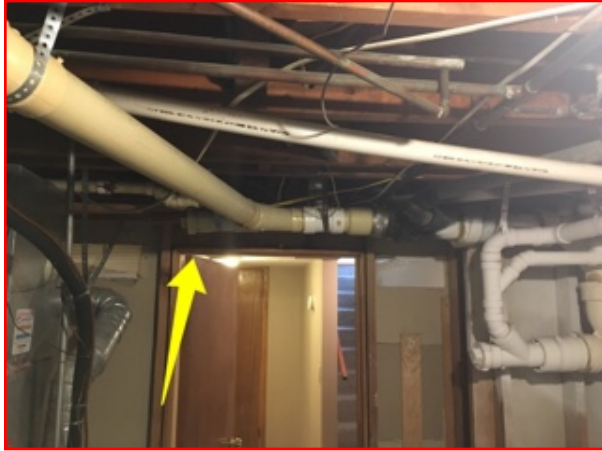
Figure 19-1

17) Comment 19: Some of the drain plumbing in the utility room appears to be graded in the wrong direction. This could allow water and solids to build up in these areas. Recommend further evaluation by a plumber.

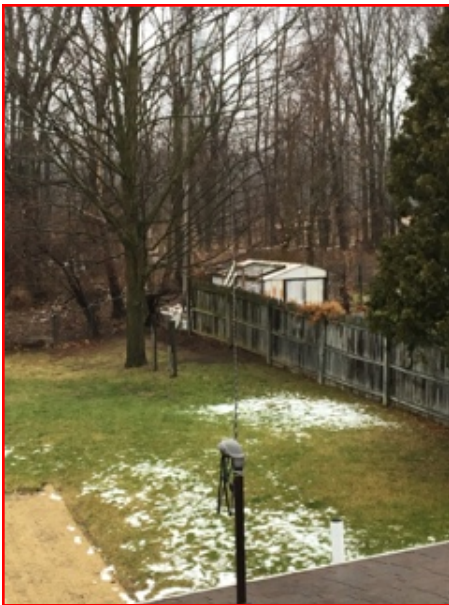
Figure 20-1

18) Comment 20: The Electric service line between the drip loop on the house and the telephone post is resting on tree branches. This is a potential hazard. Recommend consulting with the electric company to trim the branches back away from the service line.

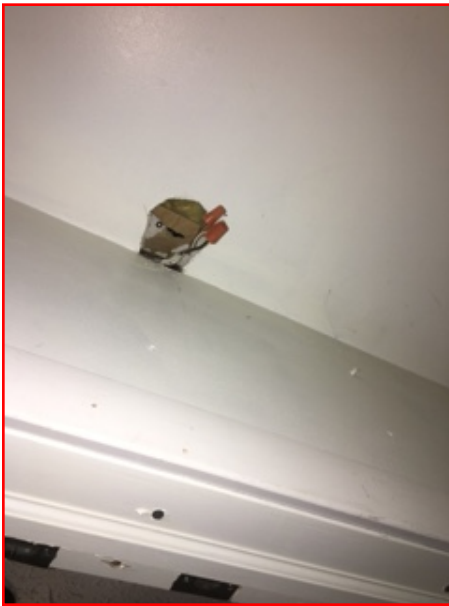
Figure 21-1

19) Comment 21: There are electrical terminations and connections that are not in covered junction boxes. Recommend evaluation and repair by an electrician.

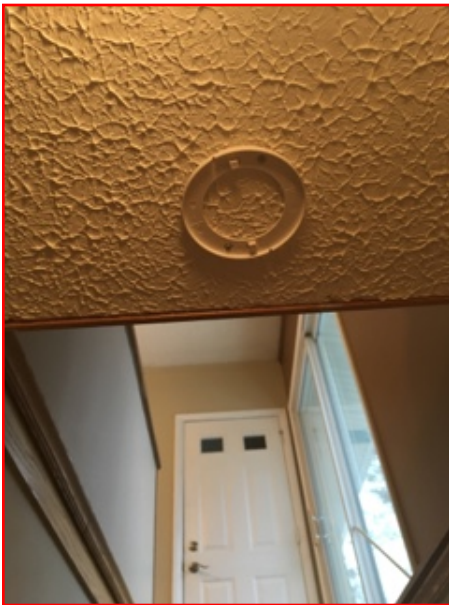
Figure 22-1

20) Comment 22: Some of the smoke detectors in the house are missing. Recommend replacement.

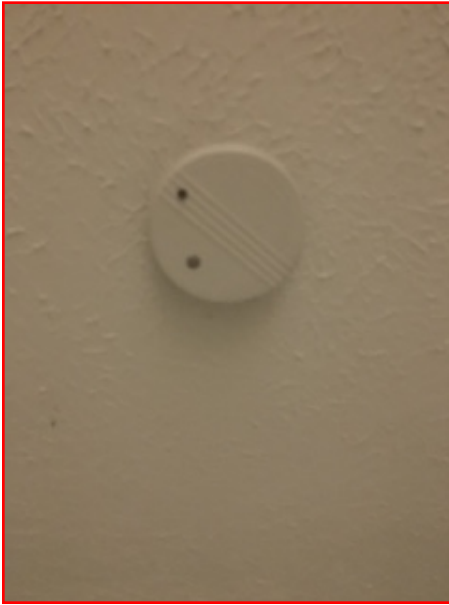
Figure 23-1

21) Comment 23: Some of the batteries are dead or missing in the smoke detectors. Recommend replacing the missing batteries.
