Home Inspection Training Class #11

July 28, 2015

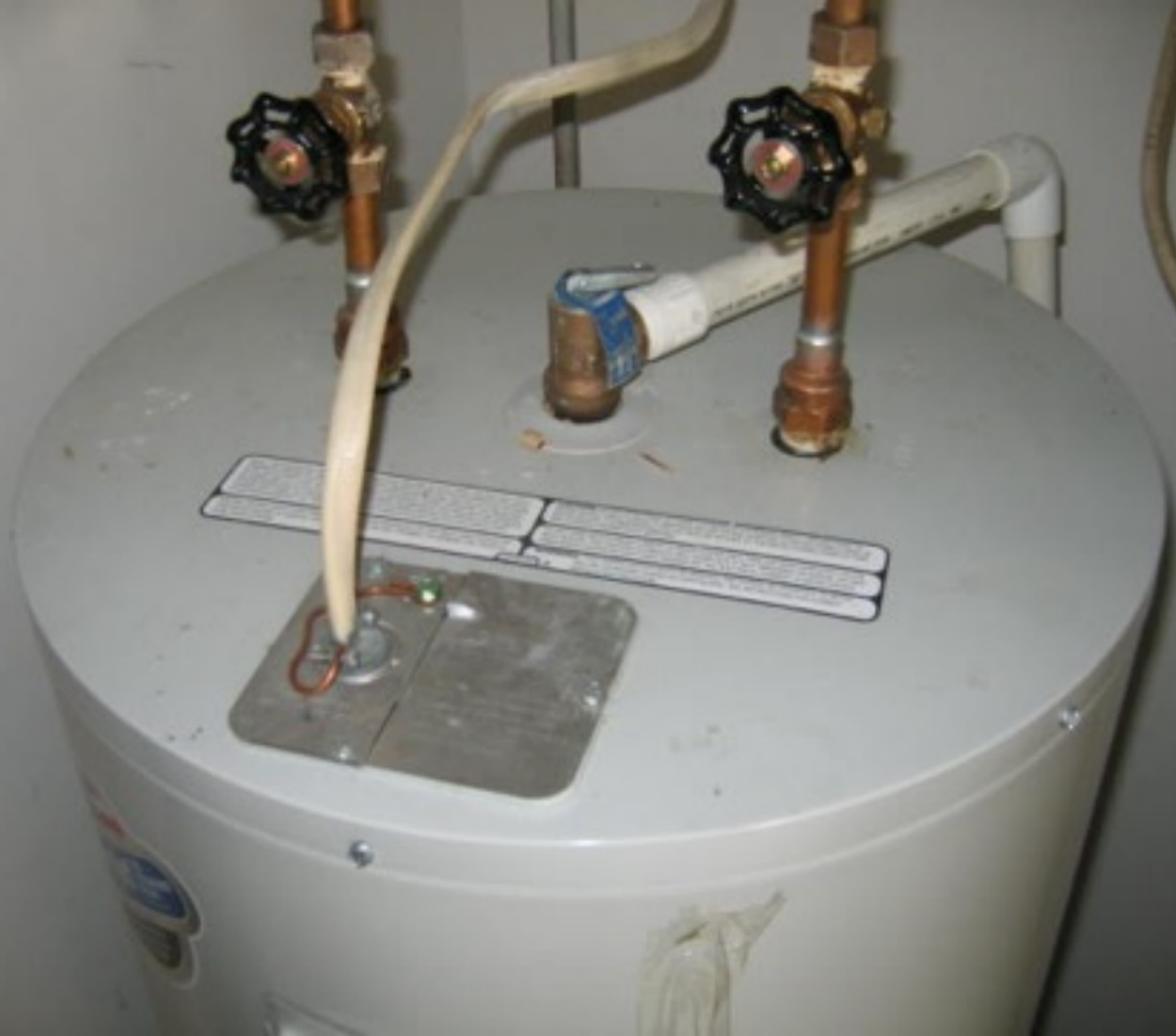
AUTOMATIC STORAGE WATER HEATER

Press: Test 300(psi), Working 150(psi)

Wattage rating based on 60 HZ

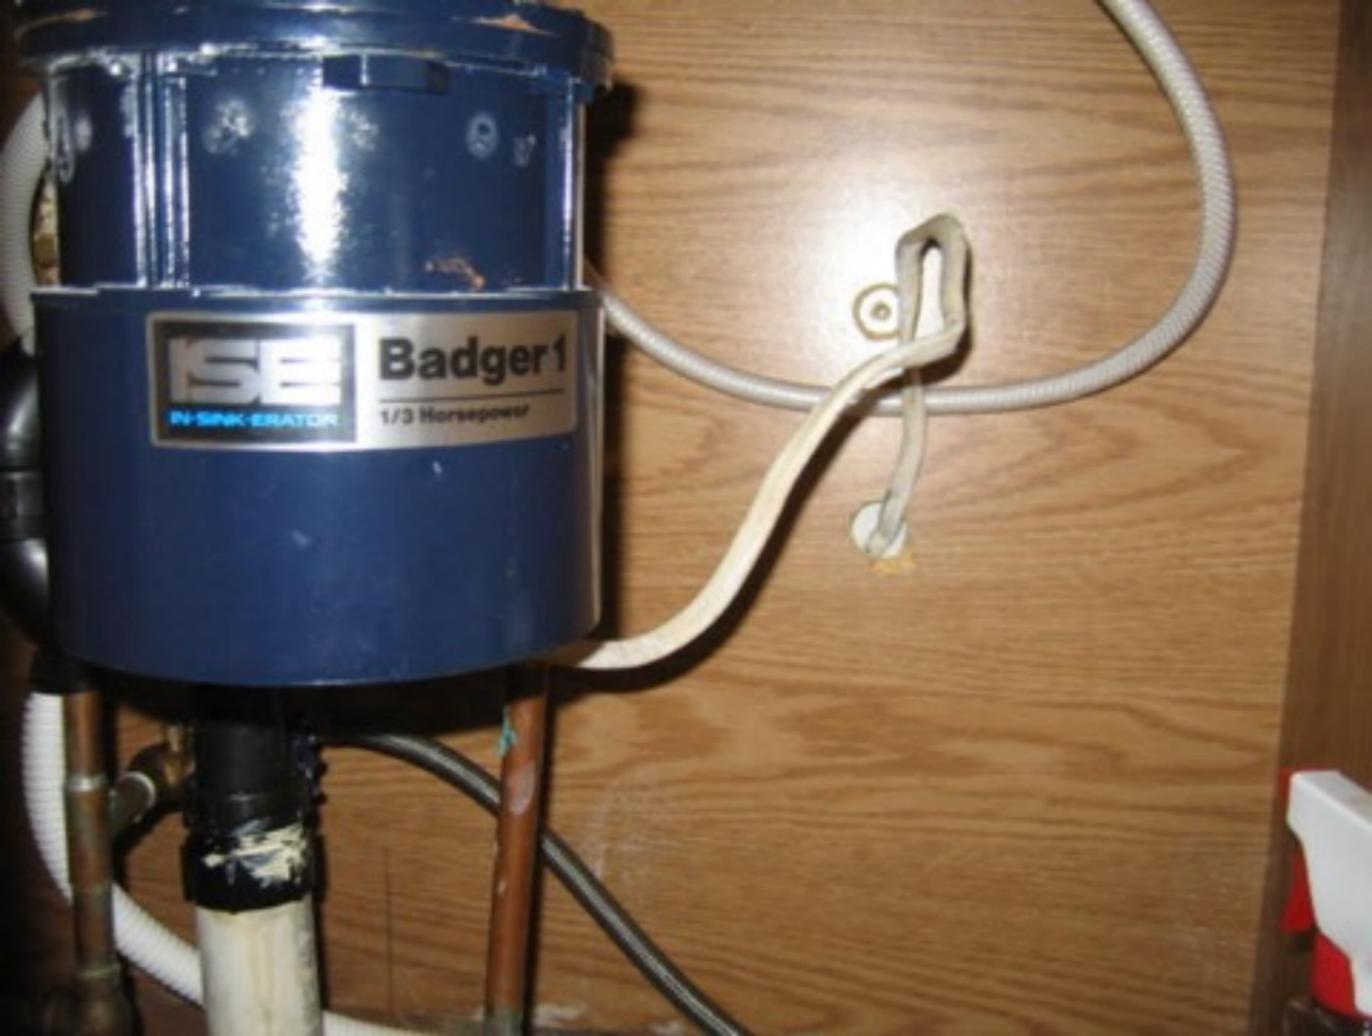
ISE
IN-SINKERATOR

Badger 1

1/3 Horsepower
