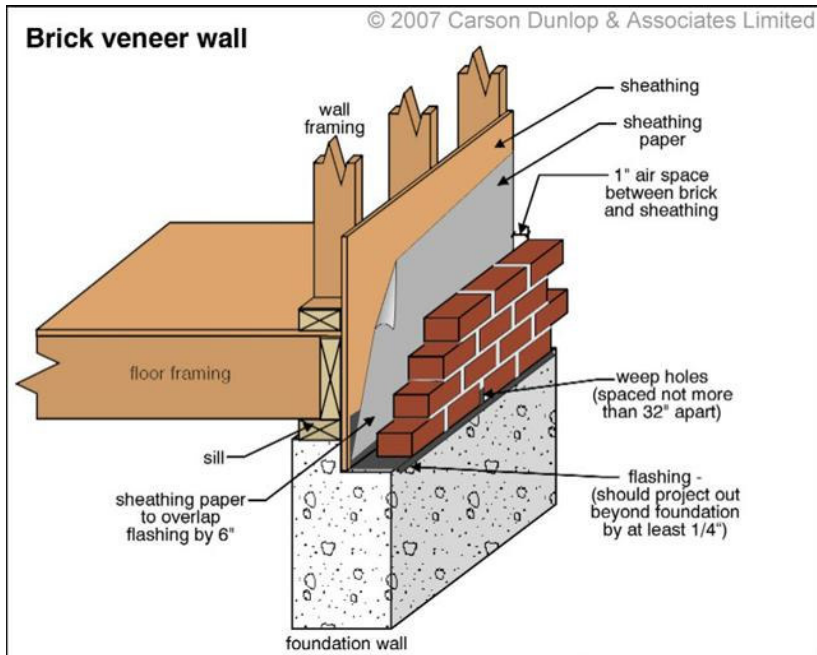
Since roughly 1970, brick veneer walls have had weep holes provided at the bottom. A brick veneer wall built today employs a rain screen principle. This principle acknowledges that a wind driven rain will pass through a brick wall, and as a result, a one inch air space is left behind the brick, between the inner face of the brick and the sheathing on the wood studs. Water is allowed to pass through the wall and run down the inner face of the brick, or the outer surface of the sheathing.

At the bottom row of bricks, every fourth vertical mortar joint (typically) is left out. A flashing is used that allows water at the bottom of the wall cavity to drain out through the weep holes. The flashing prevents the water from entering the foundation. It is also common to find weep holes above door and window openings in the brick walls. Where steel lintels are used above openings, the joint between the steel and the brick above should not be caulked.
